**Fig 1 : Adams Bristow Yard:  
Unauthorised storage of inert waste and skip waste.**

**Fig 10 : Field Common South – A total of 5 Yrs +  
from establishing the breach to remediation.**

**Fig 20 : Hurtmore Golf Course -  
Access track: removed and restored.**

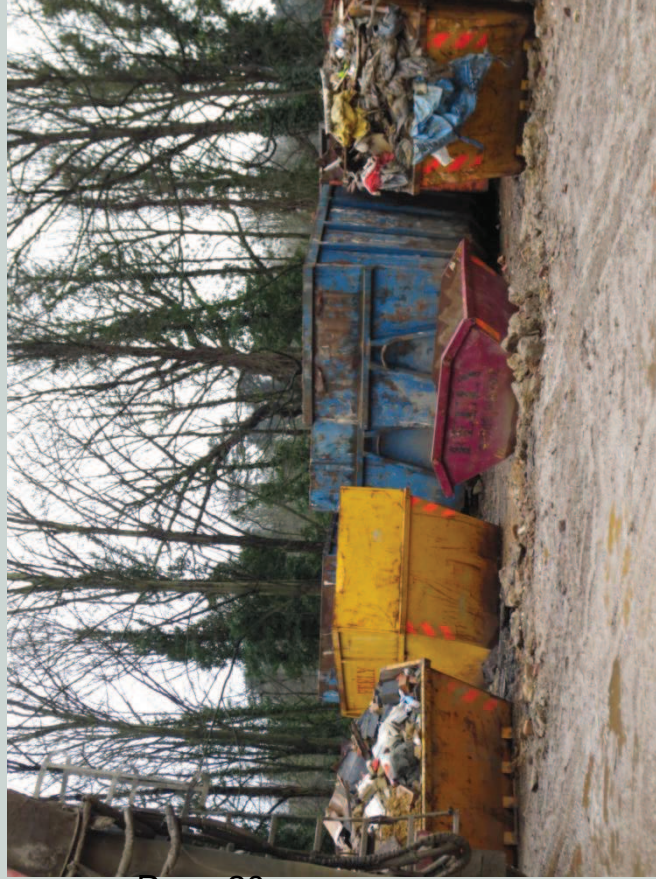
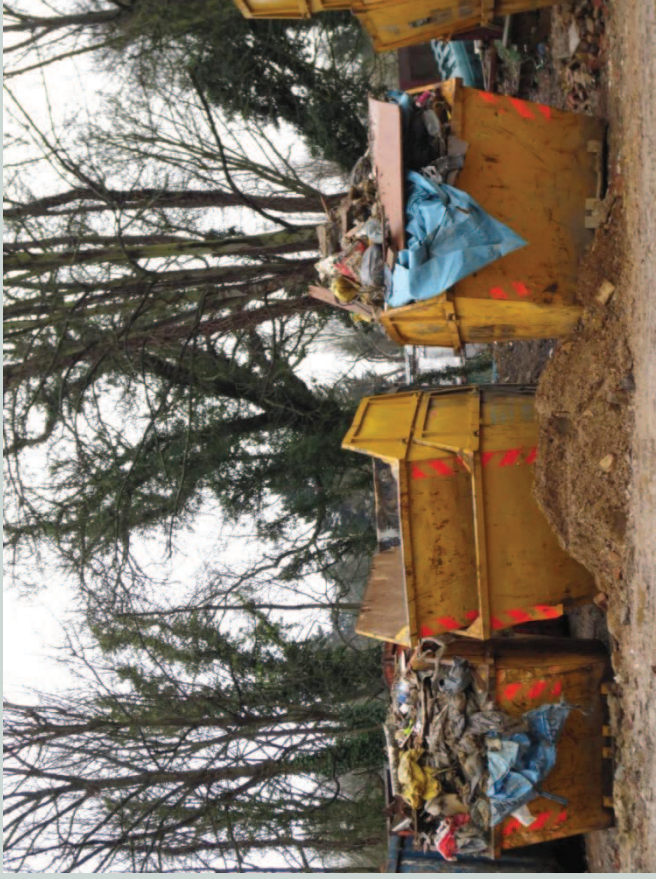
Fig 2 : Unauthorised storage of both inert and skip waste.

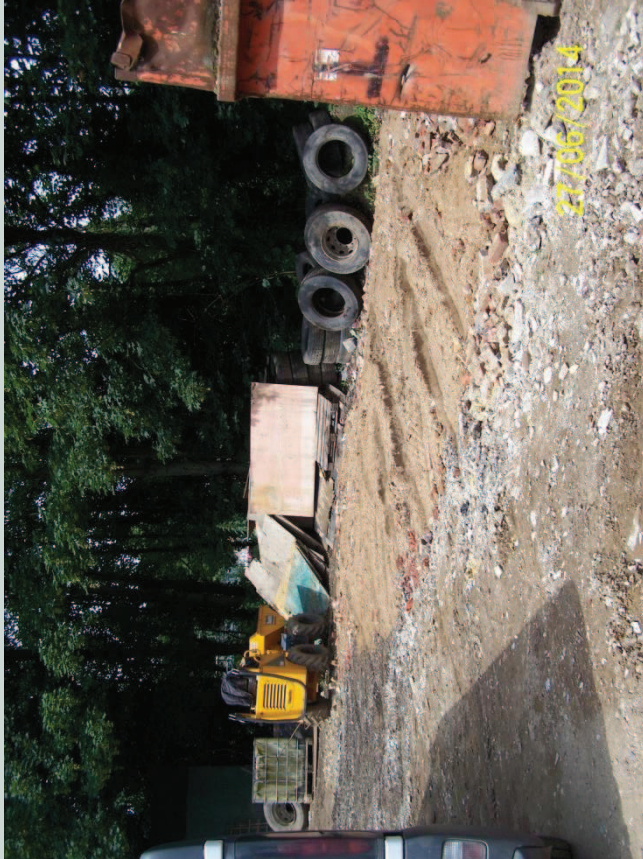
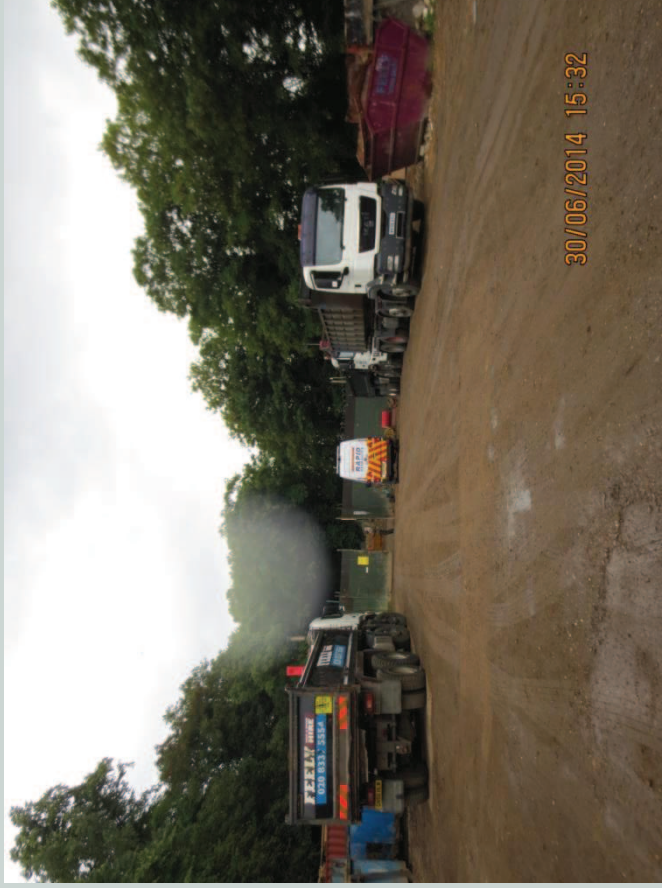
Fig 3 : Site cleared of all inert and skip waste.

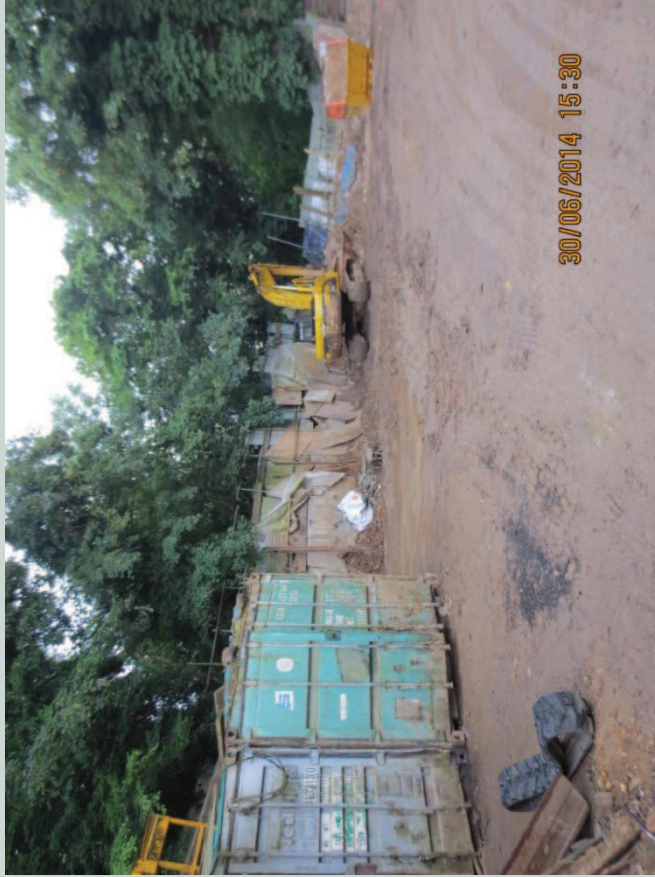
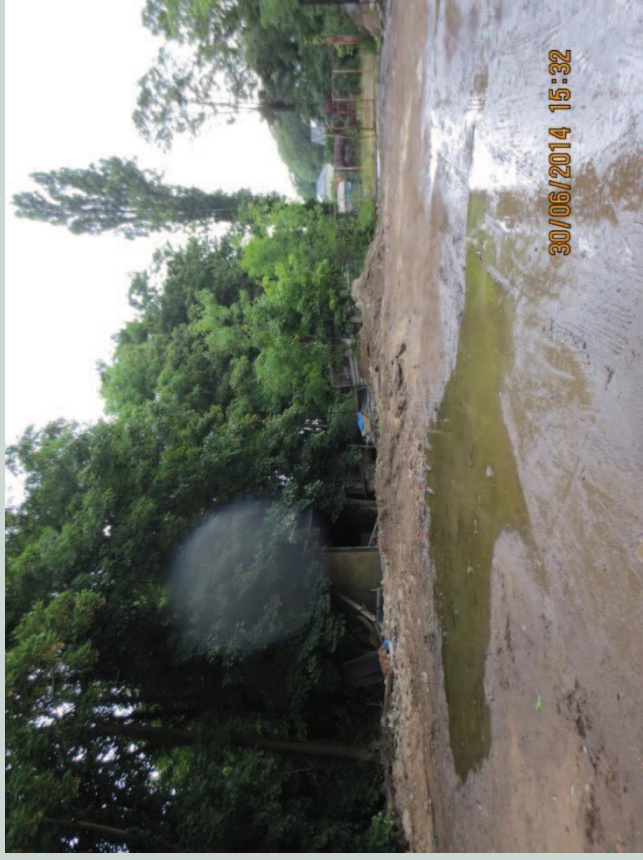
Fig 4 : Site cleared.

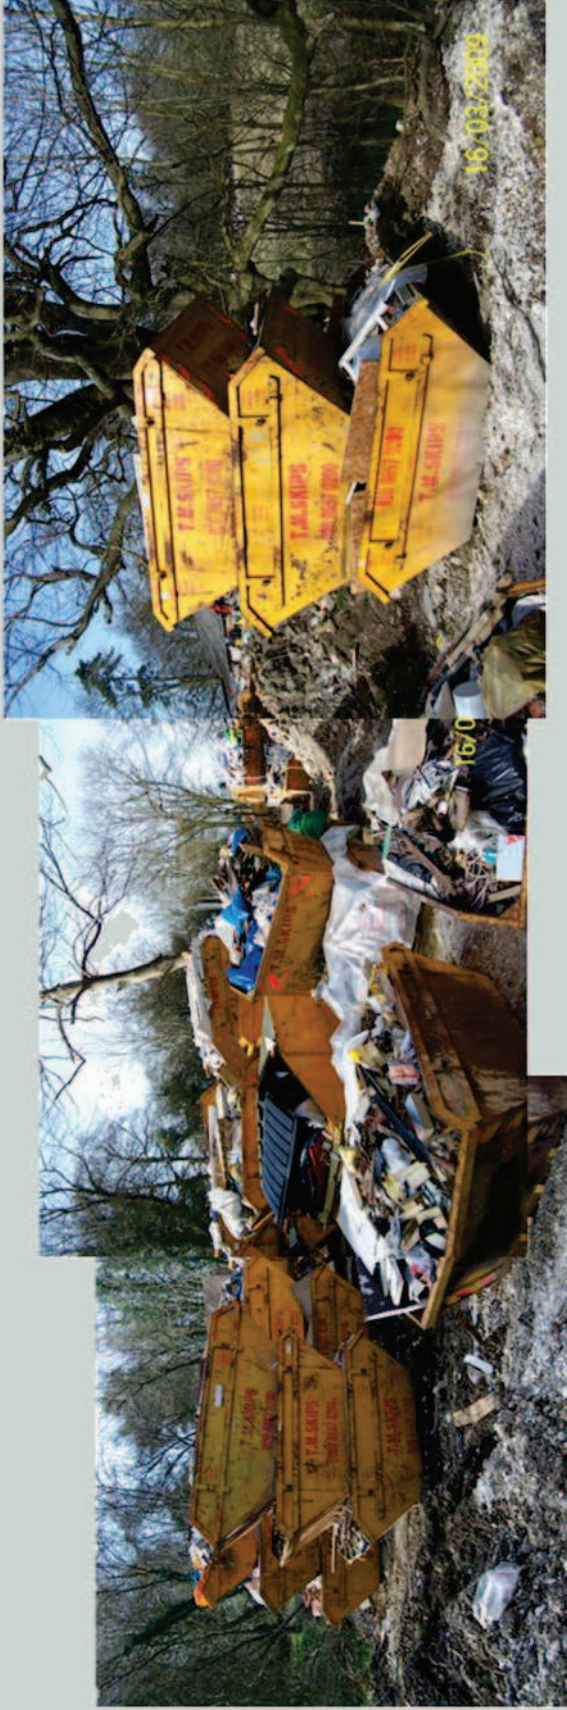
Fig 5 : Barnfield: Unauthorised waste deposit, transfer & disposal - 2009.

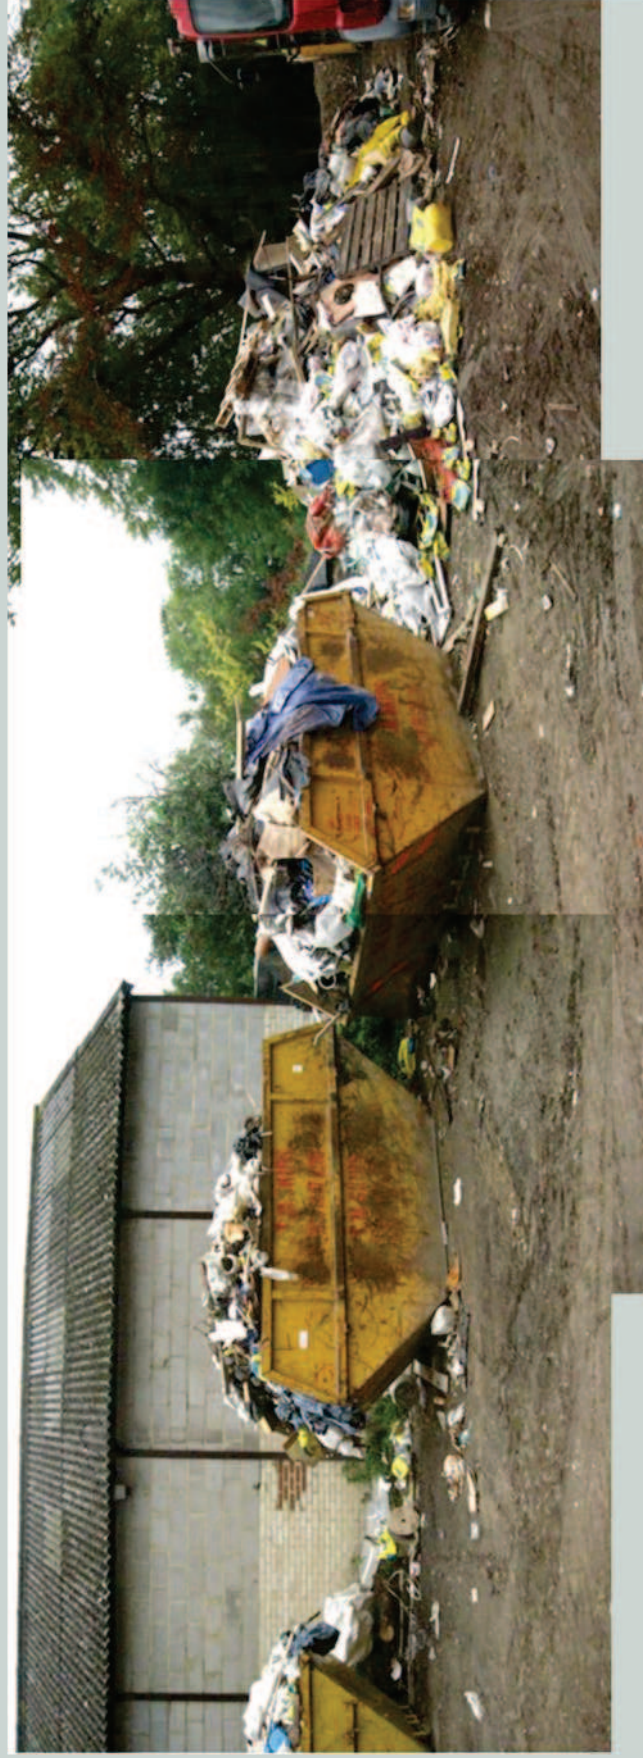
Fig 6 : Unauthorised waste deposit, transfer & disposal – 2010.

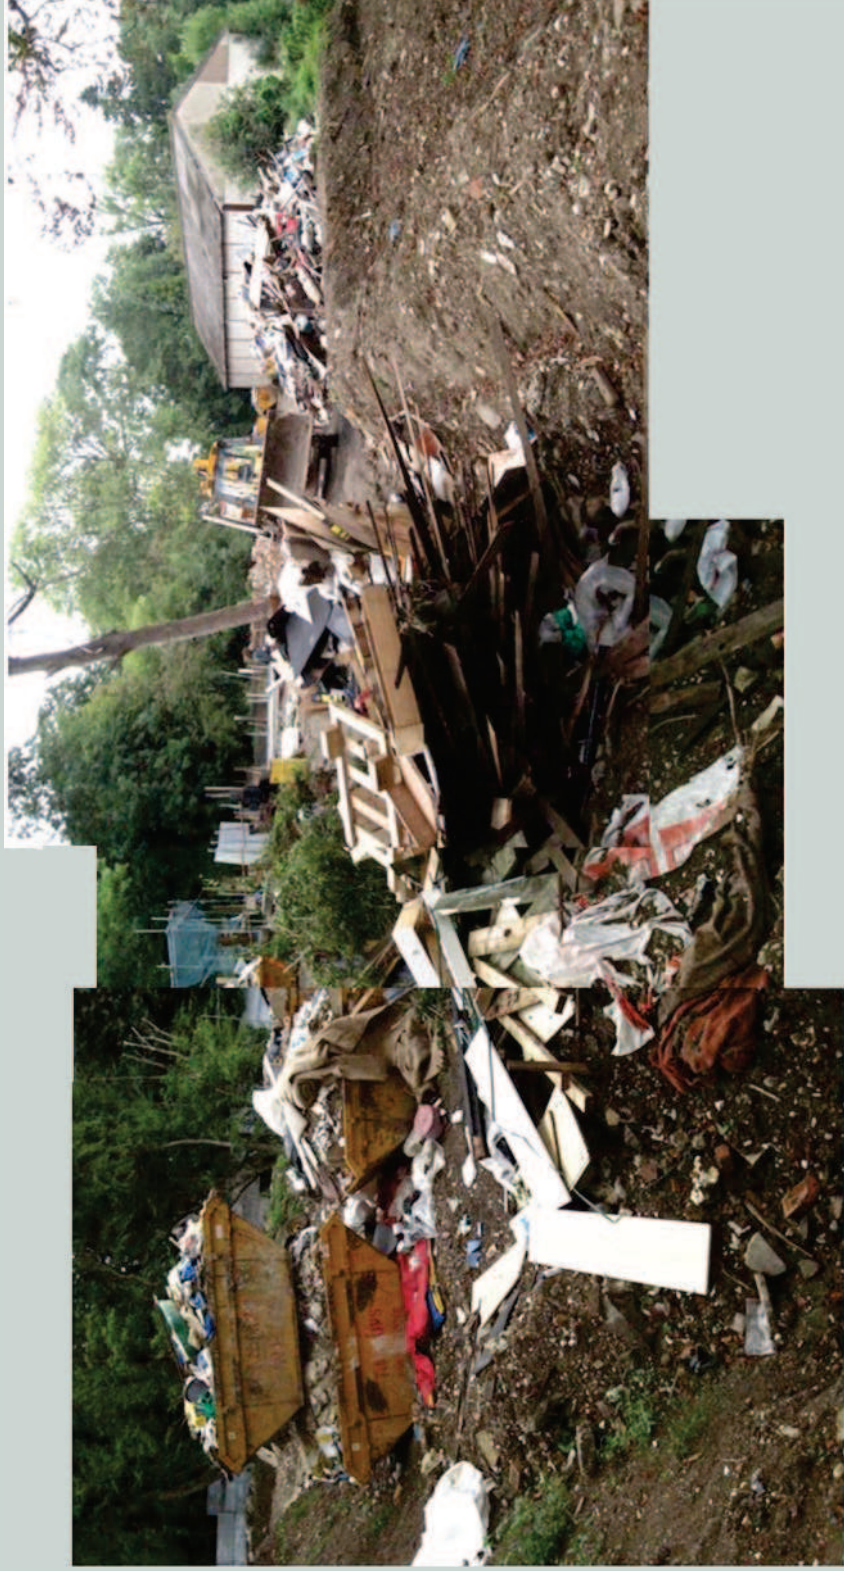
**Fig 7 : Unauthorised waste deposit, transfer & disposal – 2010.**

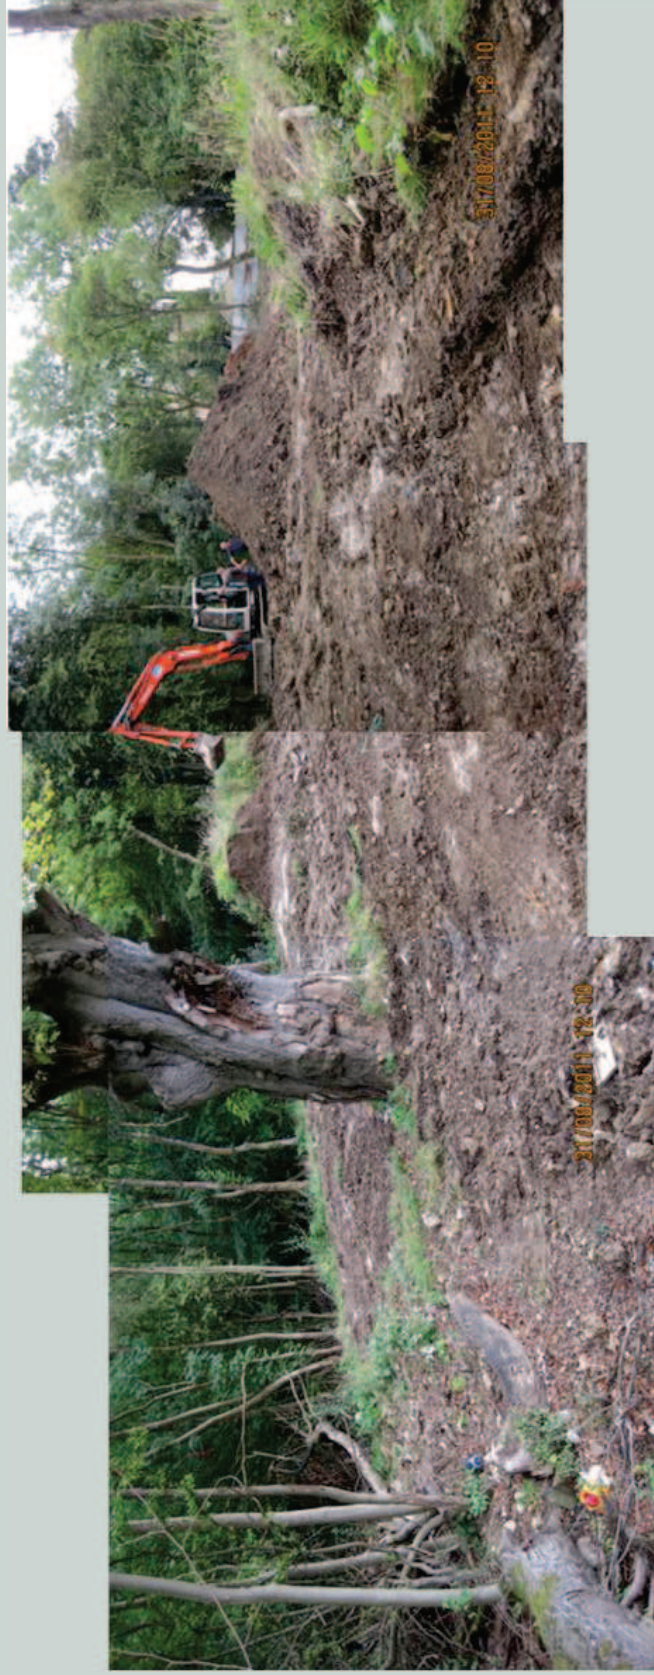
Fig 8 : Unauthorised waste deposit, transfer & disposal – 2010.  
Starting to reduce the ground levels around the beech tree where  
waste has been tipped

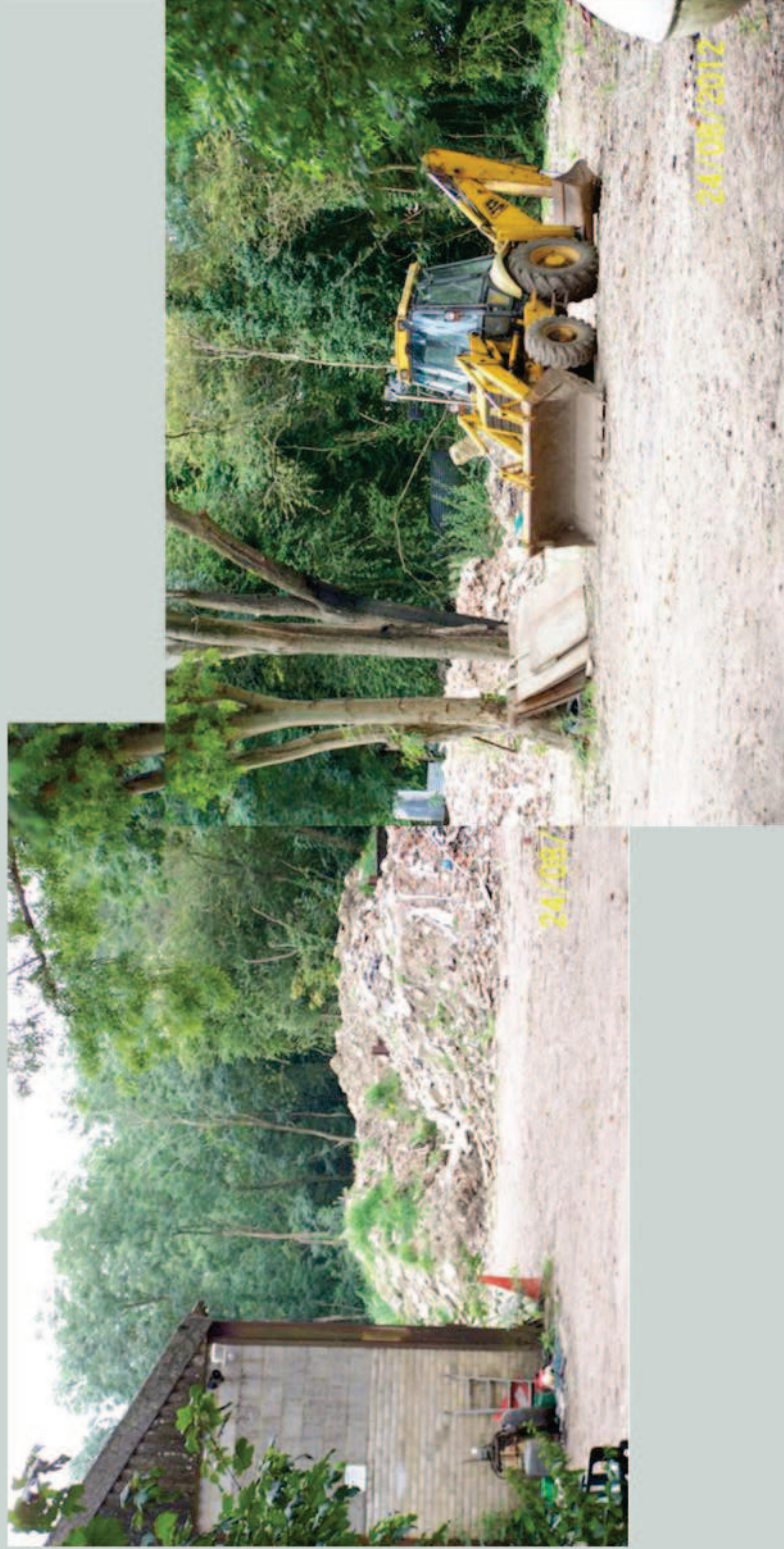
**Fig 9 : Unauthorised waste deposit, transfer & disposal – 2012.  
Skips & waste cleared, just the hardcore remaining.**

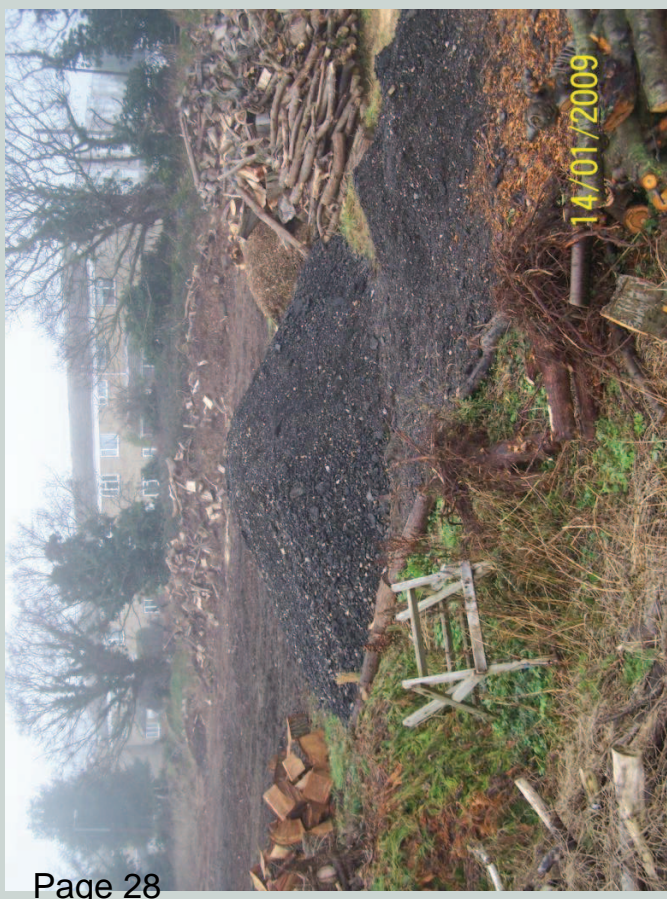
Woodyard: timber & composting.

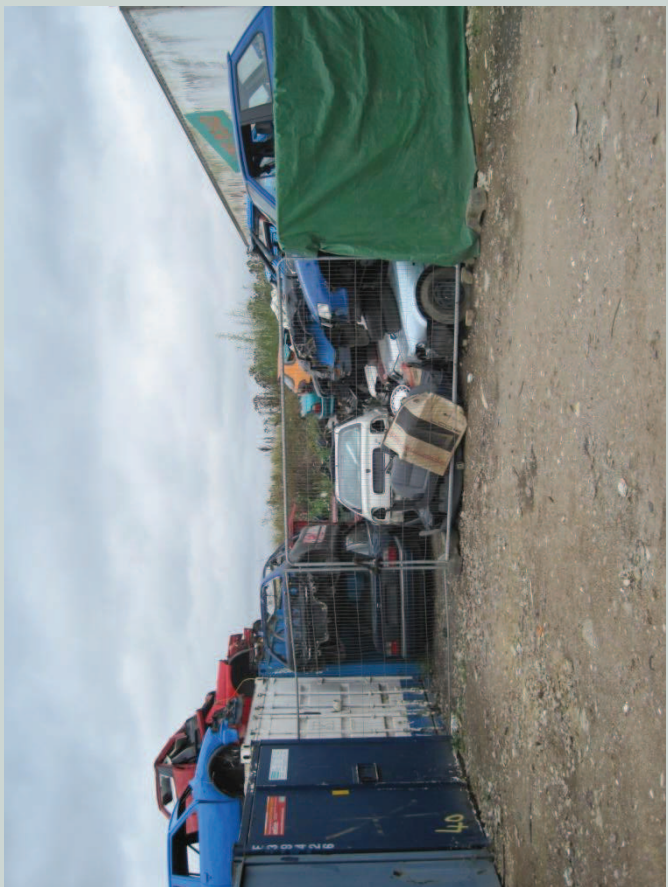
Scrapyard & breaking.

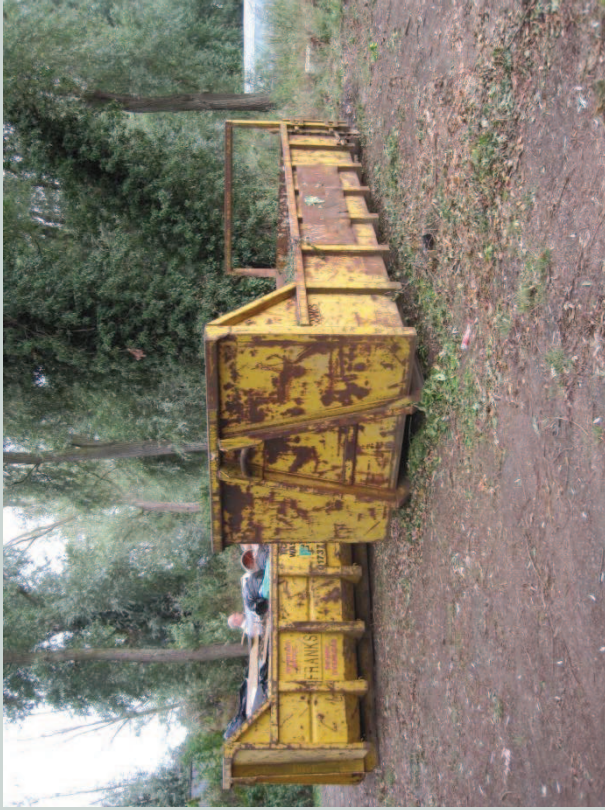
Fig 11 :

Landscaper contractors yard

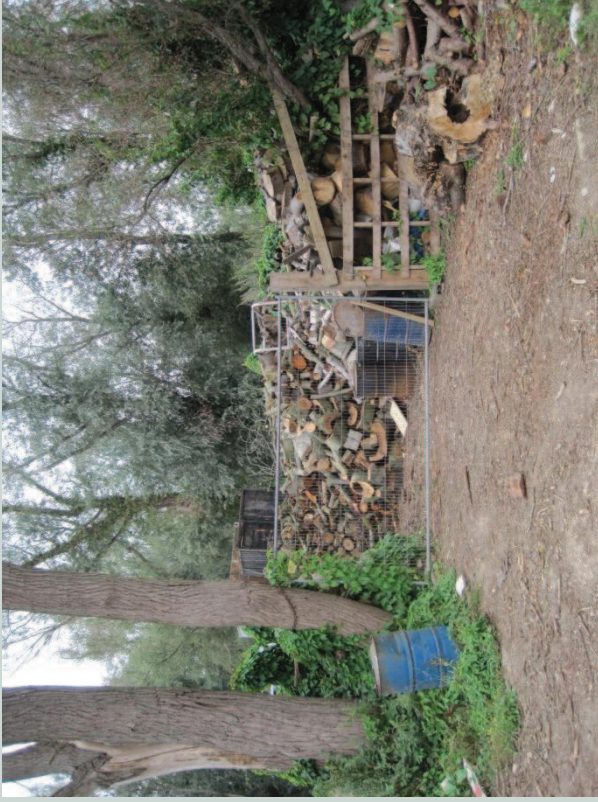
Log storage area

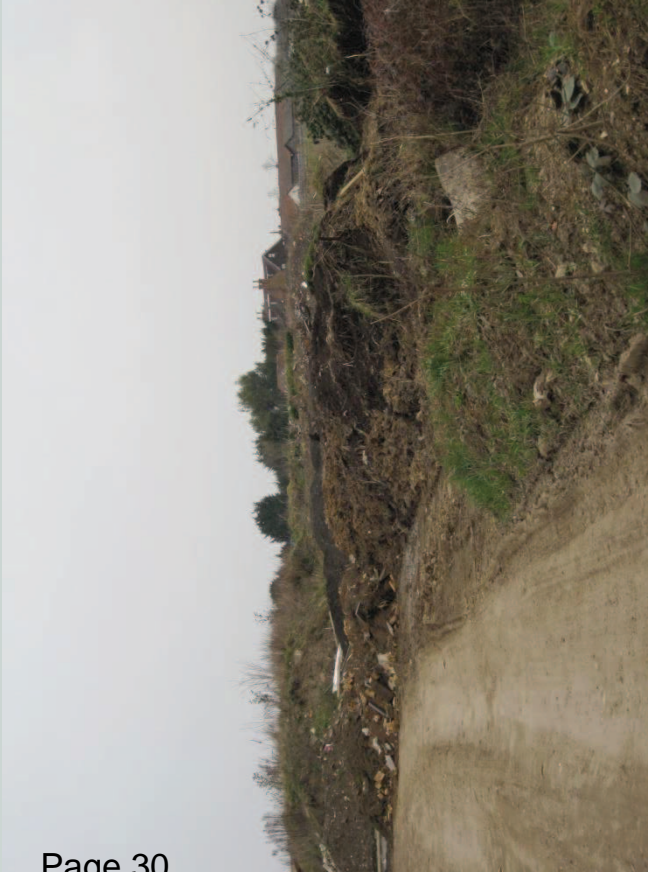
Fig 12 :

Timber burning, soil & hardcore tipping area.

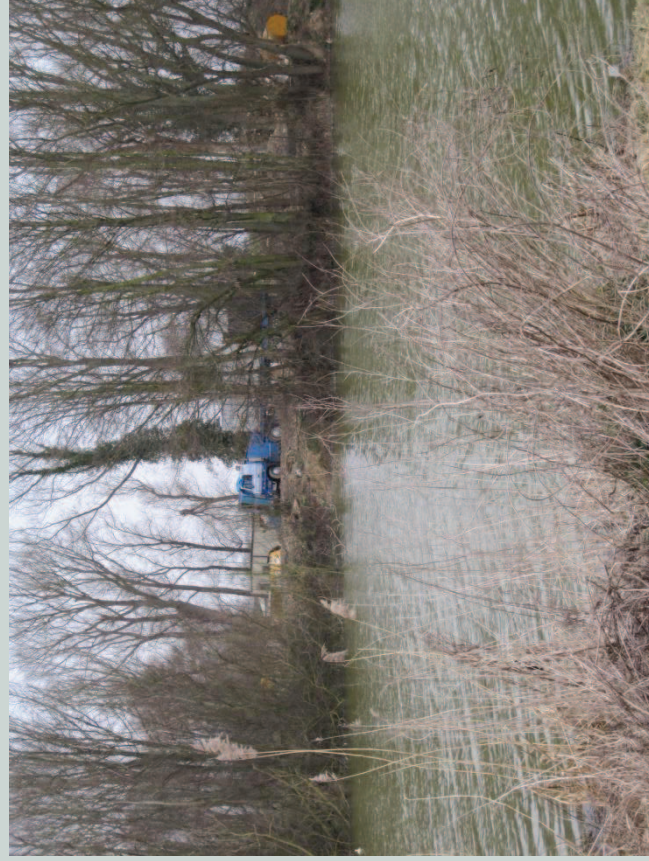
Fig 13 :

Area of land raising at rear of lake.

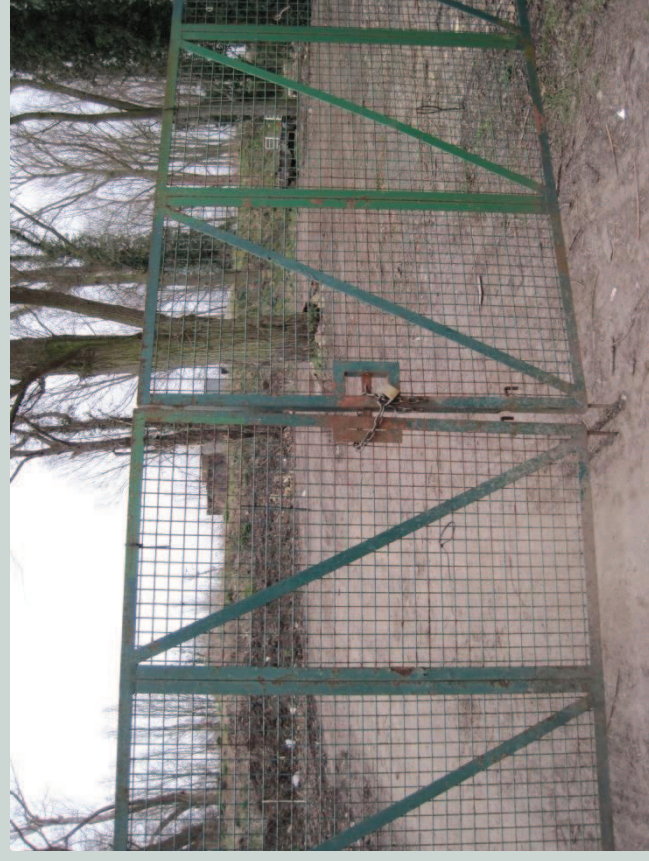
Landscape contractor's compound.

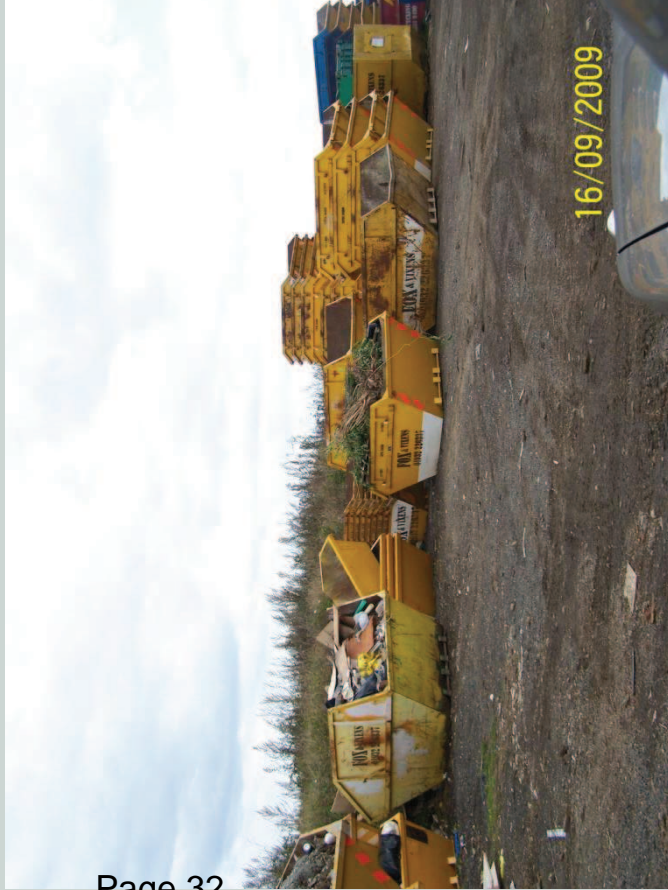
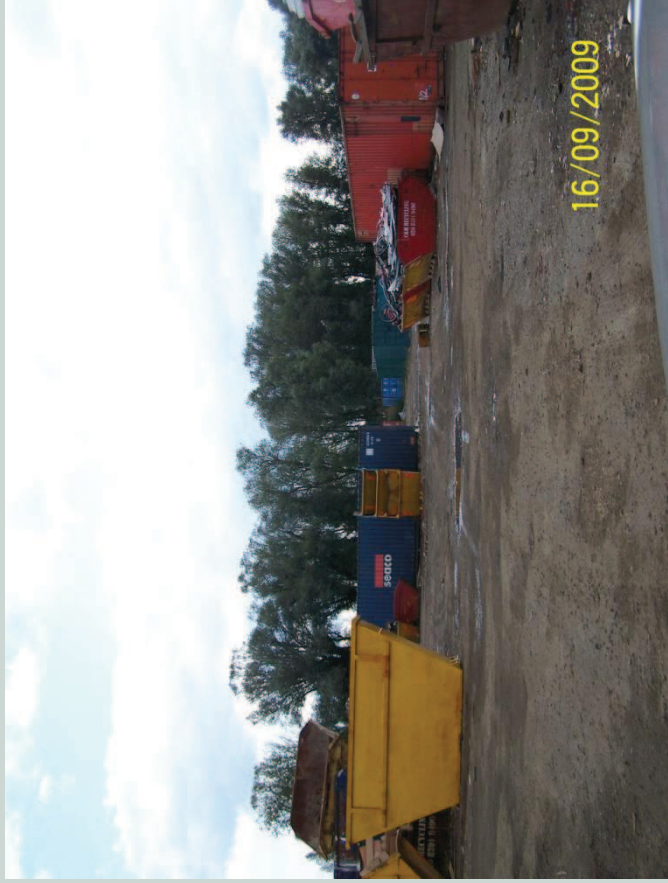
**Fig 14 : Two companies with adjacent skip yards:  
used for waste deposit, transfer & recycling.**

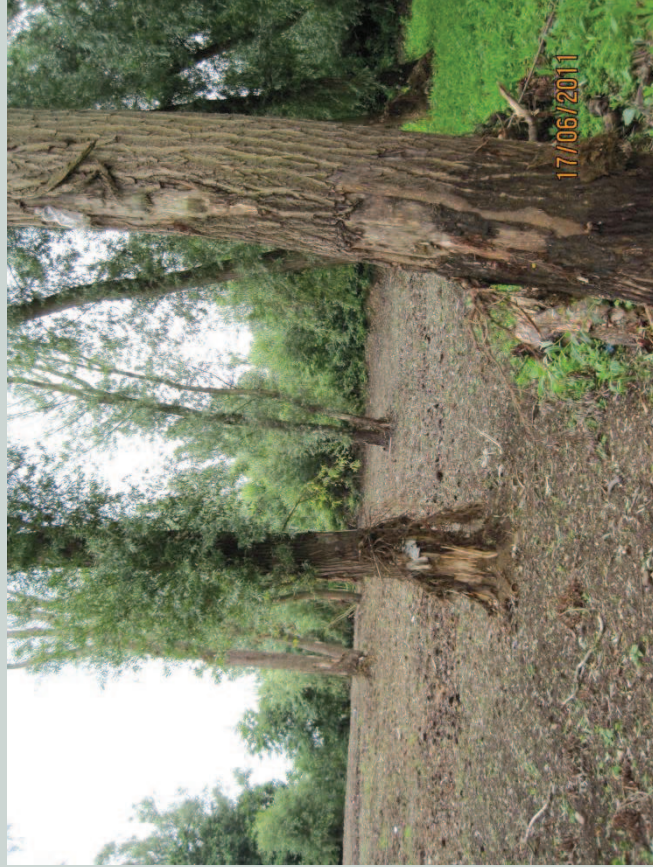
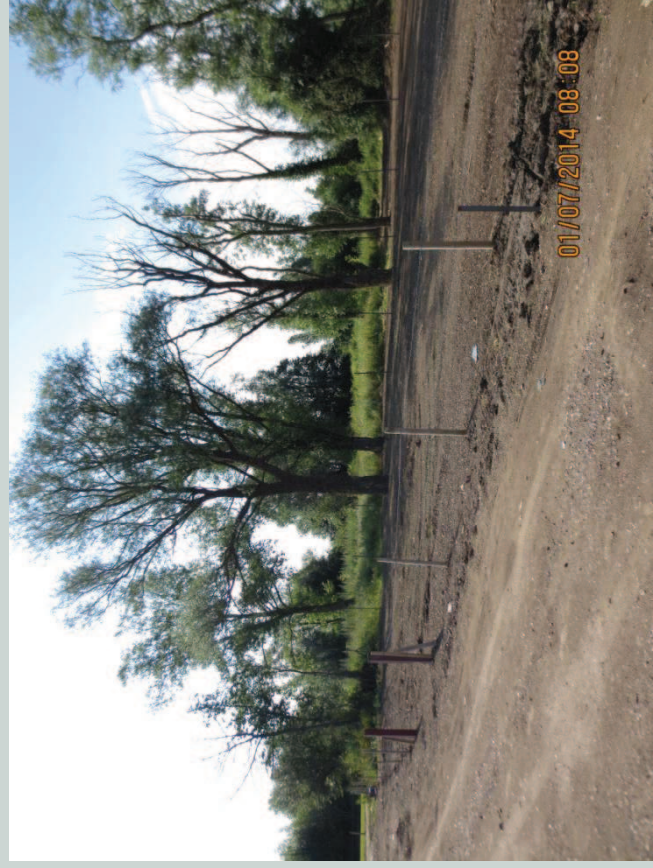
Fig 19 : Regeneration of the area that had been landraised within the willow copse.
