Annex G - Request for bus stop clearways at 19 bus stops on the K3 bus route in the Elmbridge area

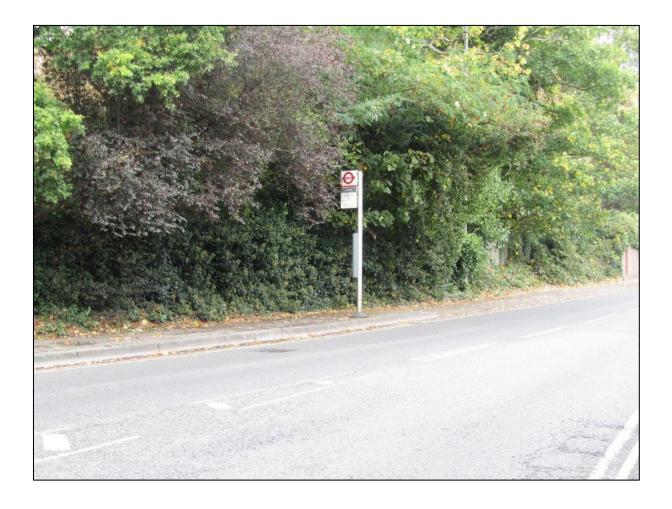
Location: Existing northbound bus stop in Claremont Lane, Esher at Clare Hill,

Problem: This bus stop is currently protected by double yellow lines and has benefitted from investment in raising the kerb for step free access. The bus stop is located within a short walk of Esher CoE Primary School. A high incidence of on street parking occurs at school drop off and pick up times, indicating the need to protect the bus stop, and to support the previous investment.

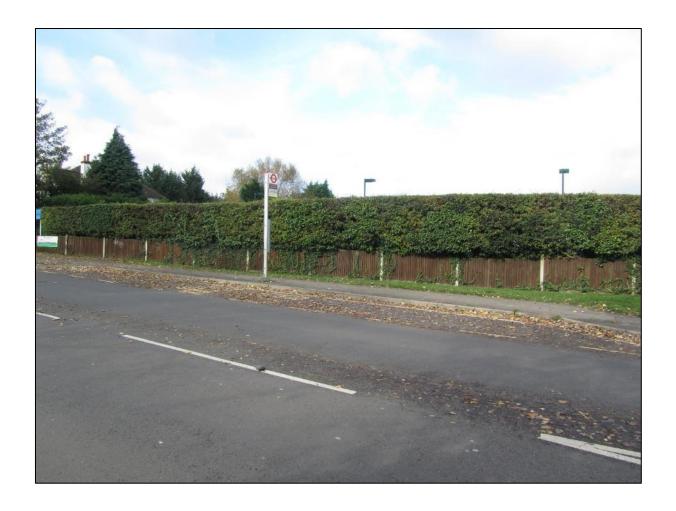
Location: Existing eastbound bus stop in Milbourne Lane, Esher at Orchard Way,

Problem: This bus stop, which is within a lay-by, is located very close to Esher CoE Primary School. The bus stop already has a bus cage and clearway markings. A high incidence of on street parking occurs at school drop off and pick up times, indicating the need to protect the bus stop clearway markings. The bus cage and clearway road markings comply with TSRGD diagram 1025.3. Committee approval is required to enforce the clearway marking within the bus cage.

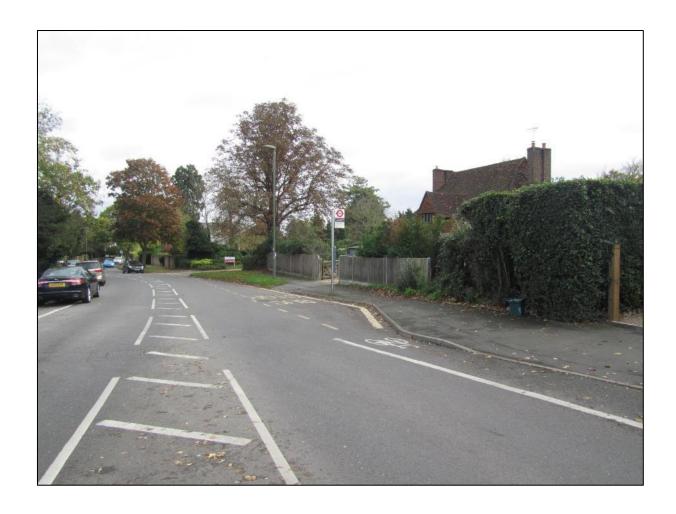
Location: Existing westbound bus stop in Milbourne Lane, Esher at Orchard Way,

Problem: This bus stop, which is within a lay-by, is located very close to Esher CoE Primary School. The bus stop already has a bus cage and clearway markings. A high incidence of on street parking occurs at school drop off and pick up times, indicating the need to protect the bus stop clearway markings. The bus cage and clearway road markings comply with TSRGD diagram 1025.3. Committee approval is required to enforce the clearway marking within the bus cage.

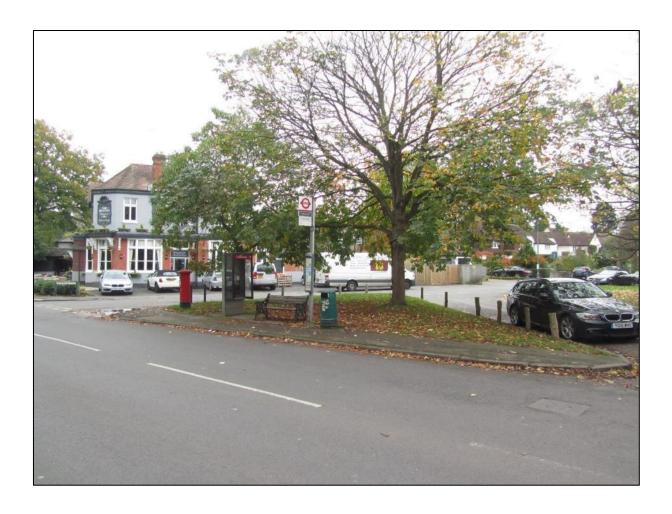
Location: Existing westbound bus stop in Milbourne Lane, Esher at Arbrook Lane

Problem: This bus stop has no bus cage. It is located at the north end of Arbrook Lane where there is some on-street parking pressure from local residents without off street parking and also The Swan PH. These pressures suggest that, for the future protection of the bus stop, there is a need to provide bus cage and clearway road markings.

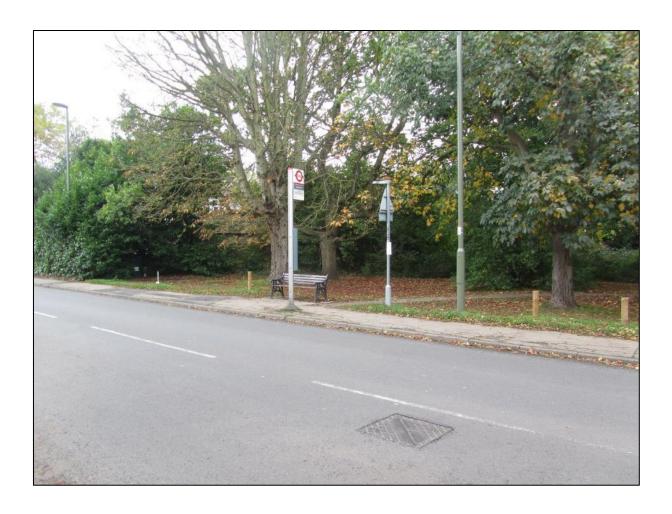
Location: westbound bus stop in Milbourne Lane, Esher at Arbrook Lane

Problem: This bus stop has no bus cage. It is located opposite the north end of Arbrook Lane where there is some on-street parking pressure from local residents without off street parking and also The Swan PH. These pressures suggest that, for the future protection of the bus stop, there is a need to provide bus cage and clearway road markings.

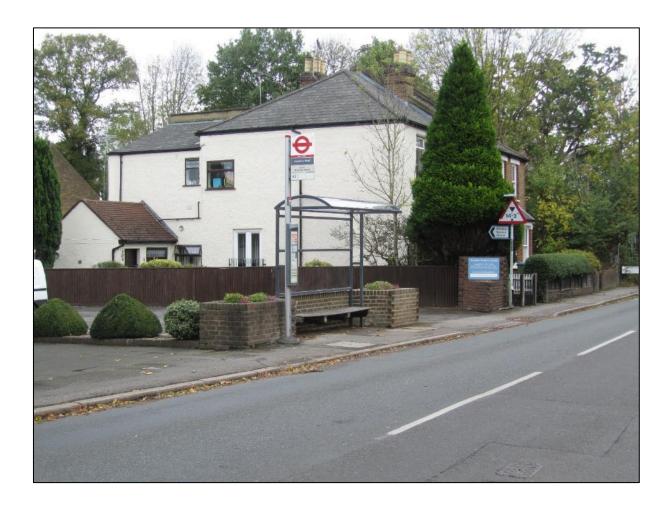
Location: Existing eastbound bus stop in Hare Lane, Claygate at Loseberry Road

Problem: The bus stop has a bus shelter and bench but no cage and clearway markings. To match the investment in passenger waiting facilities a bus cage and clearway is sought.

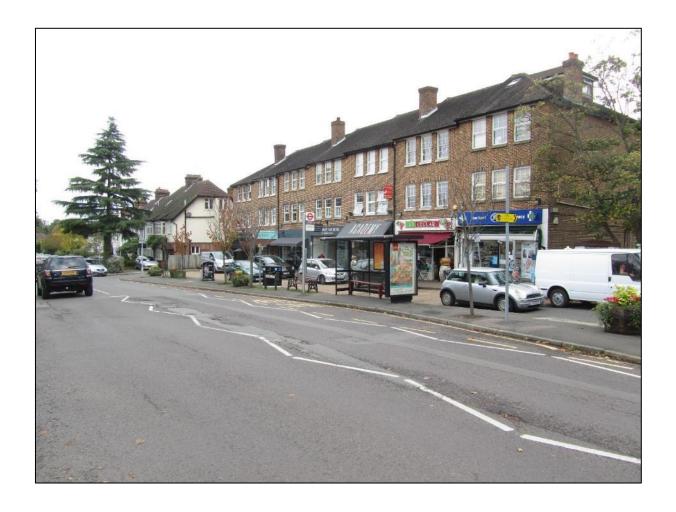
Location: Existing southbound bus stop in Hare Lane, Claygate at Claygate Station

Problem: This bus stop is located near Claygate station and local shops. The bus stop already has a bus cage and clearway markings. Hare Lane has a high incidence of on street parking, due to the local shops and station, indicating the need to protect the bus stop clearway markings. The existing bus cage and clearway road markings comply with TSRGD diagram 1025.1. Committee approval is required to enforce the clearway marking within the bus cage.

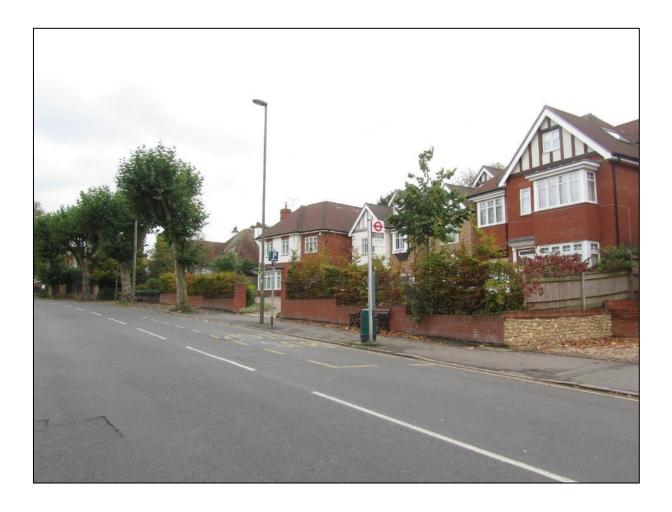
Location: Existing northbound bus stop in Hare Lane, Claygate at Claygate Station

Problem: This bus stop is located near Claygate station and local shops. The bus stop already has a bus cage and clearway markings. Hare Lane has a high incidence of on street parking, due to the local shops and station, indicating the need to protect the bus stop clearway markings. The existing bus cage and clearway road markings comply with TSRGD diagram 1025.1. Committee approval is required to enforce the clearway marking within the bus cage.

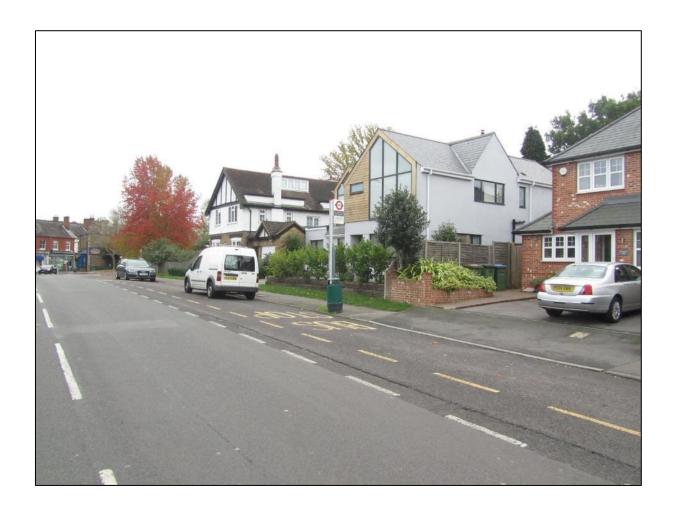
Location: Existing bus stop in Hare Lane, Claygate at Dalmore Avenue

Problem: This bus stop is located in near central Claygate. The bus stop is within a lay-by and already has a bus cage but no clearway markings. The lay-by is used for causal parking due its close proximity to the village centre, indicating the need to provide additional protection of the bus stop markings. With the clearway bar added the road markings would then comply with TSRGD diagram 1025.1. VCOs within the lay-by would be unaffected by the clearway. Committee approval is requested to provide the bus stop clearway marking within the bus cage.

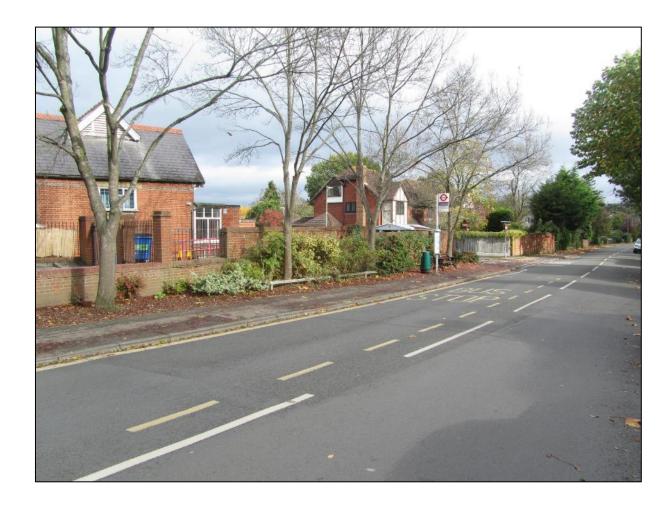
Location: Existing bus stop in St Leonard's Road, Claygate, at the Green,

Problem: This busy bus stop is located in the centre of Claygate and is close to local shops and the Borough's Day Centre for the Community in Elm Road. It already has a bus cage and clearway markings. The bus cage and clearway road markings comply with TSRGD diagram 1025.1. Committee approval is required to enforce the clearway marking within the bus cage.

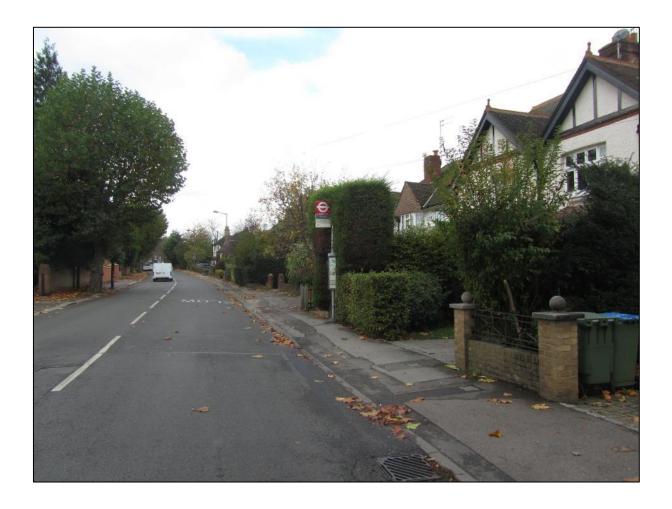
Location: Existing bus stop in St Leonard's Road, Claygate, at Red Lane,

Problem: This bus stop is located in central Claygate with a residential frontage. There are VCOs for each property on both sides of St Leonards Road, but the gaps in between provide potential locations for casual parking. Protection of the bus stop from parked cars is recommended.

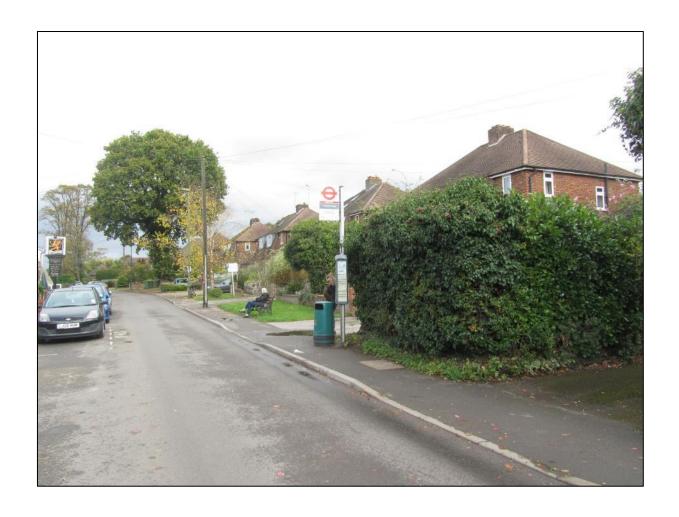
Location: Existing bus stop in Common Road, Claygate

Problem: This bus stop is located in central Claygate on a narrow residential street. There are VCOs for each property on the east side of Common Road, and the gaps in between provide potential locations for casual parking. In addition, on the west side of Common Road is the Griffin PH, and terraced properties with no off street parking, which adds to on street parking pressures.

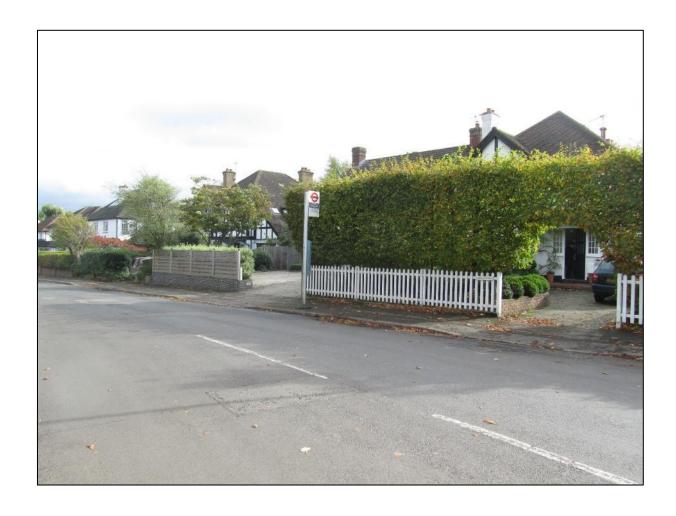
Location: Existing bus stop in The Causeway, Claygate

Problem: This bus stop is located in central Claygate on a residential street. There are VCOs for each property on the east side of Common Road, and the gaps in between provide potential locations for casual parking. Neighbouring residential streets have a high incident of parking and protecting this bus stop from potential parking pressure is recommended.

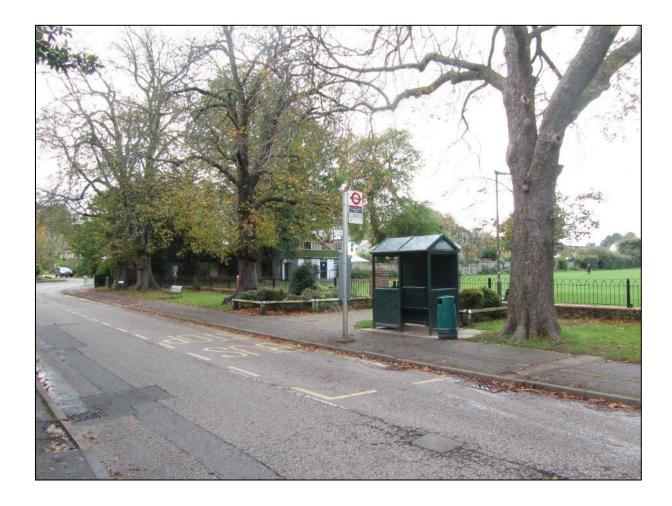
Location: Existing bus stop in Church Road, Claygate at the Recreation Ground

Problem: This bus stop is located in central Claygate. The bus stop already has a bus cage and clearway markings. Church Road has a high incidence of on street parking, indicating the need to protect the bus stop from parked cars. The bus cage and clearway road markings comply with TSRGD diagram 1025.1. Committee approval is required to enforce the clearway marking within the bus cage.

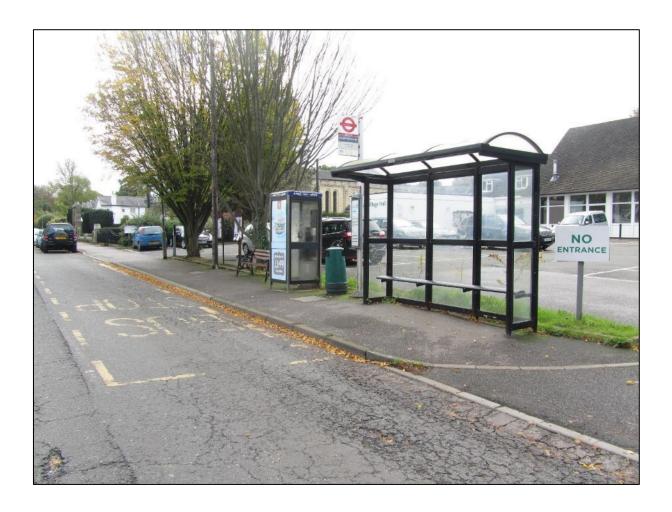
Location: Existing bus stop in Church Road, Claygate at Village Hall

Problem: This bus stop is located in central Claygate near to local shops and the village hall. The bus stop already has a bus cage and clearway markings but these require refreshing. Church Road has a high incidence of on street parking, indicating the need to protect the bus stop from parked cars. The bus cage and clearway road markings, although faded, comply with TSRGD diagram 1025.1. Committee approval is required to enforce the clearway marking within the bus cage.

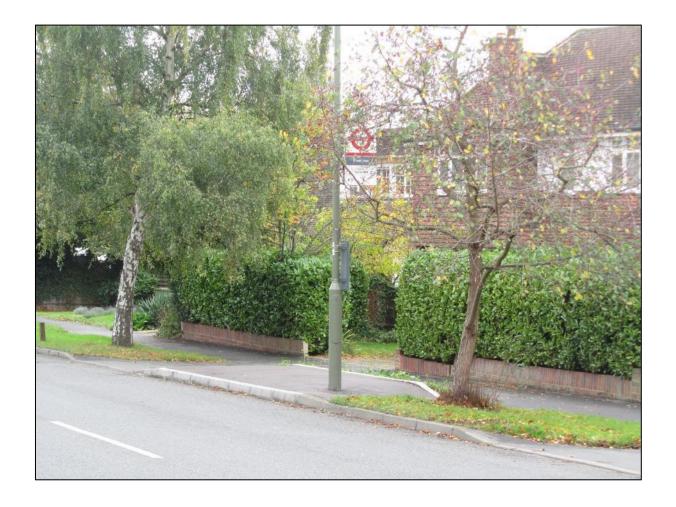
Location: Existing northbound bus stop in Manor Road South, Hinchley Wood, at Greenways

Problem: The existing bus stop has recently benefitted from footway works to raise the footway and kerb to offer step free access. To match this infrastructure investment the bus stop should be protected from potential casual parking by a bus cage with a bus stop clearway.

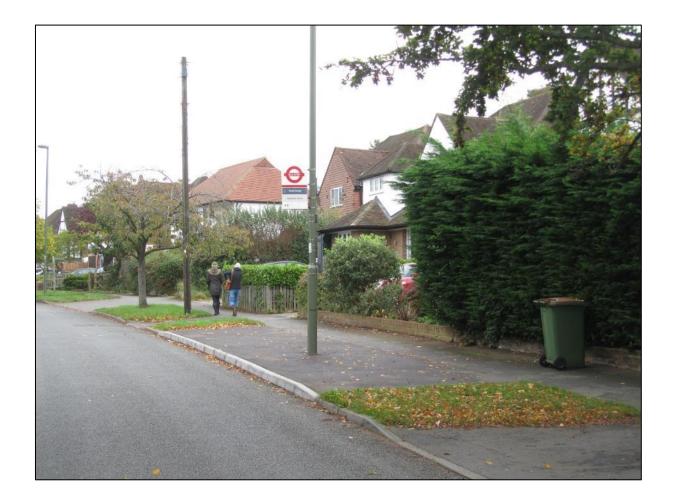
Location: Existing southbound bus stop in Manor Road South, Hinchley Wood, at Greenways,

Problem: The existing bus stop has recently benefitted from footway works to raise the footway and kerb to offer step free access. To match this infrastructure investment the bus stop should be protected from potential casual parking by a bus cage with a bus stop clearway.

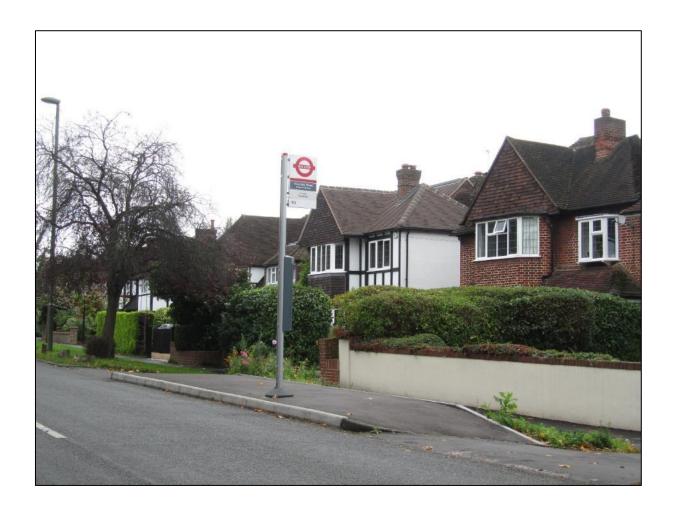
Location: Existing northbound bus stop in Manor Road South, Hinchley Wood, at Kingston By-pass

Problem: The existing bus stop, being close to Hinchley Wood Station, potentially could be subjected to on street parking pressure from commuters in future years. There are no parking restrictions either side of the existing bus stop cage. The bus stop has recently benefitted from footway works to raise the footway and kerb to offer step free access. Protection by a bus cage with a bus stop clearway is recommended.

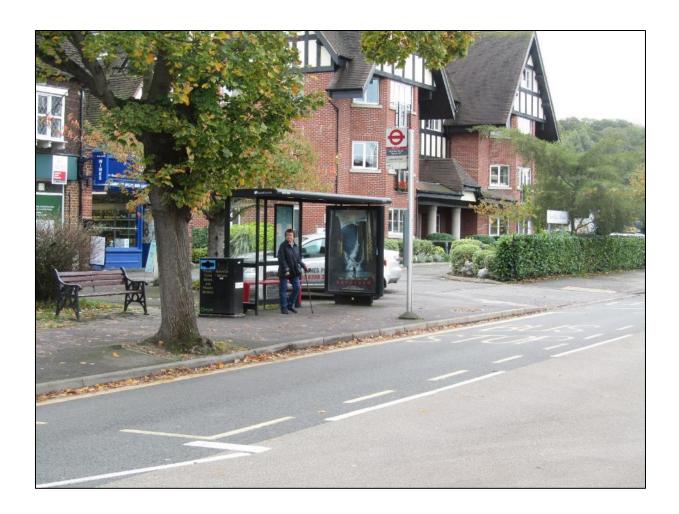
Location: Existing southbound bus stop in Manor Road South, Hinchley Wood at Hinchley Wood Station.

Problem: The existing bus stop is located opposite Hinchley Wood Station Approach, which generates significant on street parking pressure. There are double yellow line parking restrictions to the north of the existing bus stop cage, and a zebra crossing to the south. The bus cage and clearway road markings comply with TSRGD diagram 1025.1. Committee approval is required to enforce the clearway marking within the bus cage.

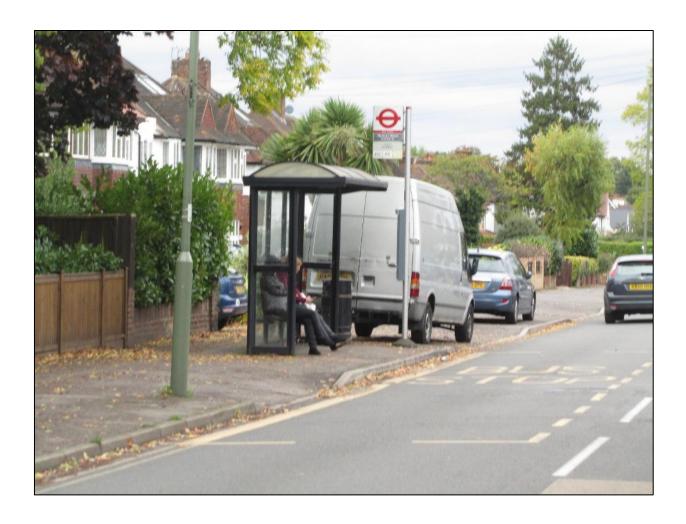
Location: Existing northbound bus stop in Manor Road South, Hinchley Wood at Hinchley Wood Station

Problem: The existing bus stop is located approximately 25m to the south of Hinchley Wood Station Approach, which generates significant on street parking pressure. There are double yellow line parking restriction on the south side of the existing bus stop cage. The bus cage and clearway road markings comply with TSRGD diagram 1025.1. Committee approval is required to enforce the clearway marking within the bus cage.

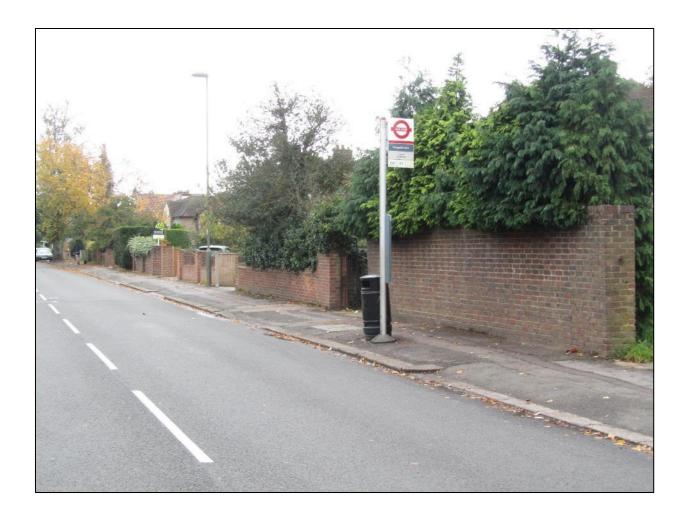
Location: Existing northbound bus stop in Manor Road South, Hinchley Wood at Claygate Lane

Problem: The existing bus stop is located just to the south of Claygate Lane. There are VCOs for each property on the west side of Manor Road South, but the gaps in between provide potential locations for casual parking. There is potential parking pressure from the schools in Claygate Lane. Protection by a bus cage with a bus stop clearway is recommended.

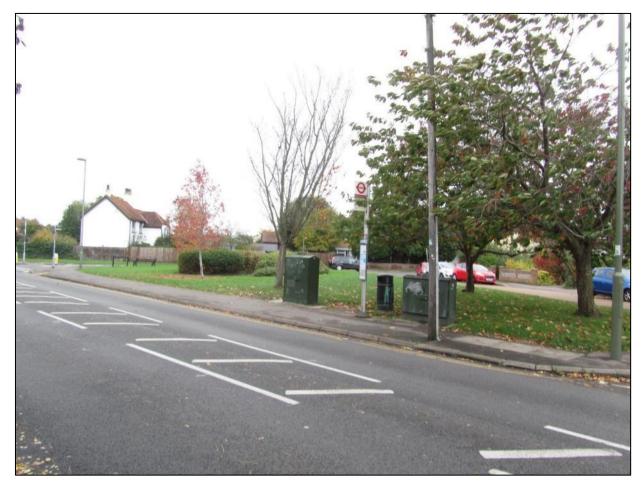
Location: Existing southbound bus stop in Manor Road South, Hinchley Wood at Claygate Lane.

Problem: The existing bus stop, located next to a small 'green' or open space, has double yellow line parking restrictions. These restrictions possibly relate to parking pressure from the schools in Claygate Lane. Protection by a bus cage with a bus stop clearway is nevertheless recommended.

Proposal: To provide a new bus cage and clearway road markings to comply with TSRGD diagram 1025.1. To approve the bus stop clearway formally to enable the restrictions to be enforced. The times of restriction should be 'no stopping at any time', which is appropriate to the operating times of the bus services (in accordance with DfT guidance for introducing bus stop clearways). No homes or businesses are affected by this proposal.

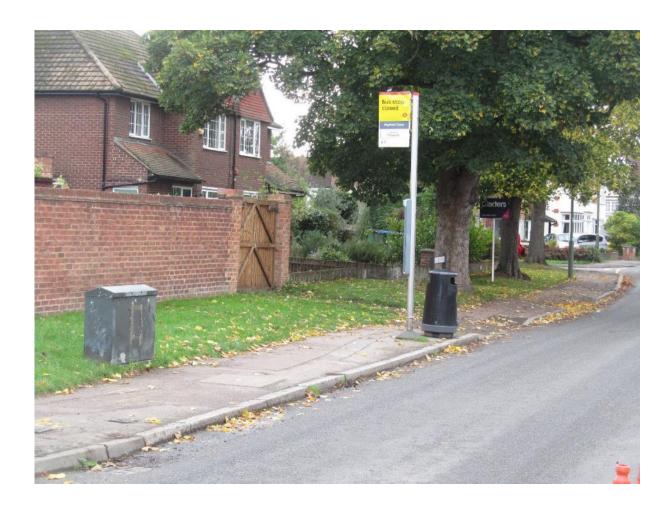
Location: Existing south-westbound bus stop in Manor Road South, Long Ditton at Mayfield Close

Problem: The existing bus stop is located in a section of Manor Road South with side roads with little off street parking. This causes some residents to park in Manor Road South. The road has no 'no waiting' or parking restrictions. To ensure the bus stop is protected from residents' cars a new bus cage with a bus stop clearway is requested. The opposite northeastbound stop has recently been upgraded and benefits from a bus stop clearway.

Proposal: To provide a new bus cage and clearway road markings to comply with TSRGD diagram 1025.1. To approve the bus stop clearway formally to enable the restrictions to be enforced. The times of restriction should be 'no stopping at any time', which is appropriate to the operating times of the bus services (in accordance with DfT guidance for introducing bus stop clearways). No homes or businesses are affected by this proposal.
