Epsom Downs Improvements to equestrian facilities.

Feasibility Report

Project Title: Epsom Downs
Improvements to Equestrian Facilities

Document Title: Feasibility Report

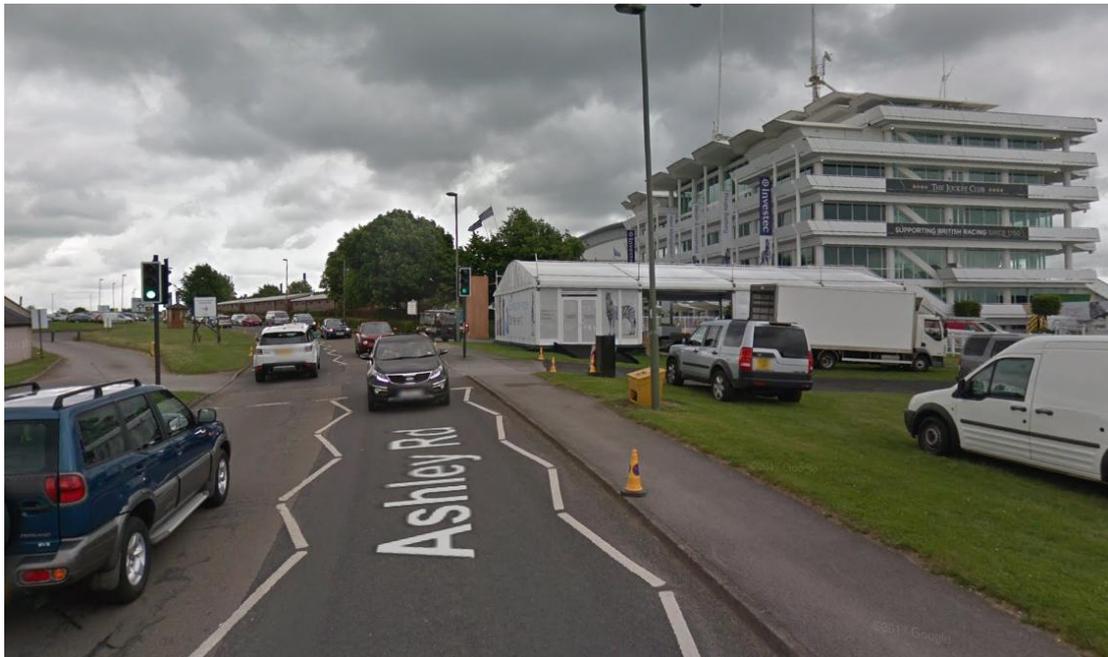
Figure-2: Eastbound view of Ashley Road approaching existing Equestrian Crossing
(source of images: Google Streetview)

B290 Ashley Road is a distributor of local traffic to the local towns of Epsom, Tadworth, Ashted and Leatherhead. Through traffic from a wider area also uses the road linking routes such as the A24, A217 and providing access to the M25. Due to this volume of traffic and speed of vehicles, equestrian riders can sometimes experience difficulties as horses require an adequate margin of separation from vehicles.

Ashley Road is a single carriageway road with a continuous inclination from its junction with Langley Vale Road past the racecourse. The carriageway width measures 7.6m with lane widths of 4.1m westbound and 3.5m eastbound. The road is subject to a 40mph speed limit throughout the section of Ashley Road. A system of street lighting is present and the horizontal and vertical alignments of the road provides good visibility in each direction. Bus stops are located in both directions.

It is noted from observations reported by the Jockey Club that engine noise and the strong air current from passing vehicles can be distressing for horses and riders using the crossing. In accordance with normal practice push buttons have been installed for equestrian riders at a distance of approximately 20m away from the crossing allowing time for the crossing to activate and vehicles to stop as equestrians approach and cross Ashley Road.

- Remove existing 3no. equestrian push buttons located approximately 20m away from the crossing point and install new user-friendly (equestrian) buttons. At the time of writing, discussions are ongoing with specialist suppliers with regards to replacement buttons that are compatible with the existing equipment as well as suitable for the needs of equestrians.
Cost to be confirmed

- Provision of Horse warning signs on the approaches to the crossing. This will ensure motorists are aware of the crossing and should anticipate equestrians to be crossing the carriageway.
Cost included in civil work.

- Widen the existing signal crossing from 3.5m to 6.5m, including relocation of signal poles and the provision of additional equestrian signal heads. The crossing widths could be widened up to a maximum width of 10 metres however this would attract significant additional expenditure to relocate a controller cabinet and other services.
Cost (Signal) £7k

- The crossing would be maintained on the existing desire line whilst providing greater separation margins to equestrian riders to minimise distress from the engine noise and vibration from vehicles. Please refer to the drawing PC 0862_02 in Appendix 1.
Cost (civil works) £17k

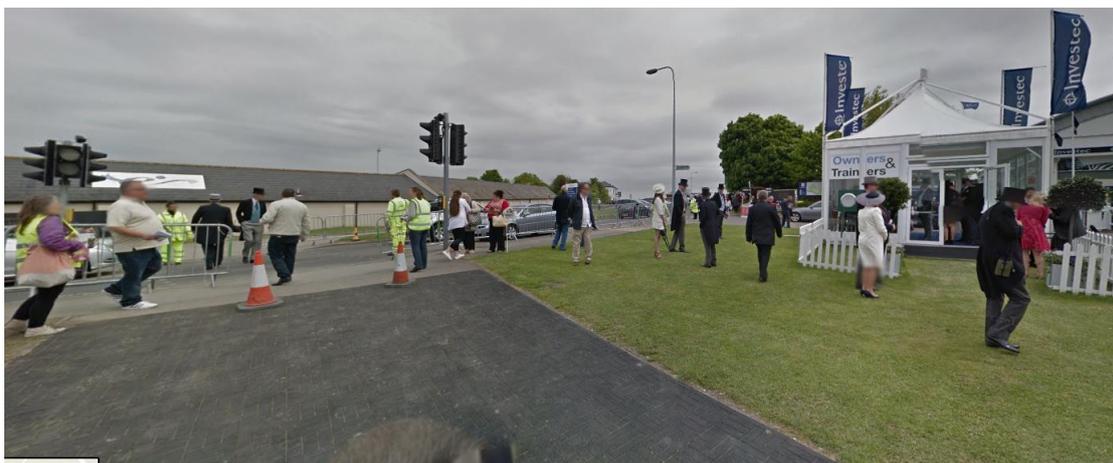
Figure-3: View to Equestrian Crossing in Ashley Road

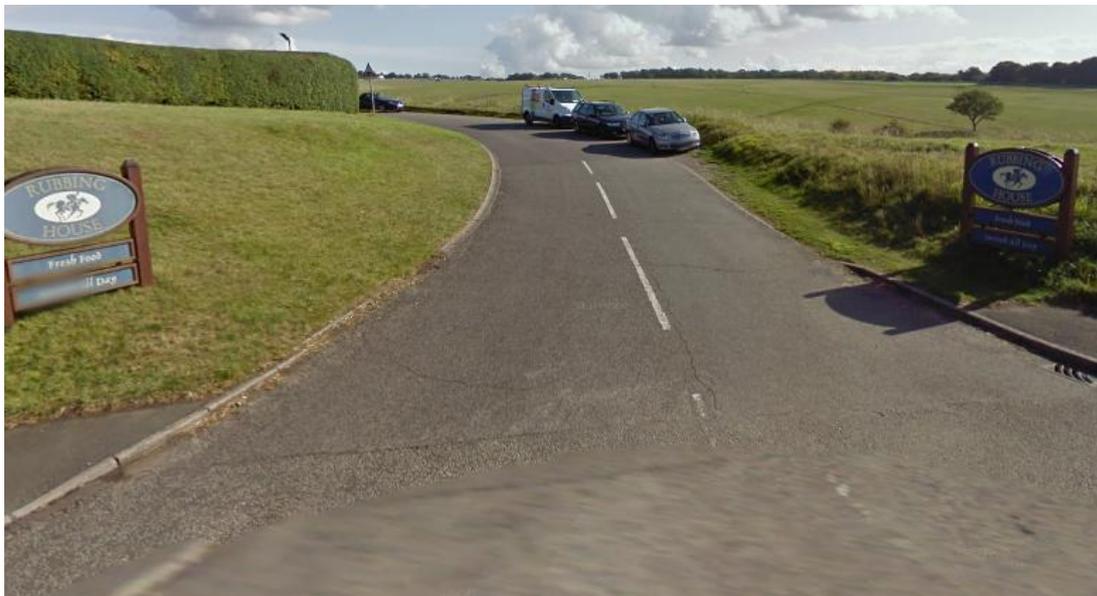
Figure-4: Access Road leading to Rubbing House PH

The access road leading to the Rubbing House PH is approximately 100m in length with a width of 5.6m for two way traffic. Approximately 40 parking spaces are provided in the PH car park at the end of the access. No waiting or loading restrictions exist on the access road.

The access road is used regularly on a daily basis by equestrians to access training facilities and a network of equestrian trails. Similarly, dog walkers also use the access road for parking to access the Downs and it is reported that conflict between the two user groups does occur due to the unexpected nature of movements and noises. The narrow width of the access road can result in congestion when parking overflows from the PH car park.

- It is considered that a waiting restriction to control parking on the access road may be of benefit in addressing the concerns raised. The road has been included in a forthcoming parking review with an initial site visit planned during the spring of 2018, with any subsequent proposals being brought forward for implementation during 2019. Temporary measures may also be considered for busier times.
- An additional option is to place temporary “No Parking” cones along the verge as referred on the drawing: PC 0862_02 in Appendix 1.

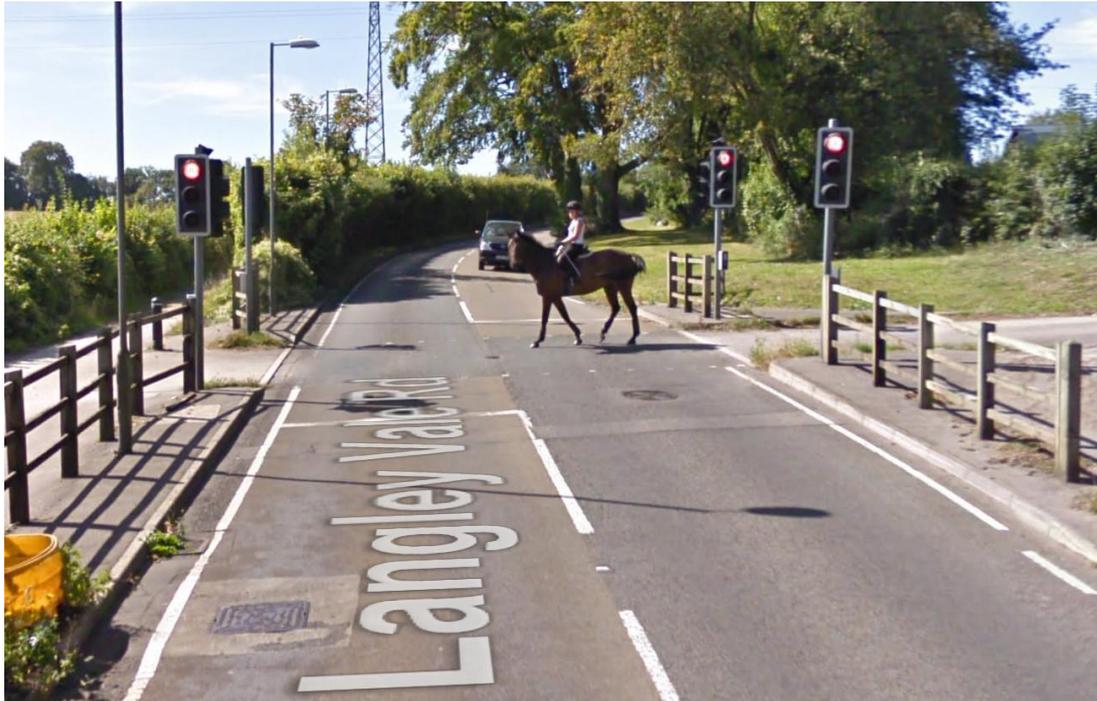
Figure-5: Equestrian crossing located in Langley Vale Road

On the northbound approach to the crossing there is a slight bend and a mature tree located approximately 36m south west of the crossing which restricts visibility to the absolute minimum requirements. Visibility to the crossing in a southwest direction exceeds desirable standards.

Four street lighting columns are provided on the south side of Langley Vale Road to illuminate the crossing point. Road signs warning other road users of the accompanied horses or ponies likely to be in or crossing the road are present on both approaches to the crossing. These are supplemented with 'slow' road markings laid on red surfacing. Vegetation has overgrown a warning sign and a defunct vehicle activated sign (VAS). Existing road markings at the crossing no longer comply with current regulations.

The carriageway forms a curvature nature in two locations, south-west to the crossing and North-East to Rosebery Road junction. Eight personal injury accidents were recorded between January 2012 and November 2017. The accident data shows that no pedestrian or equestrian related collisions have occurred at this location. The collisions that have occurred in Langley Vale Road, mostly travelling south west bound, have been between vehicles making overtaking movements or vehicles losing control due to contributory factors such as skidding or speeding on the bend road section.

- TA 3/03 ‘Equestrian Crossing facilities for ridden horses’ indicates that in common with other crossings, such as Puffin, Pelican and Toucan crossings, zig-zag markings be used where the vehicle stops solely for those wishing to cross the carriageway. To comply with the above requirements the existing road marking layout should be amended with new Zig-Zag markings introduced. Renewal of the existing ‘high friction surface’ (HFS) to the approaches of the crossing would also be of benefit as shown on drawing PC 0862_04 in Appendix 1.
Cost (Civil work) £17k

- Replace existing 2no. equestrian push buttons located approximately 15m away from the crossing point and install new user-friendly larger buttons.
Replacement cost included in VAS.

- Cut back the vegetation to increase sightlines for the riders and install dual display VAS on the approaches to the crossing and modify existing push buttons to activate both the traffic signals and the VAS simultaneously. An additional speed limit roundel could be provided adjacent to the VAS along with ‘slow’ road markings on the 40mph to 30mph section of Langley Vale Road near to Rosebery Road. This will improve driver awareness of the crossing on each approach.
Cost (VAS) £16k

- The HFS surface treatment will address loss of control accidents.
Cost included in civil works.
- Total cost (excluding cabling) 33K

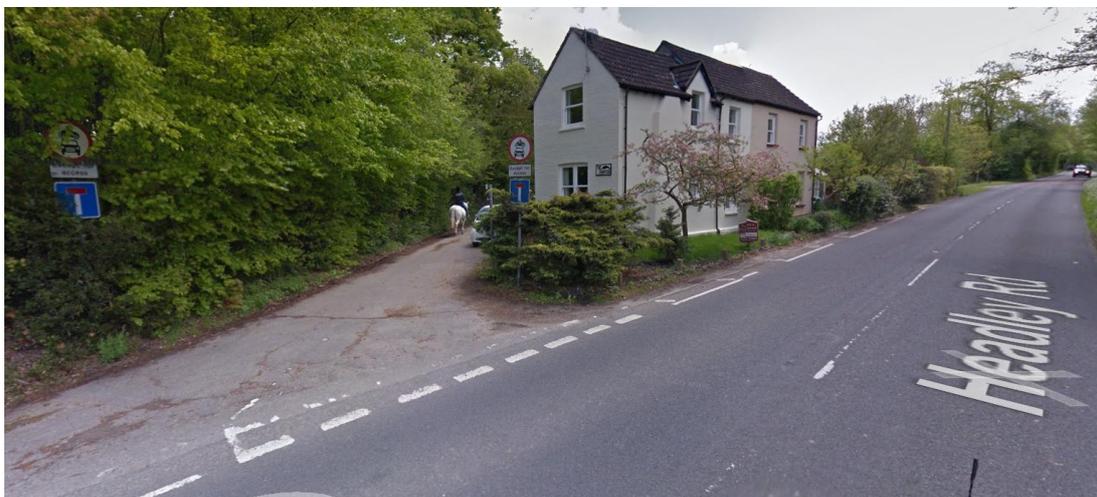
Figure-6: Headley Road junction with Chalk Pit Road

The junction of Chalk Pit Road and Headley Road is an acute angle junction. A 1.1m wide hatch marking is laid from the kerb edge each side of the junction enabling the give way lines to be moved forward for improved visibility of approaching vehicles from within the junction.

Wig Wag warning lights on each approach to the junction have been out of order for some time. These lights were activated by equestrians near the junction with Chalk Pit Road and Woodruffe Stables. 'Slow' road markings are present on both approaches to the junction with Chalk Pit Road.

- Decommissioning of the existing Wig Wags, warning signs and solar panel on both approaches to the junction, and the push buttons.
- Provision of VAS on the approaches to the junction with Chalk Pit Road and push buttons to activate the VAS. This will ensure motorists are provided with advance warning of equestrians near the junction.
- Renew road markings as shown on drawing PC 0862_05 in Appendix 1. Cut back vegetation to increase sightlines for equestrians.
Cost (Civil works) £2k
