Albury Road, Merstham bus stop (S'bound)

Current situation

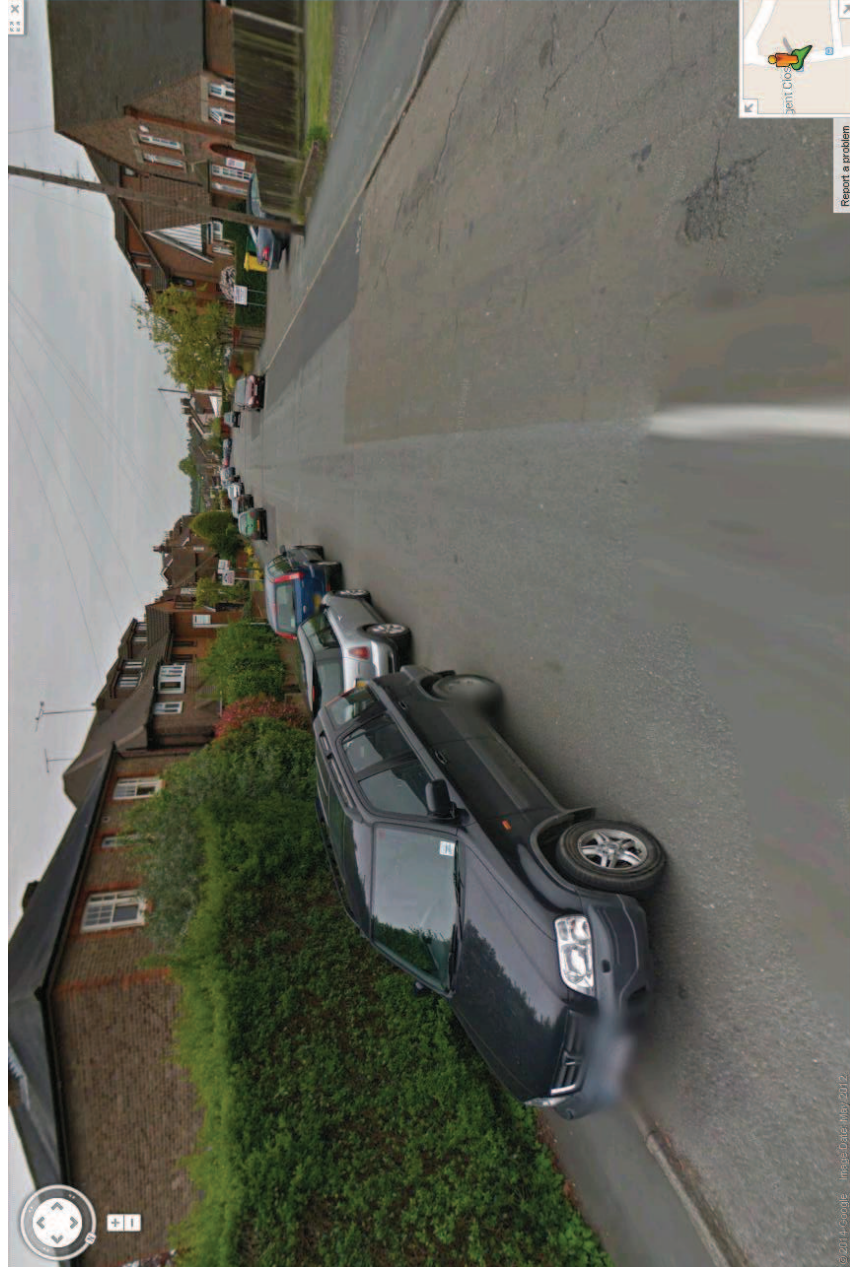
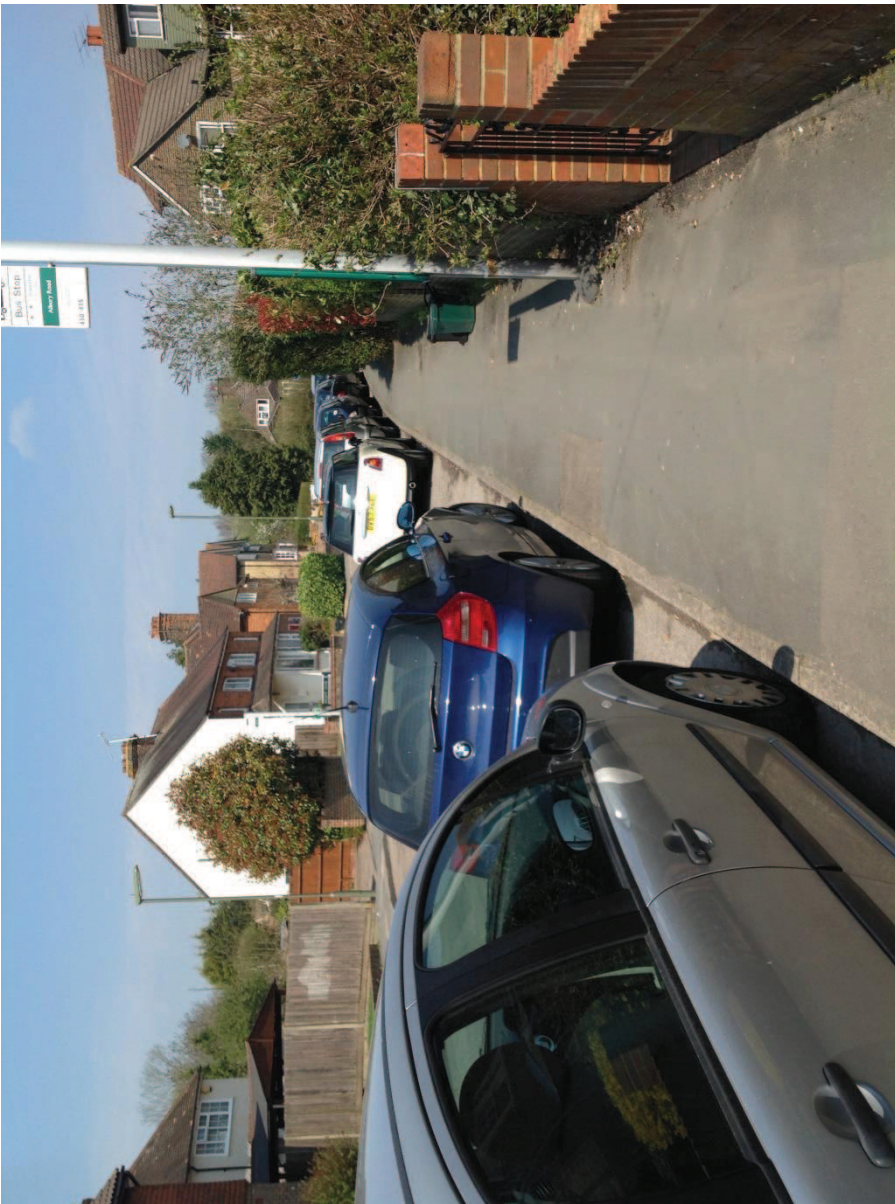
Bus stopping area (bus stop is just beyond hedge in front of blue car on LHS of carriageway) is currently obstructed by parked cars meaning that bus passengers are unable to have step-free access onto/off the bus due to the bus having to stop in the road next to the parked cars, or only being able to pull into the stop at an angle just beyond any parked cars. This not only is an issue with regards to accessibility it also has repercussions on reliability of buses as they are having to negotiate the parked cars rather than being able to easily pull in & out of the kerb at the bus stop.

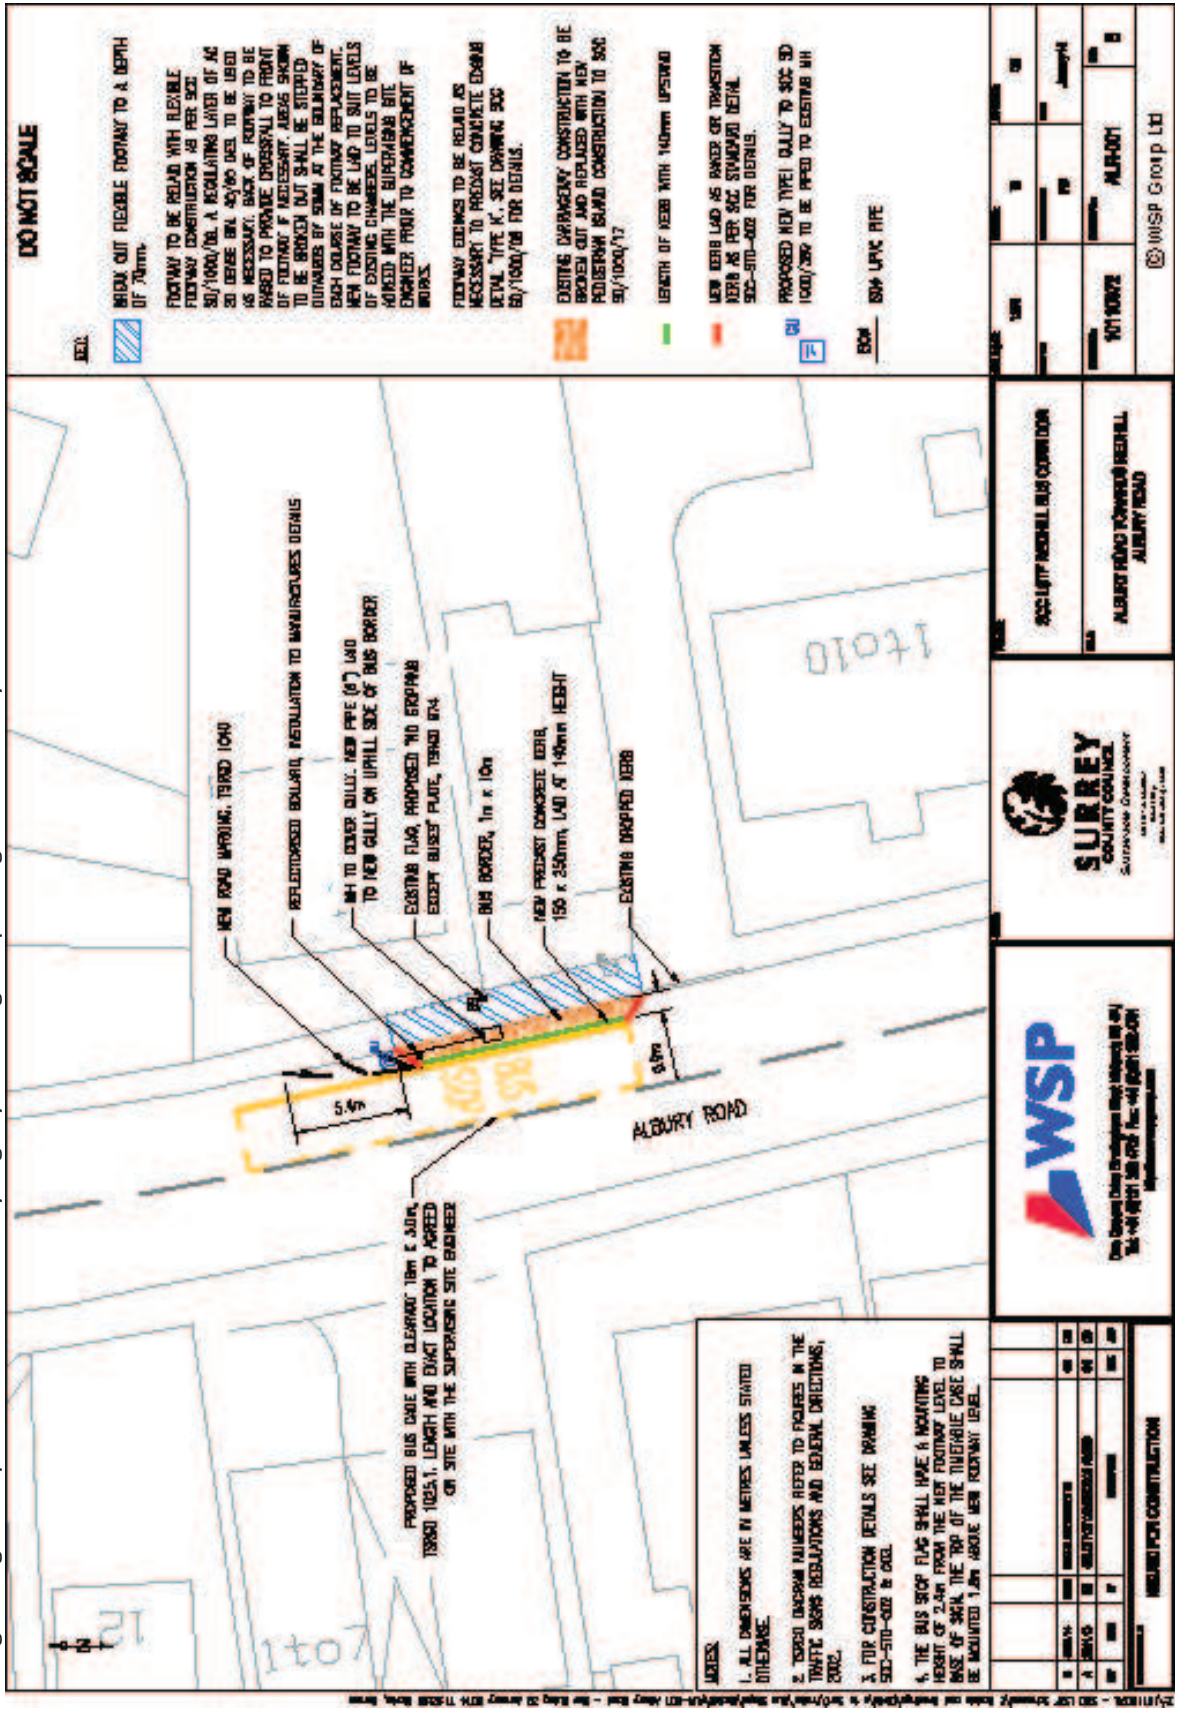
Design Solution

This incorporates a small bus boarder which still allows for parking in the area but provides an area for the buses to align parallel to the kerb allowing bus passengers level access onto the bus. This solution will provide a better bus facility for passengers as well as improving reliability for bus services by buses not having to negotiate parked cars whilst only slightly reducing the parking in the locality.
