A307 Portsmouth Road, Esher

Pedestrian Refuge Island

Feasibility Report

February 2018

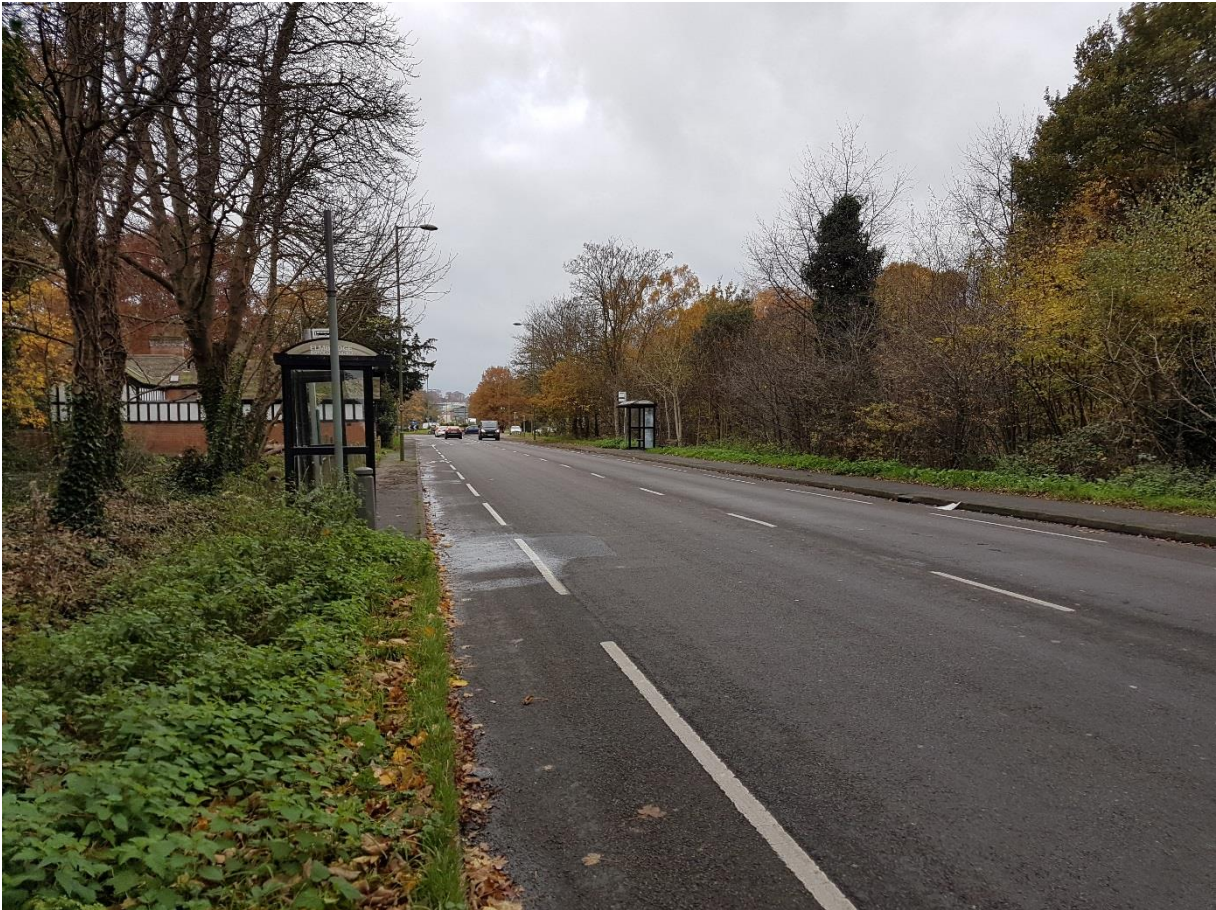
Figure 3 – Photo A307 Portsmouth Road (bus stops SW bound)

Staggered bus stops are located on either side A307 Portsmouth Road, north –east of the Scilly Isles roundabout, close to Littleworth Lodge. The north-eastbound and south-westbound stops are approximately 80 and 120 metres from the roundabout respectively.

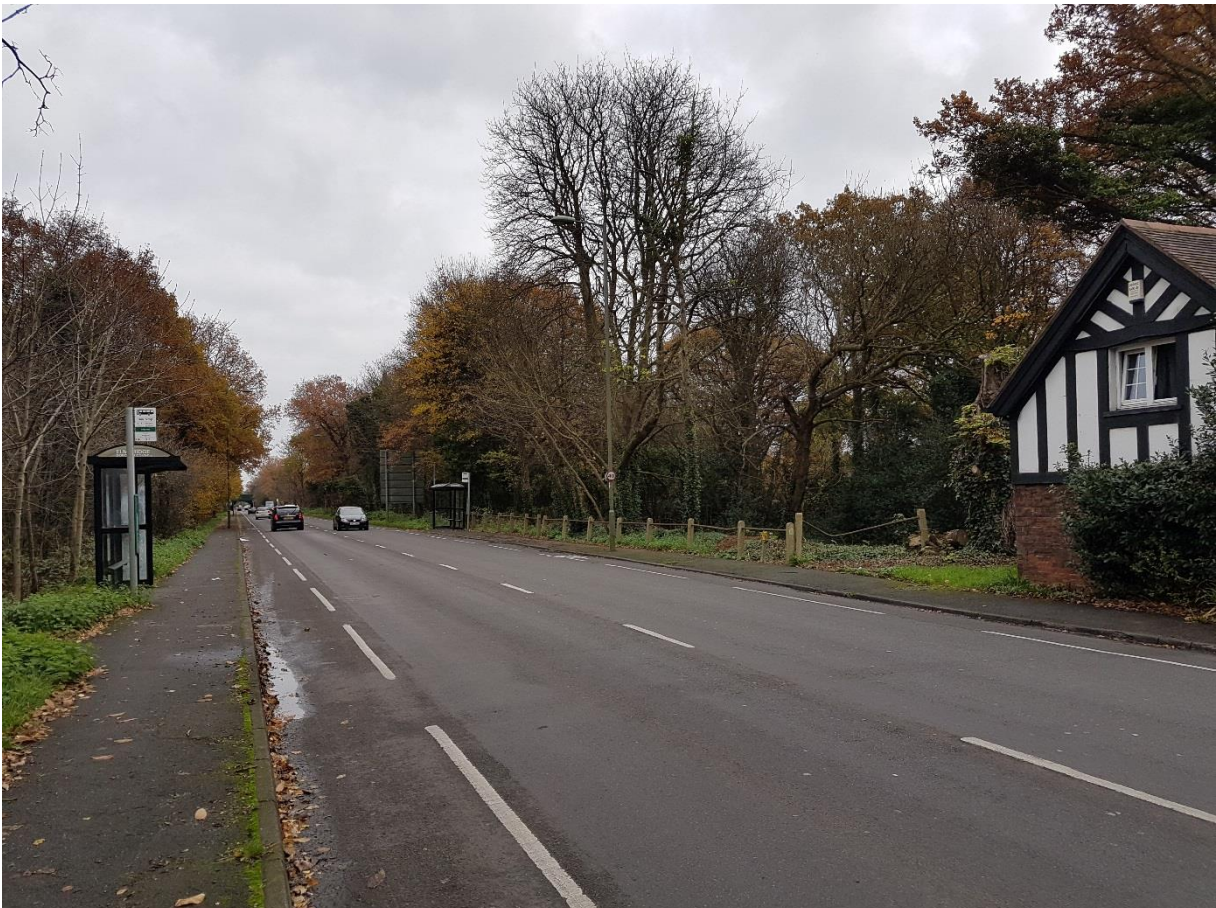
Figure 4 – Photo A307 Portsmouth Road (bus stops NE bound at Littleworth Lodge)

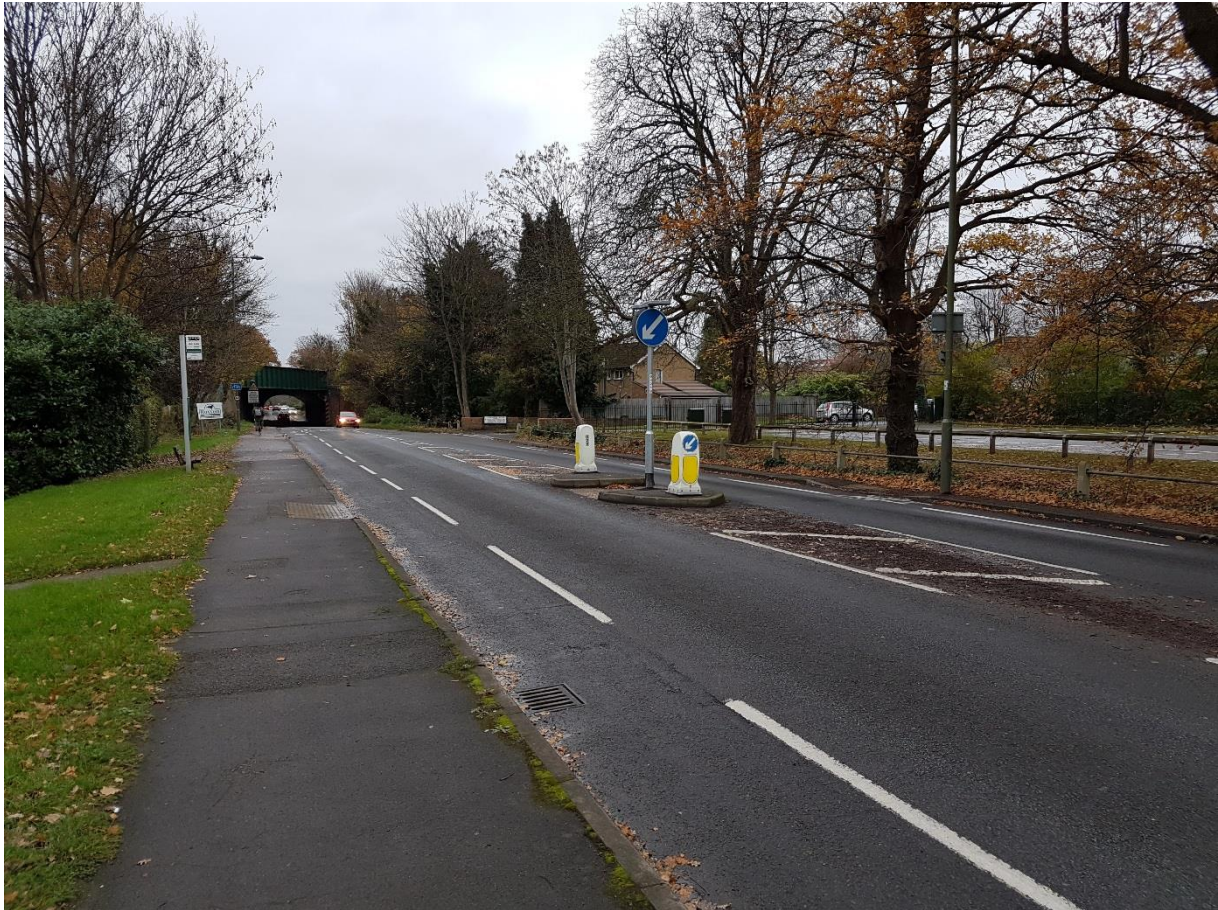
Figure 5 – Photo A307 Portsmouth Road (pedestrian refuge at Couchmore Avenue)

- An uncontrolled crossing at the roundabout splitter island (0.9m crossing width x 1.8m wide island, no tactile paving).
- A pedestrian refuge island (2.0m crossing width x 2.0m wide island, with tactile paving) near the request stop south-west of the junction with Couchmore Avenue. Remaining lane widths are approximately 3.8m (1.0m advisory cycle lane, 2.8m wide running lanes)

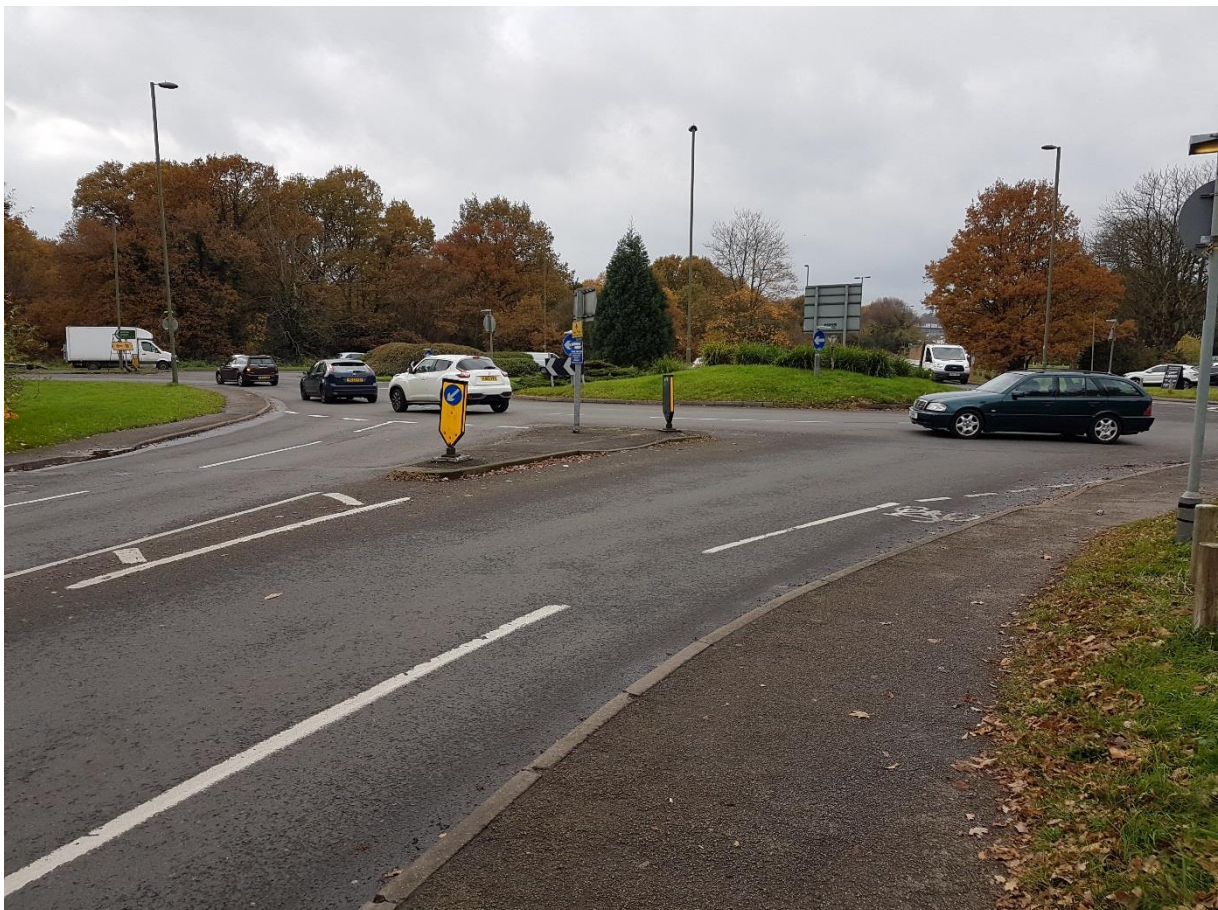
Figure 6 – Photo A307 Portsmouth Road (Scilly Isles roundabout splitter island)

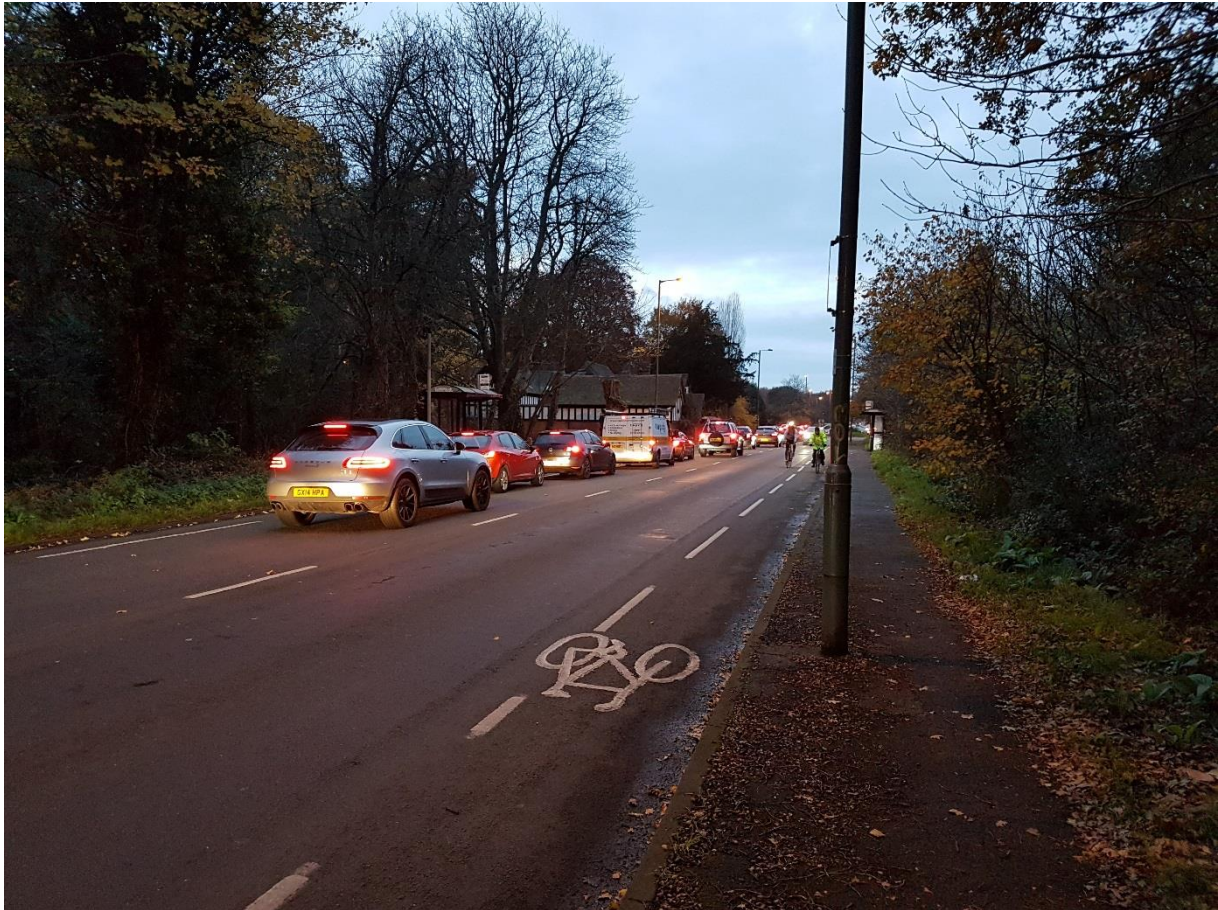
Figure 7 – Photo A307 Portsmouth Road (PM peak SW bound)

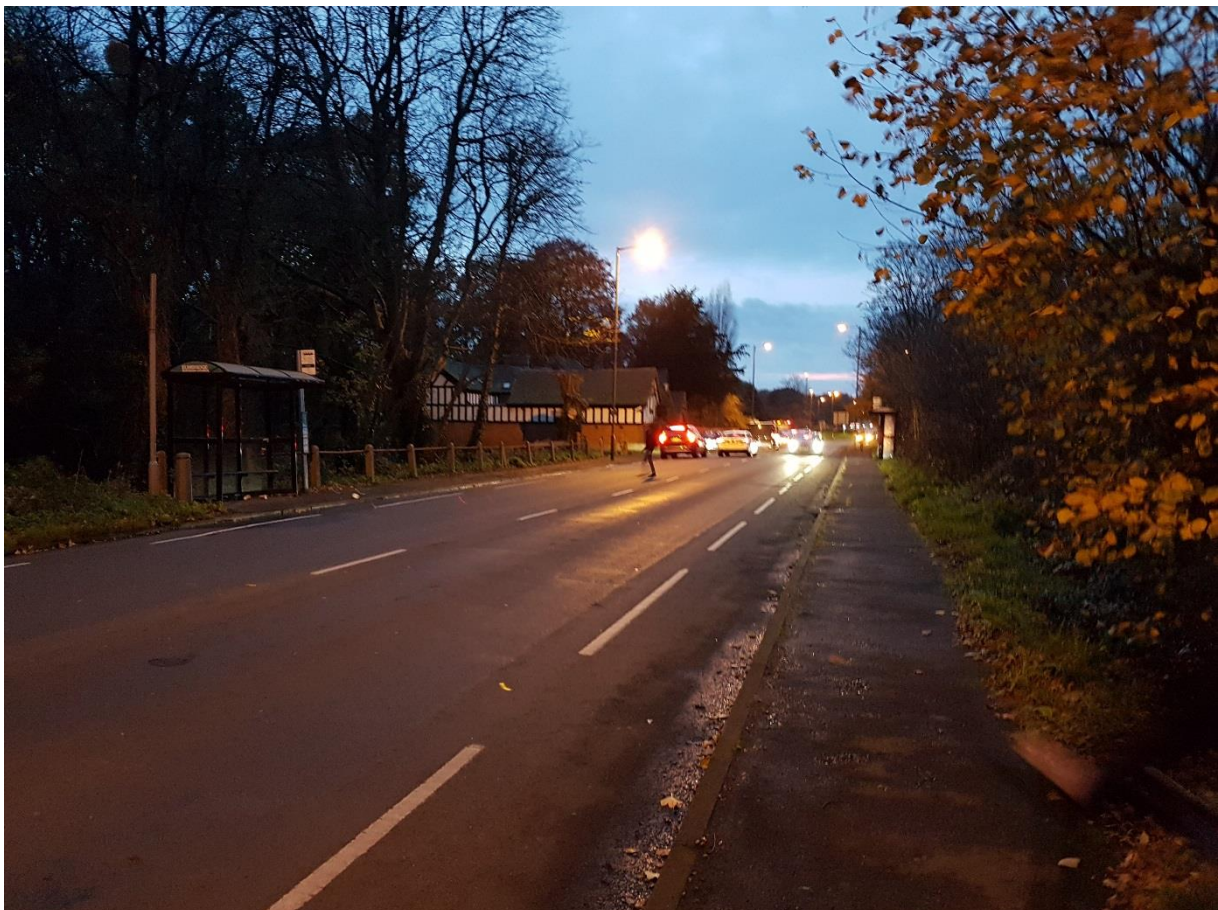
Figure 8 – Photo A307 Portsmouth Road (pedestrian crossing between bus stops)
