High Street Walton on Thames Pedestrian Crossing Facilities

Feasibility Report

Project Title: High Street, Walton on Thames
Pedestrian Crossing Facilities

Document Title: Feasibility Report

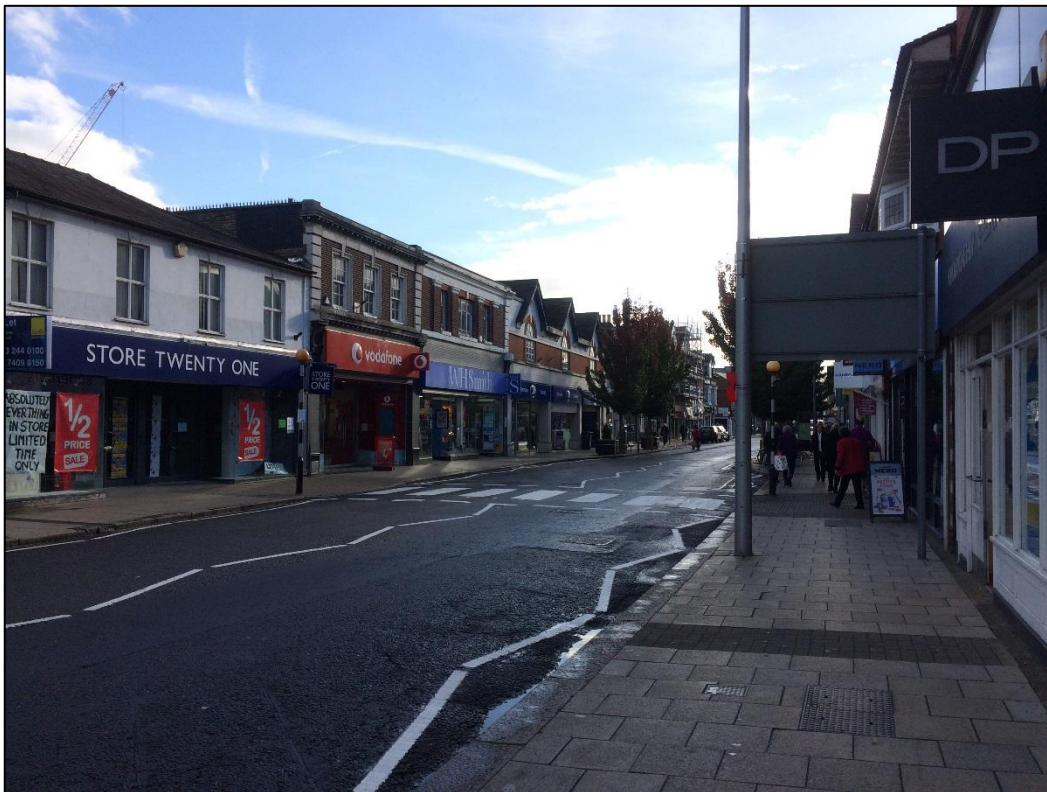
Figure 1: North-east zebra crossing.

At the north-west end of the High Street (junction with Church Street) there is a controlled crossing which forms part of the signalised junction. Approximately 53m further south-east is a Zebra Crossing (outside Caffé Nero) (See Figure 1). A further 33m south-east is the entrance to The Heart shopping centre, outside the shopping centre are footway build outs on both sides of the carriageway (See Figure 2). A further 69m south-east is a second zebra crossing adjacent to the junction with Churchfield Road (See Figure 3). 89m south-east of the second zebra crossing is a controlled crossing which forms part of the signalised junction at New Zealand Avenues.

The visibility to the zebra crossings is affected by the existing parking arrangements as well as street furniture on the footways, including trees and planters.

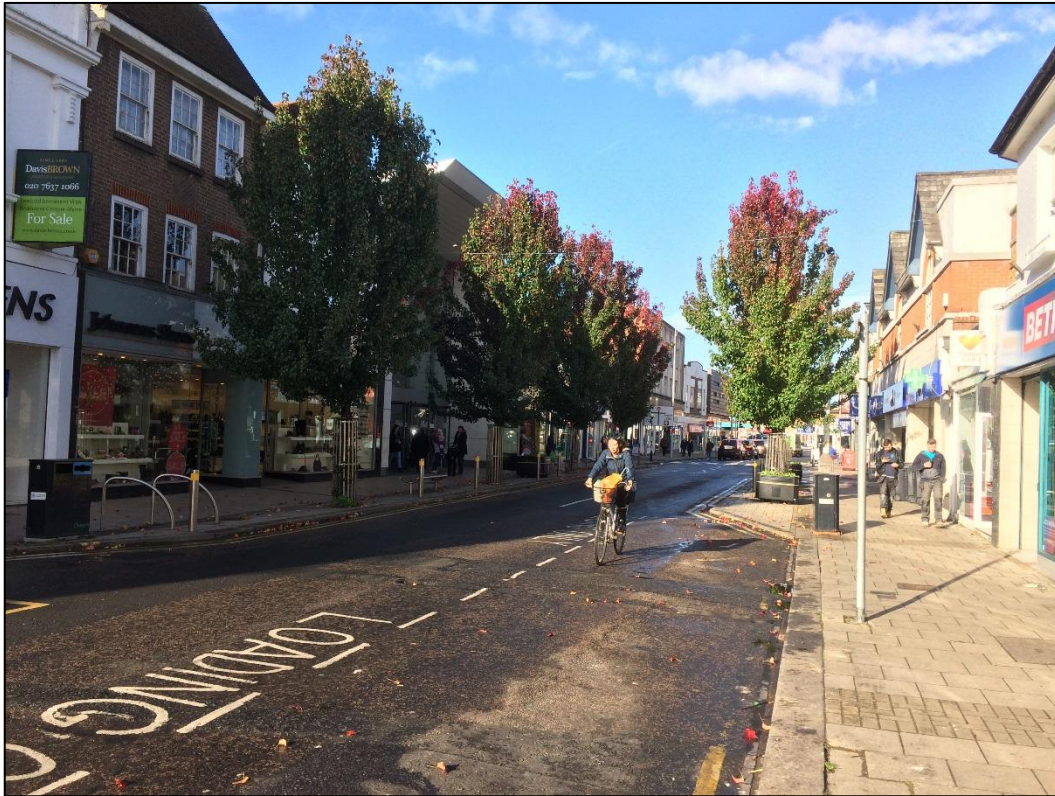
Figure 2: Footway build outs outside The Heart shopping centre.

There are currently footway build outs on both sides of the carriageway outside The Heart shopping centre, this option is to install an uncontrolled crossing on a raised table positioned between the two build outs. Due to the proximity of the adjacent north-west zebra crossing (30m approx), this zebra would be removed. The raised table would calm traffic approaching the crossing point. Existing trees and a disabled parking bay would have to be removed and the bus stop to the south-east would need relocating to create the required pedestrian visibility. The existing footway buildout outside The Heart shopping centre would have to be reduced in size to accommodate the new bus stop. Existing street furniture would have to be removed or relocated to make space for the crossing facility.

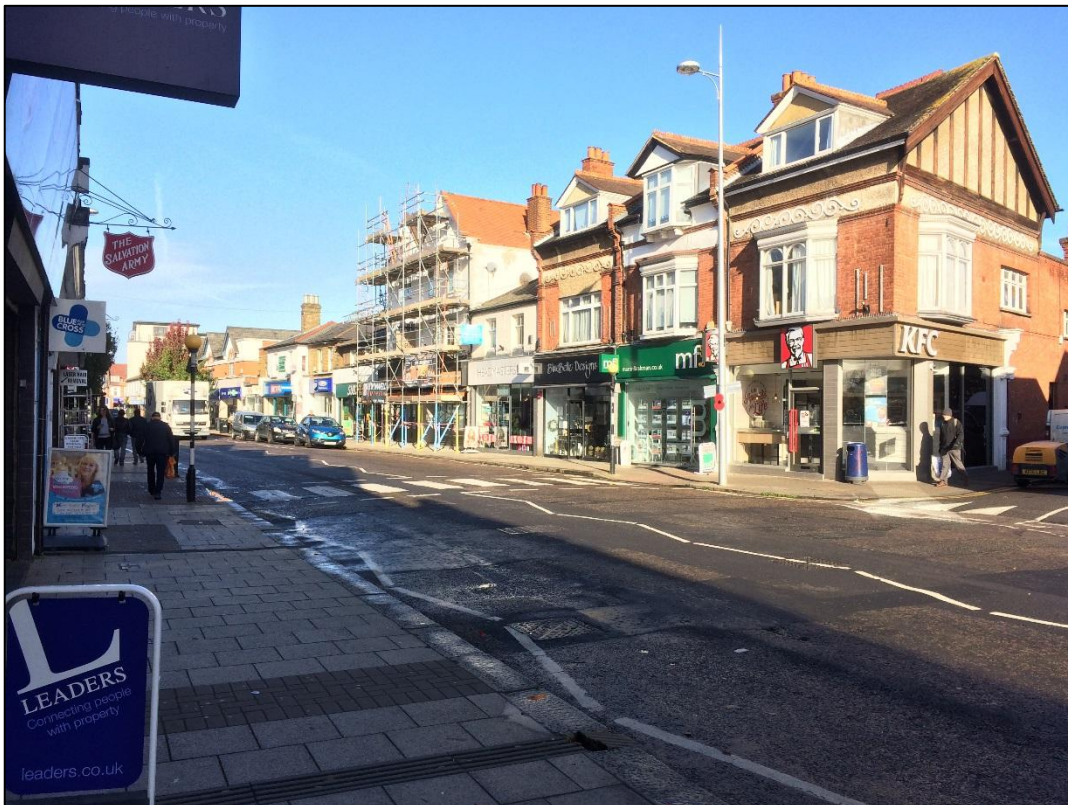
Figure 3: South-east zebra crossing.

This option looks at building out the footways at the existing south-east zebra crossing. The implementation of the build outs would improve the visibility of the pedestrians who can be obscured to approaching traffic by parked vehicles.
