Spelthorne School

Safety Improvements

Feasibility Report

June 2018

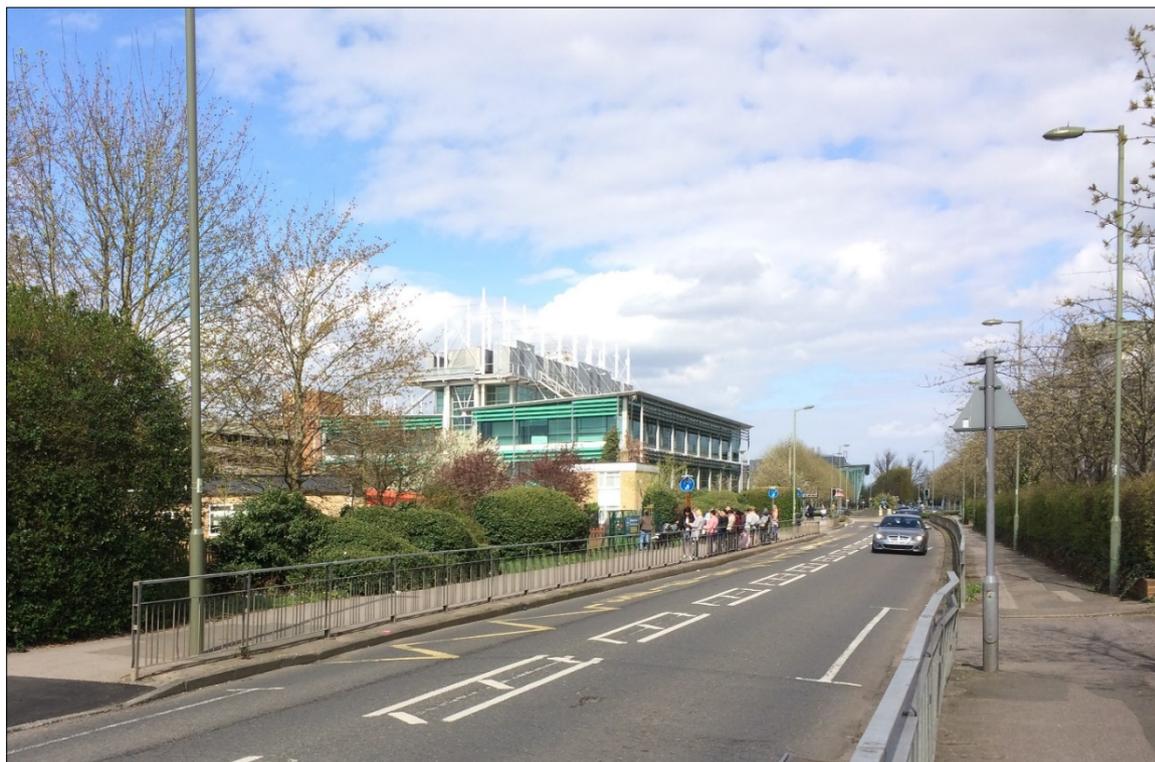
Figure 2: Chertsey Road, looking North East

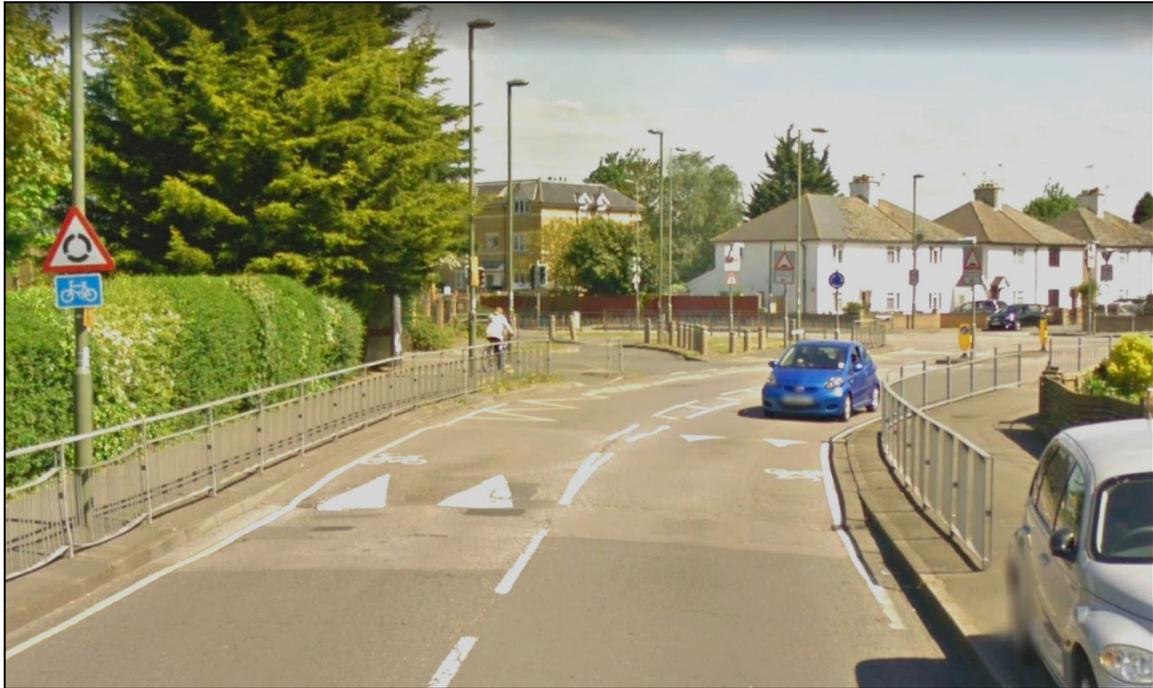
Figure 3: Outside School, Feltham Hill Road looking East

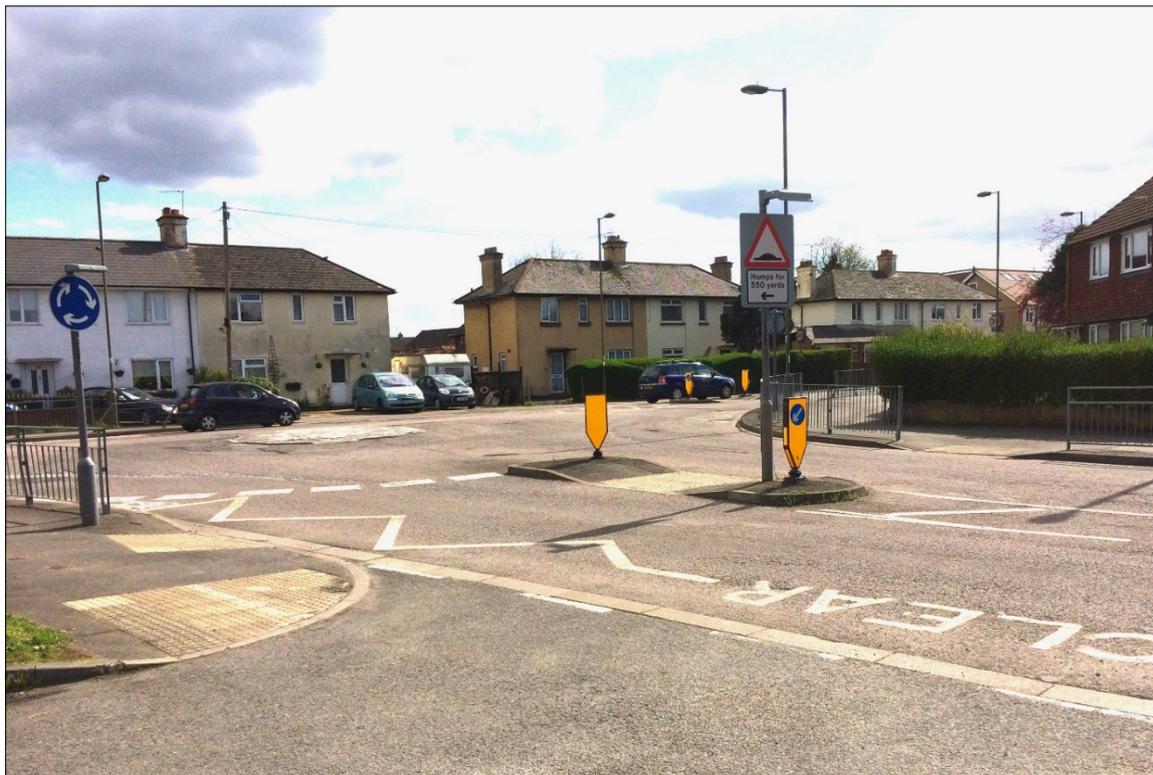
The initial Road Safety Outside Schools visit was carried out in the morning at school drop off time, no School Crossing Patrol was present. This visit found that when no School Crossing Patrol was present that the majority of pedestrians crossed Feltham Hill Road at the uncontrolled crossing point (with pedestrian refuge) adjacent to the roundabout. A School Crossing Patrol was present for the second visit and the assessment concluded that most pedestrians crossing Feltham Hill Road used the patrol. Currently there is no School Crossing Patrol. The Safer Travel Team are looking to recruit replacements, however there are a shortage of applicants for these roles.

The assessment notes that the existing pedestrian refuge lacked the necessary capacity for pedestrians when the School Crossing Patrol was not operating.

Figure 4: Uncontrolled crossing with pedestrian refuge, Feltham Hill Road

This option involves enlarging the existing pedestrian refuge without preventing vehicle movements to and from the roundabout, and in and out of the school. Drawing PC0840-01 is based on the OS map and on site measurements, if this option was to proceed to detailed design a small topographical survey would have to be carried out to determine the exact size of the new refuge.

The current capacity of the refuge is insufficient and this option would make significant improvements increasing its pedestrian capacity and making the refuge easier to use for pushchair and wheel chair users. This option would require a Road Safety Audit if to be pursued.

This said, it is clear from site observations that existing uncontrolled crossing point in Feltham Hill Road lacks the capacity needed for pedestrians at busy times. Improvements to the existing facilities are recommended. If a School Crossing Patrol is not reinstated the Zebra Crossing (Option 2) is recommended.

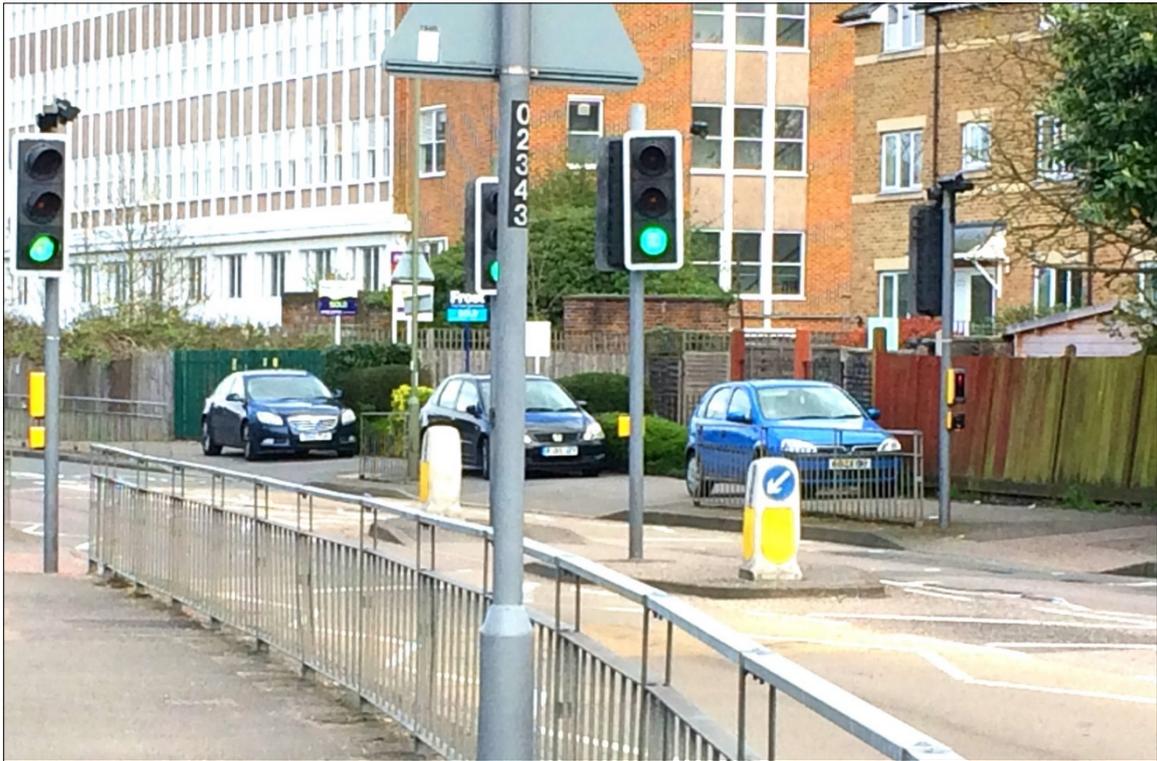
It has also been noted that a number of vehicles are parking on footways, a particular area of concern is where cars are parking behind the guardrails in Chertsey Road adjacent to the Puffin crossing (Figure 5).

Figure 5: Vehicles parked behind guardrail, Chertsey Road

Installing bollards in Chertsey Road (north east of the roundabout) would prevent vehicles parking behind the pedestrian guard rails (Figure 5) and prevent them from causing an obstruction to pedestrians.

This option resolves the issue of vehicles parking behind the guardrails adjacent to a pedestrian crossing in Chertsey Road which is busy with parents and children at school drop off and pick up time.

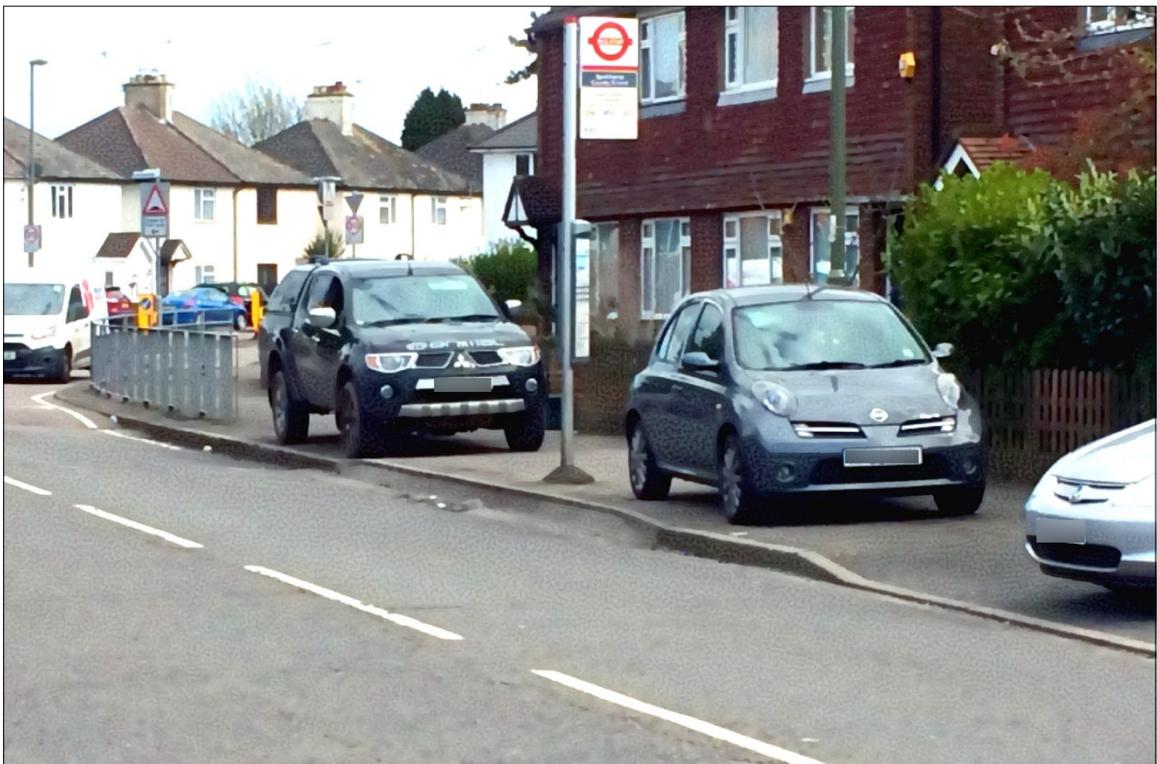
Figure 6: Vehicles parked on footway at bus stop in Feltham Hill Road

Installing bollards adjacent to the bus stops in Feltham Hill Road and Chertsey road would prevent vehicles parking on the footway and causing an obstruction to pedestrians. Bus stop markings have also been included to highlight to drivers that there is a bus stop and enable enforcement of obstructive parking.

Vehicles currently park on the footway by the bus stops in Feltham Hill Road and Chertsey Road installing bollards is low cost and would prevent access to an area busy with pedestrians at school drop off and pick up times. The addition of bus stop markings should highlight the bus stop to drivers and deter them from parking in the carriageway at this location.

It has also been noted that vehicles parking on footways is a problem in the area. It is recommended that is prevented in key locations near the School with the use of bollards.
