High Street, Shepperton Pedestrian & Parking Improvement Options

**Feasibility Report
March 2020**

Project Title: High Street, Shepperton
Pedestrian Improvements

Document Title: Feasibility Report

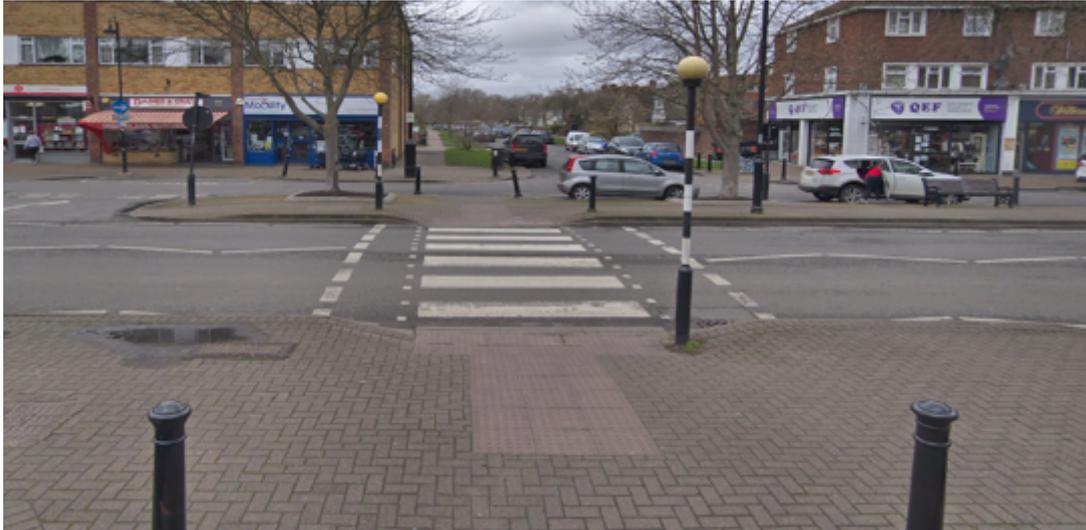
Photo 1. Existing Zebra Crossing Facility

The zebra crossing has been in place since 2005 and is positioned well in order to maximise its use. On site observations confirmed that it was well used and remains the desire line for most pedestrians wishing to cross the High Street. However, the zebra crossing has restricted visibility to the south as a result of on street parking which is marked by parking bays as shown in photo 2. Proposals to remove this on street parking will be discussed in more detail within the options. There is a good system of street lighting throughout. This will illuminate the approaches to any proposed crossing facility, and illuminate the existing zebra crossing.

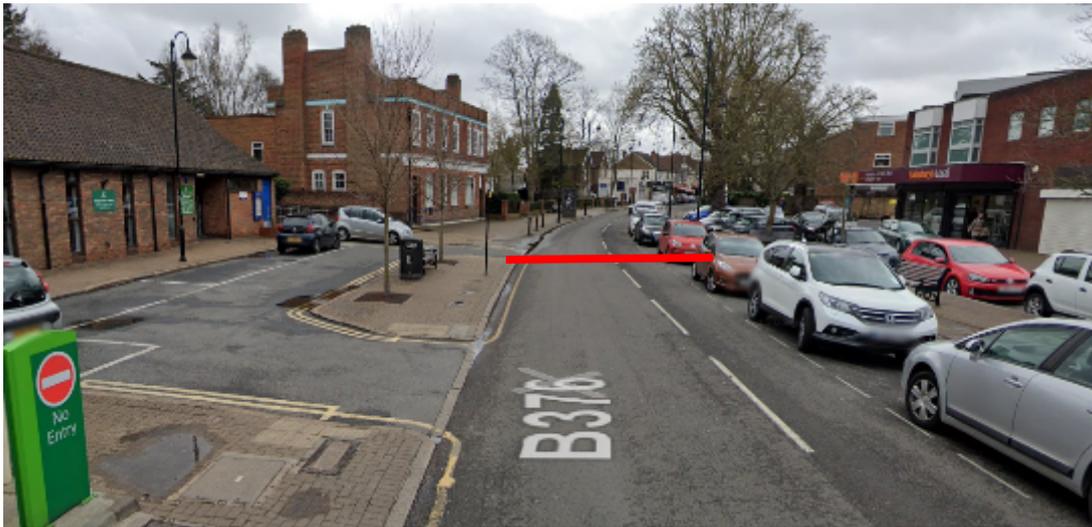
Photo 3. Desire line for pedestrian's to cross on the High Street

- An additional desire line for pedestrians to cross the High Street approximately 80 metres to the north of the zebra crossing outside the public library and opposite one of the supermarkets. As shown in photo 3
- The on street parking also restricts visibility at the proposed uncontrolled crossing outside of the library.
- The tactile paving at the zebra crossing does not comply with current guidance.
- There are several crossing points along the High Street/service roads which could benefit from tactile paving to assist the visually impaired. See photos 4 – 7

As observed whilst on site, there is an additional desire line for pedestrians wanting to cross the road near to the public library and opposite one of the local supermarkets. This option looks at three feasible options for providing an additional crossing facility on this desire line.

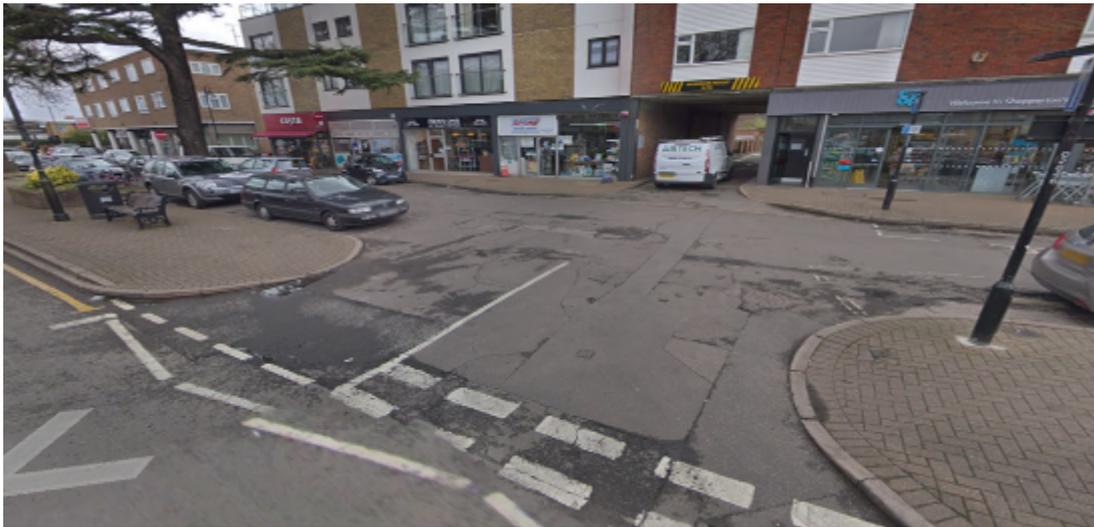
Photo 4. Location A – No tactile paving present

There are several uncontrolled crossing points along both the High Street and service roads which could benefit from tactile paving to assist the visually impaired. Layouts of all pedestrian areas should be simple, logical and consistent to make it easier and safe for visually impaired pedestrians to move around. Currently, there is an inconsistency with the provision of tactile paving on the uncontrolled crossing points throughout the High Street

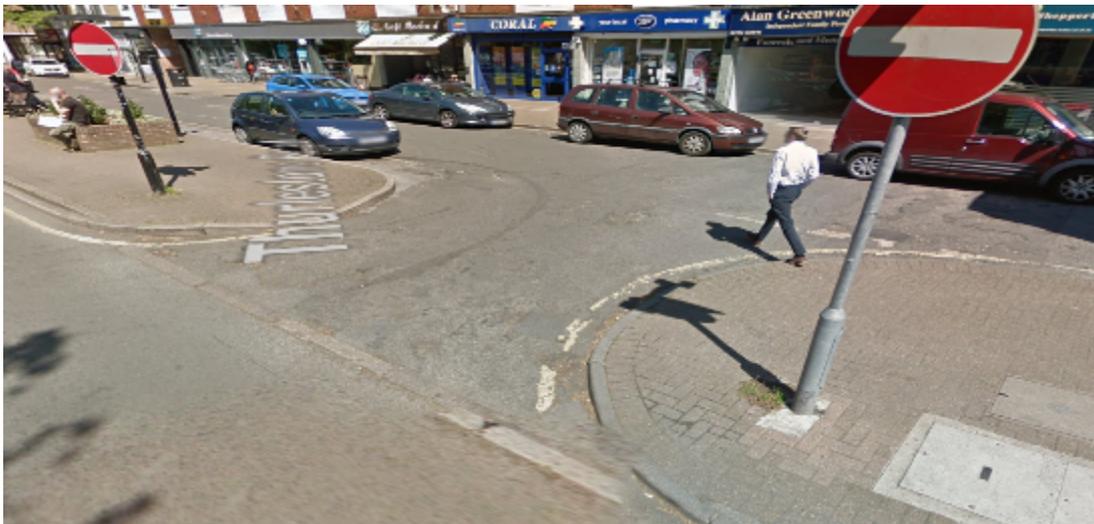
Photo 5. Location B – No tactile paving present

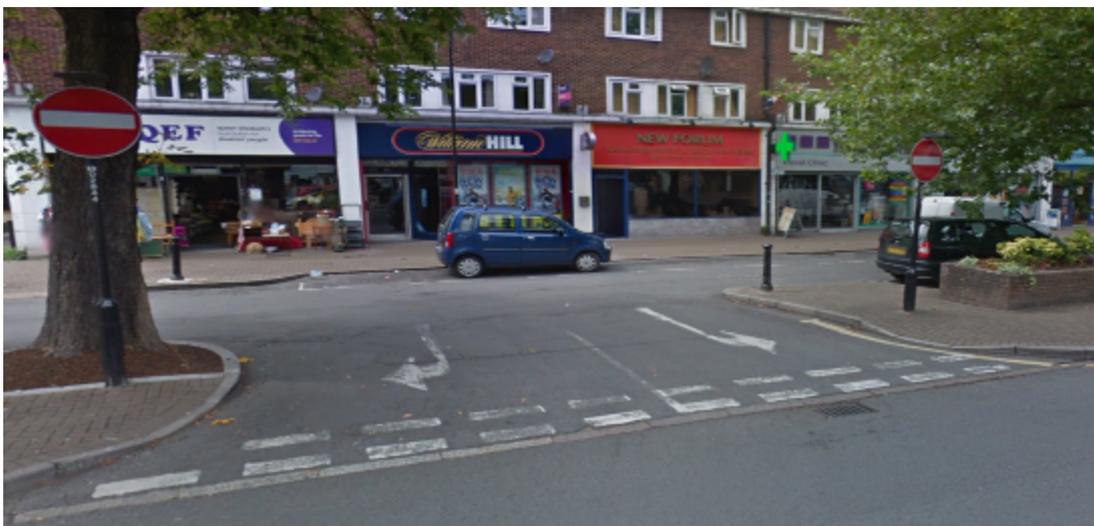
Photo 6. Location C – No tactile paving present

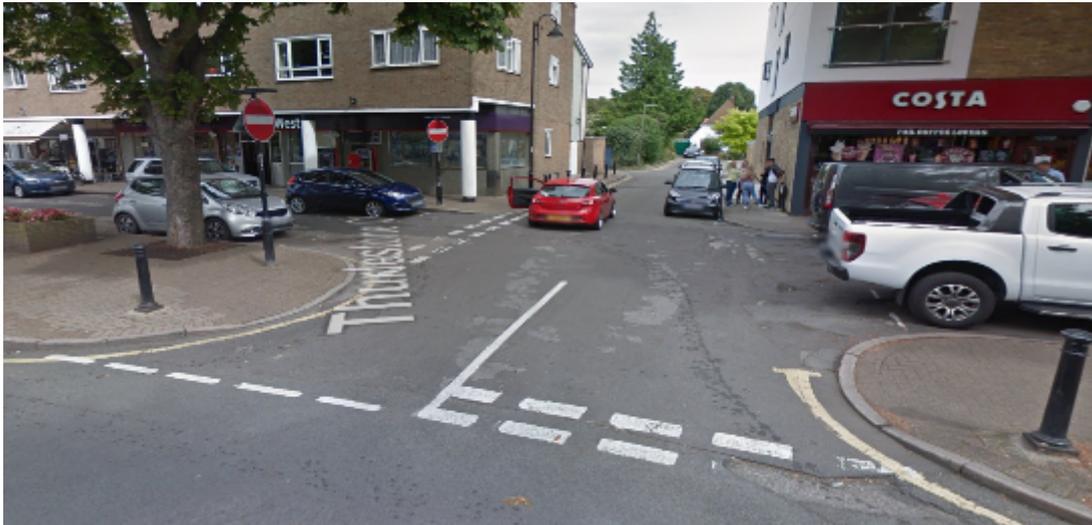
Photo 7. Location D – No tactile paving present

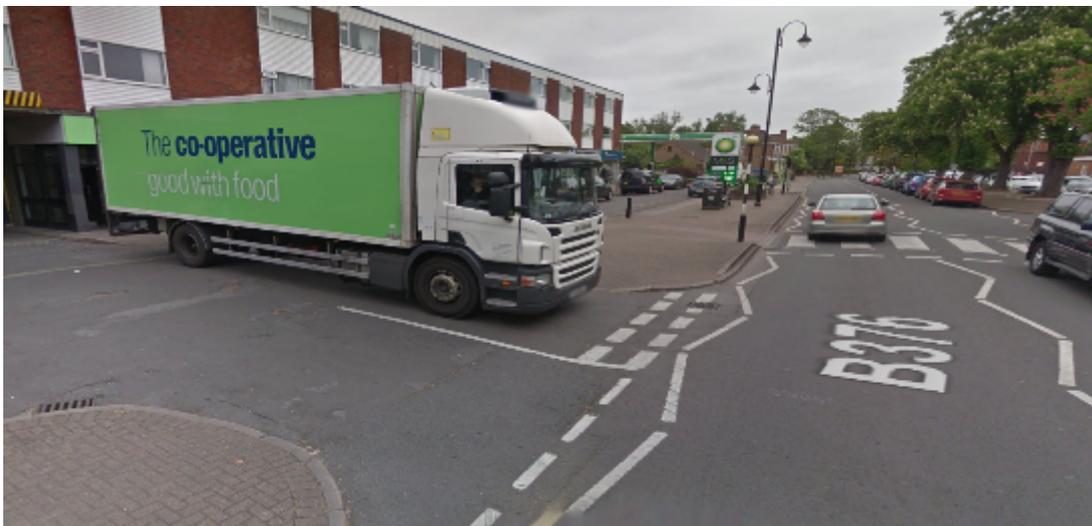
Photo 8. The north west service road

- The existing parking arrangements on both service roads makes it very difficult for cars to safely travel due to the narrow width and arrangement of parking bays. This is especially apparent when there is a HGV delivery to one of the shops. Reports from businesses state there are regular damage only incidents with vehicles.

- There is evidence of kerb strikes/damaged kerbs at the bell-mouths as drivers turn to enter and exit the service roads, potentially placing pedestrians using the footway at risk of conflict.

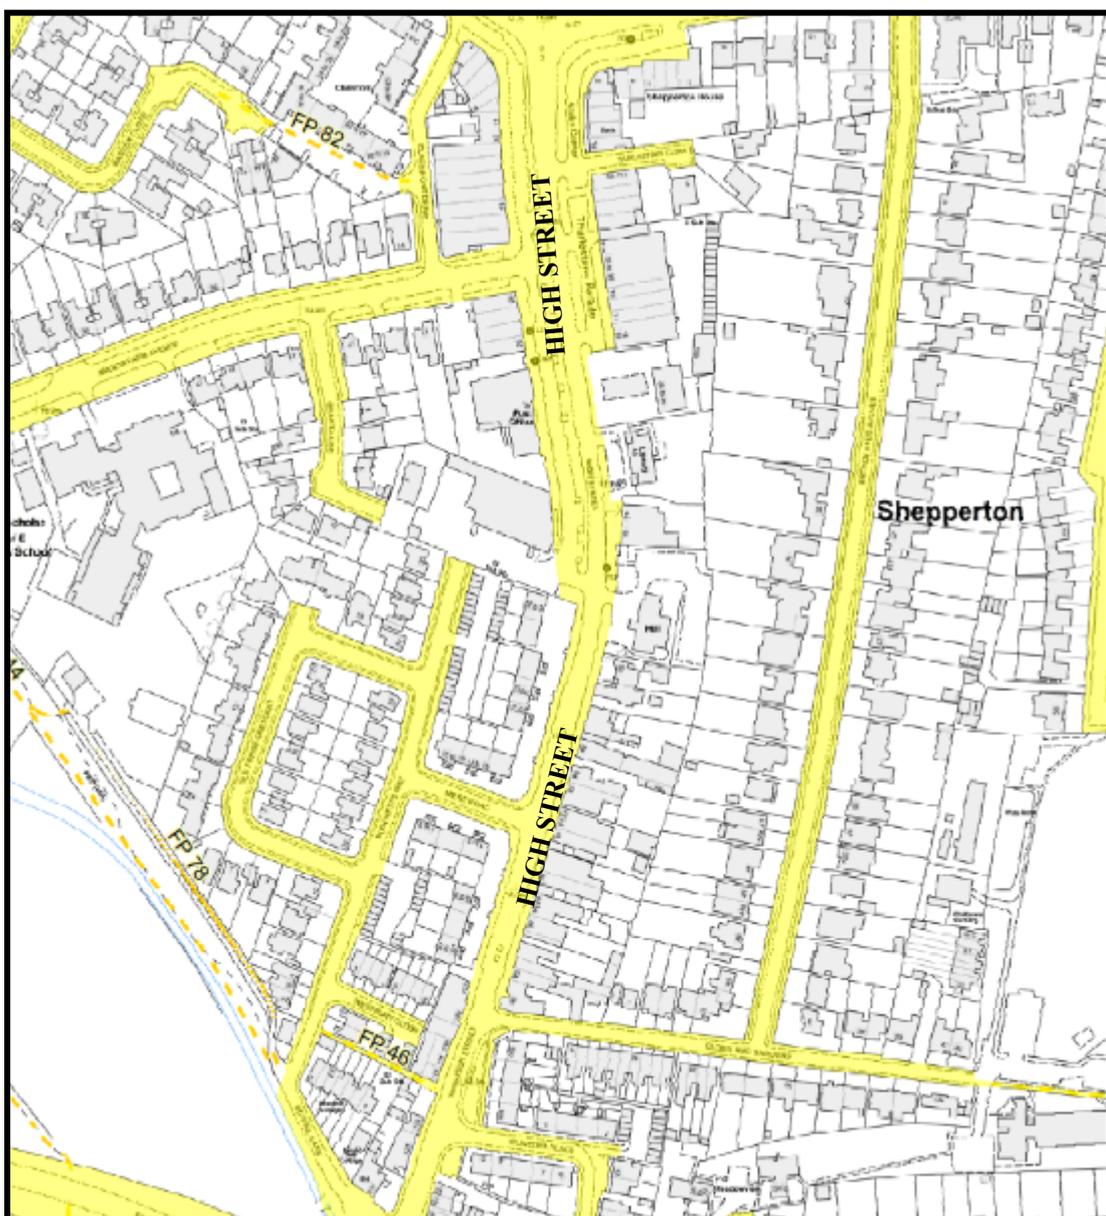
Fig 04. Extent of Publicly Maintainable Highway

The Highway Extents on the High Street and surrounding roads were obtained to understand what areas could be improved without having to acquire land.

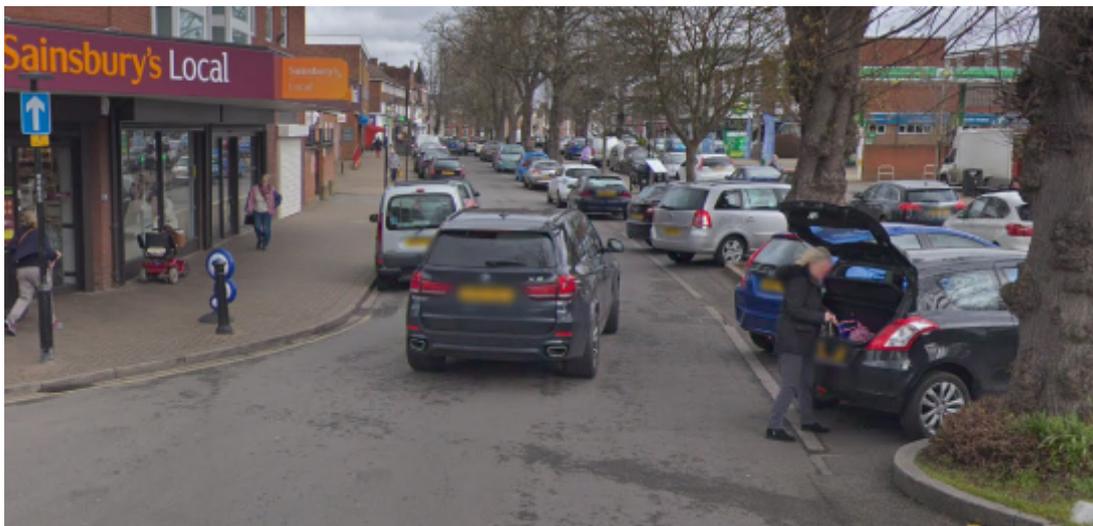
Photo 9. Zone A

The diagonal parking bays outside of Sainsbury's result in restricted visibility for parked cars as the alignment of the bays encourages front in parking. The parallel parking bay on the west side of the service road is narrow (less than 2m wide), it is recommended that the parking on the west side is removed and double yellow line parking restrictions installed. This would improve the visibility for motorists reversing out of the diagonal spaces and create additional space for vehicles to manoeuvre safely.

Zone A – Remove 3 Parking Spaces to the west

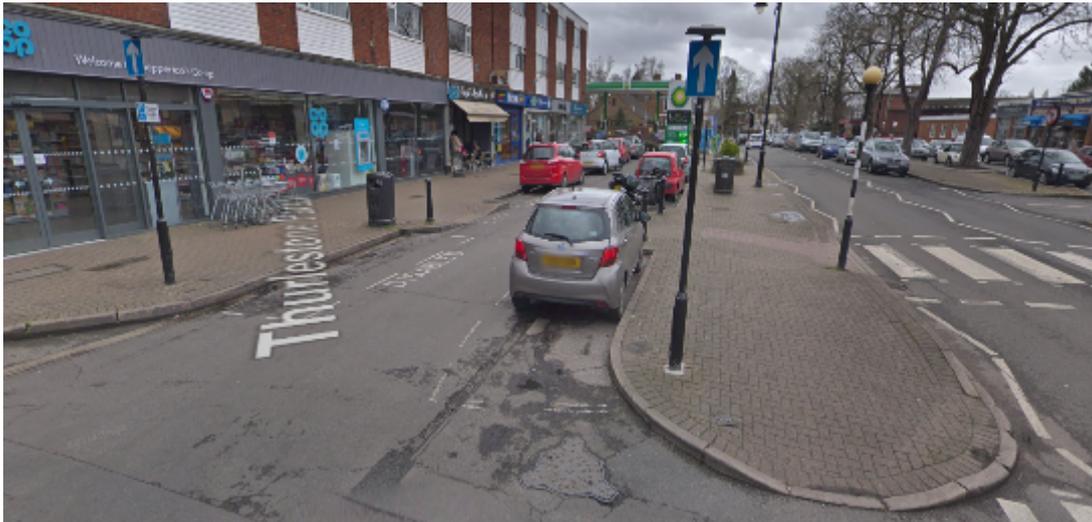
Photo 10. Zone B

Directly outside of the Co-op shop there is a disabled bay on the east of the service road and single parking space on the west. Both of these spaces cause difficulty for vehicles turning into the service road, it is recommended that they both be removed and replaced with double yellow line parking restrictions. The disabled bay could be relocated elsewhere along the service road.

Zone B – Removal of 1 Parking Bay and relocation of 1 Disabled Bay

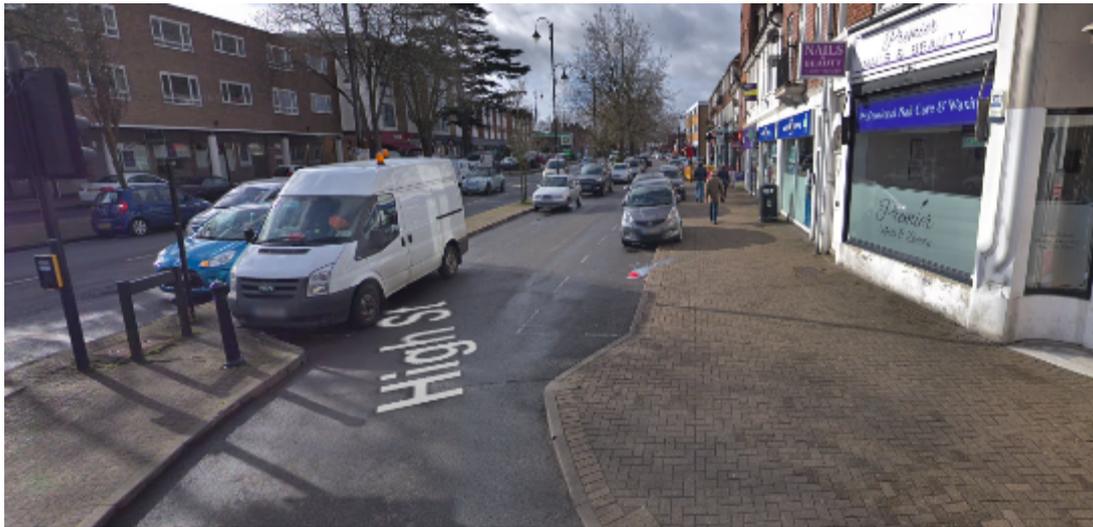
Photo 11. Zone C

This section of the service road incurs a number of vehicles using the footway to half park. There is also a pinch point where the road narrows towards the west of the service road (outside the Nail Salon). When cars are parked on both sides of the road, it is very difficult for cars to manoeuvre through this pinch point.

It is recommended that all parking on the east along the service road is removed and replaced with double yellow line parking restrictions. A length of parking on the west of the service road directly outside of the Nail Salon should be removed so that there is no longer a pinch point where the road narrows for the crossing point.
