BASINGSTOKE CANAL

ASSET MANAGEMENT PLAN

THIRD EDITION

Date: June 2010

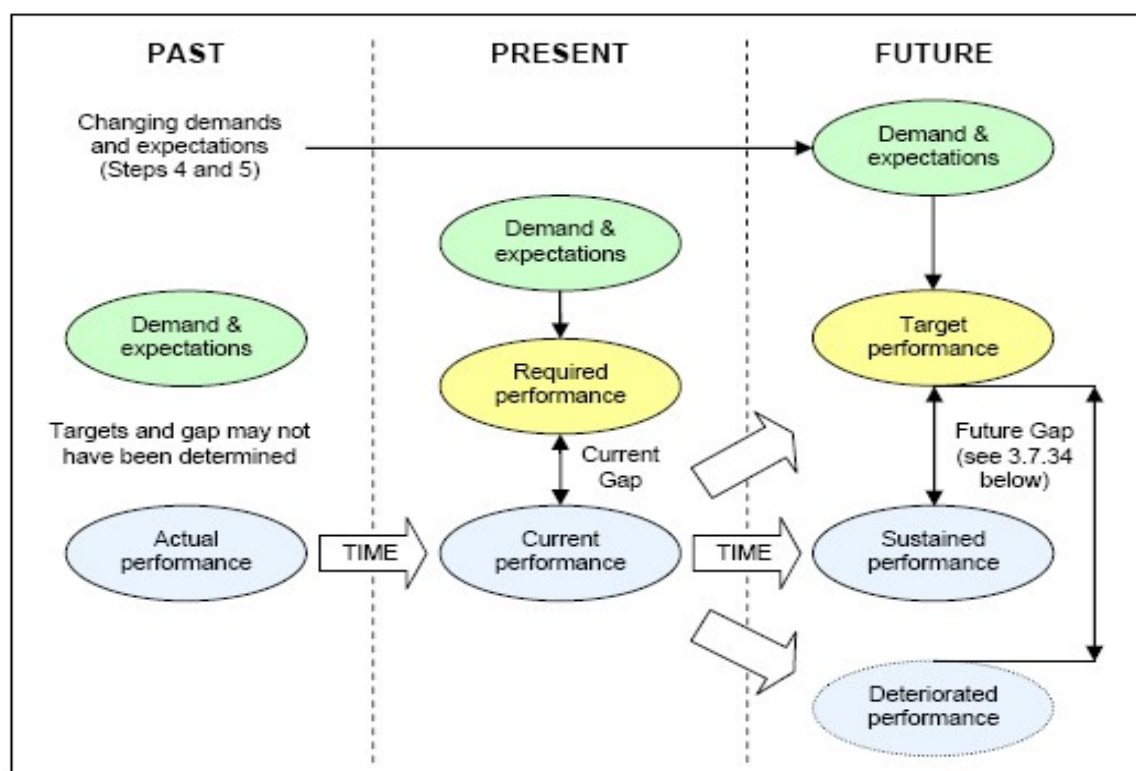
Fig. 1 – Performance Gap Analysis
(Source: [2])

2.3 The ideal situation is to be able to maintain the asset in a condition that permits the desired level of service to be achieved at the minimum whole life cost. The backlog is the amount of work required to get from the present condition to the desired condition (see Fig. 1). It is not necessary, or indeed practical, to deal with the entire backlog in a single year.

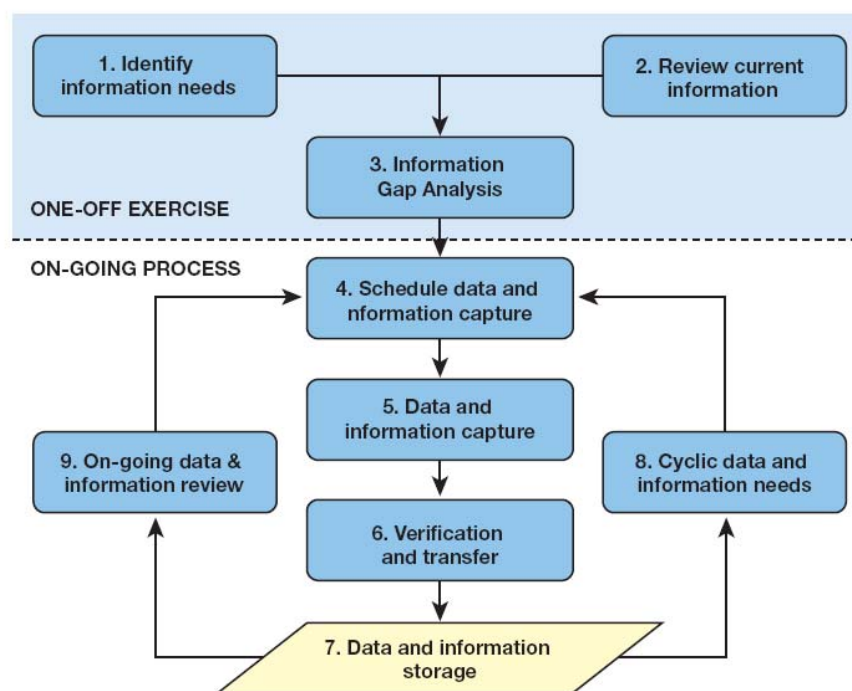
Fig. 5 – Information Management Process (Source: [2])

5.2 Good asset data and a secure asset database underpin the objective of providing a safe, reliable and sustainable Canal. Therefore, it was important to determine the method of data storage before data collection began. There was little point in commencing a data collection exercise without having first set out the 'ground rules'. It was also crucial that the inspection process and procedure was set down before the data collection exercise started. Failure to carry out basic preliminary steps could have resulted in significant abortive costs. The process for the overall management of data has been provided (see Fig. 5).

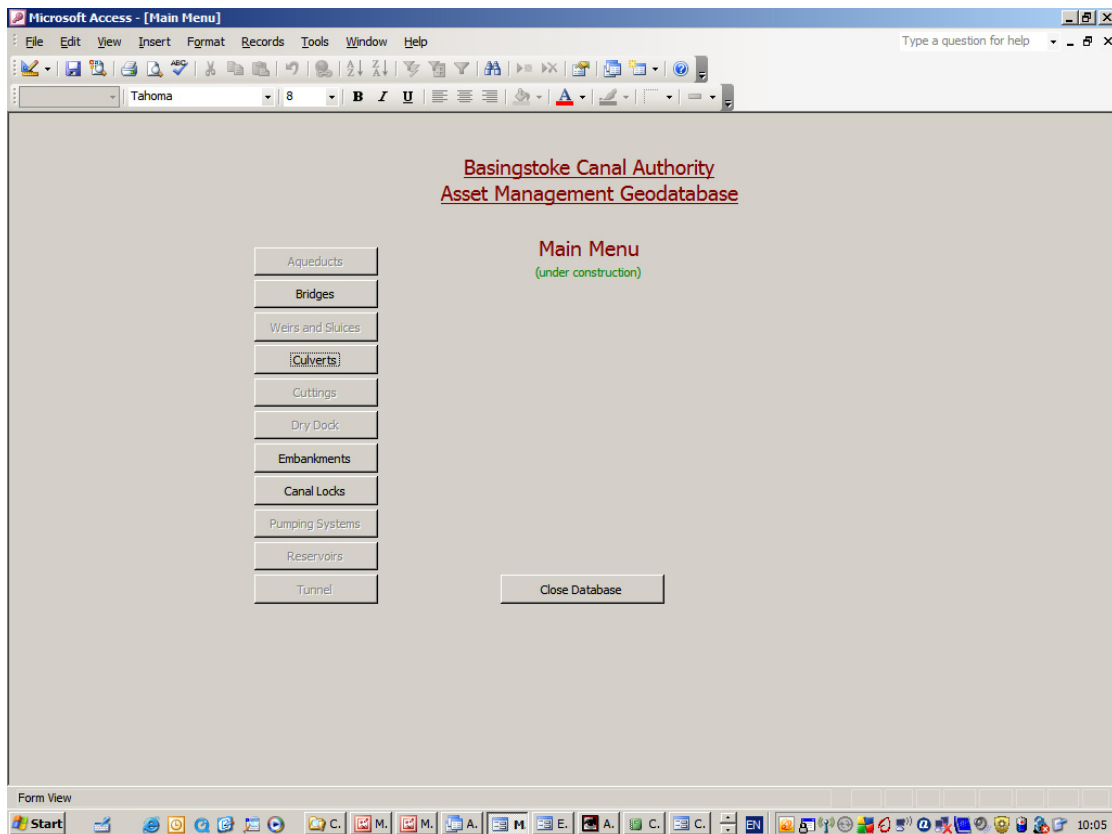
Fig. 6 – BCA Asset Management Geodatabase, Main Menu

- 5.5 Staff at the BCA developed an Access database in 2009 that was capable of holding all of the asset data required to manage the Canal, namely the Asset Management Geodatabase (AMG). A screen shot of the menu page has been provided (see Fig. 6). A more detailed data entry sheet for the embankment asset type has also been provided (see Fig. 7). Work was also undertaken to create a Geographical Information System (GIS), a form of mapping software, which presents inventory data linked to location. A screen shot of the GIS application has been provided (see Fig. 8).

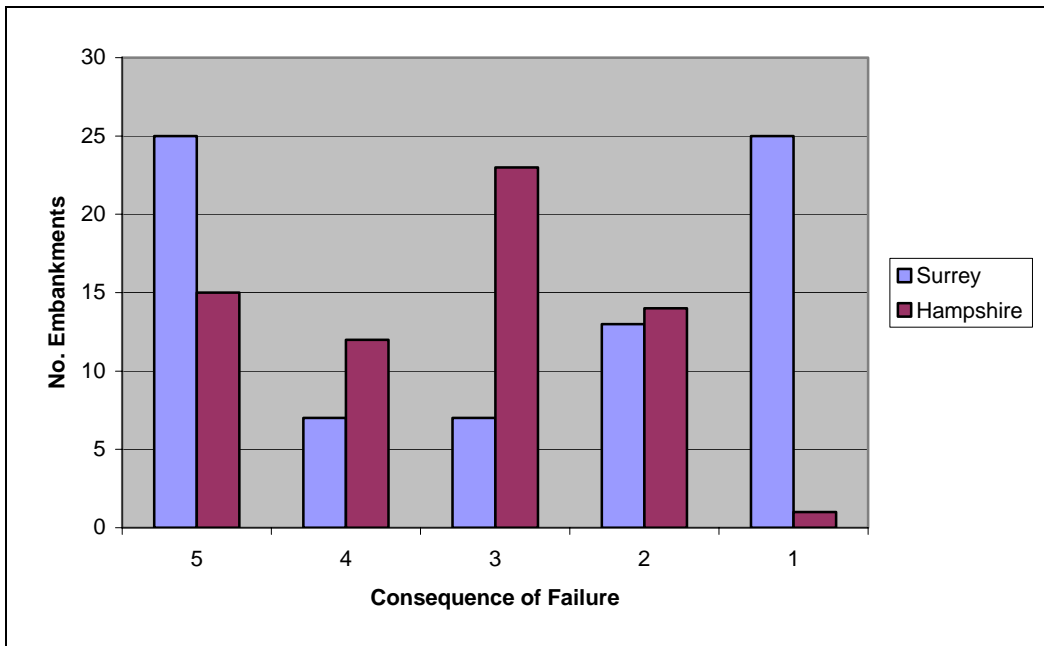
Figure 11 - Embankment ‘Consequence of Failure’ Summary, 2009
(Source [27])

8.3.1.6 For ease of interpretation Table 6 and Table 7 have been represented graphically as shown in Figure 10 and Figure 11 respectively.

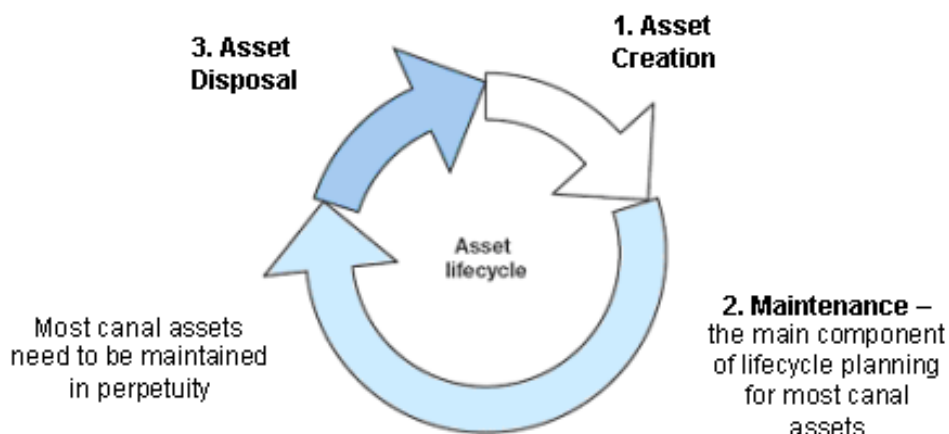
Fig. 12 – Lifecycle Phases of a Highway Structure
(Based on Fig. 3.8 [2])

12.1.3 A significant amount of work is now required to develop these lifecycle plans. Each lifecycle plan should include a complete acquisition to disposal cycle (see Figure 12). It will be necessary to determine routine maintenance activities and maintenance standards. The objective will then be to keep the assets in a serviceable state by carrying out the inspection process and then applying the stated maintenance standards.

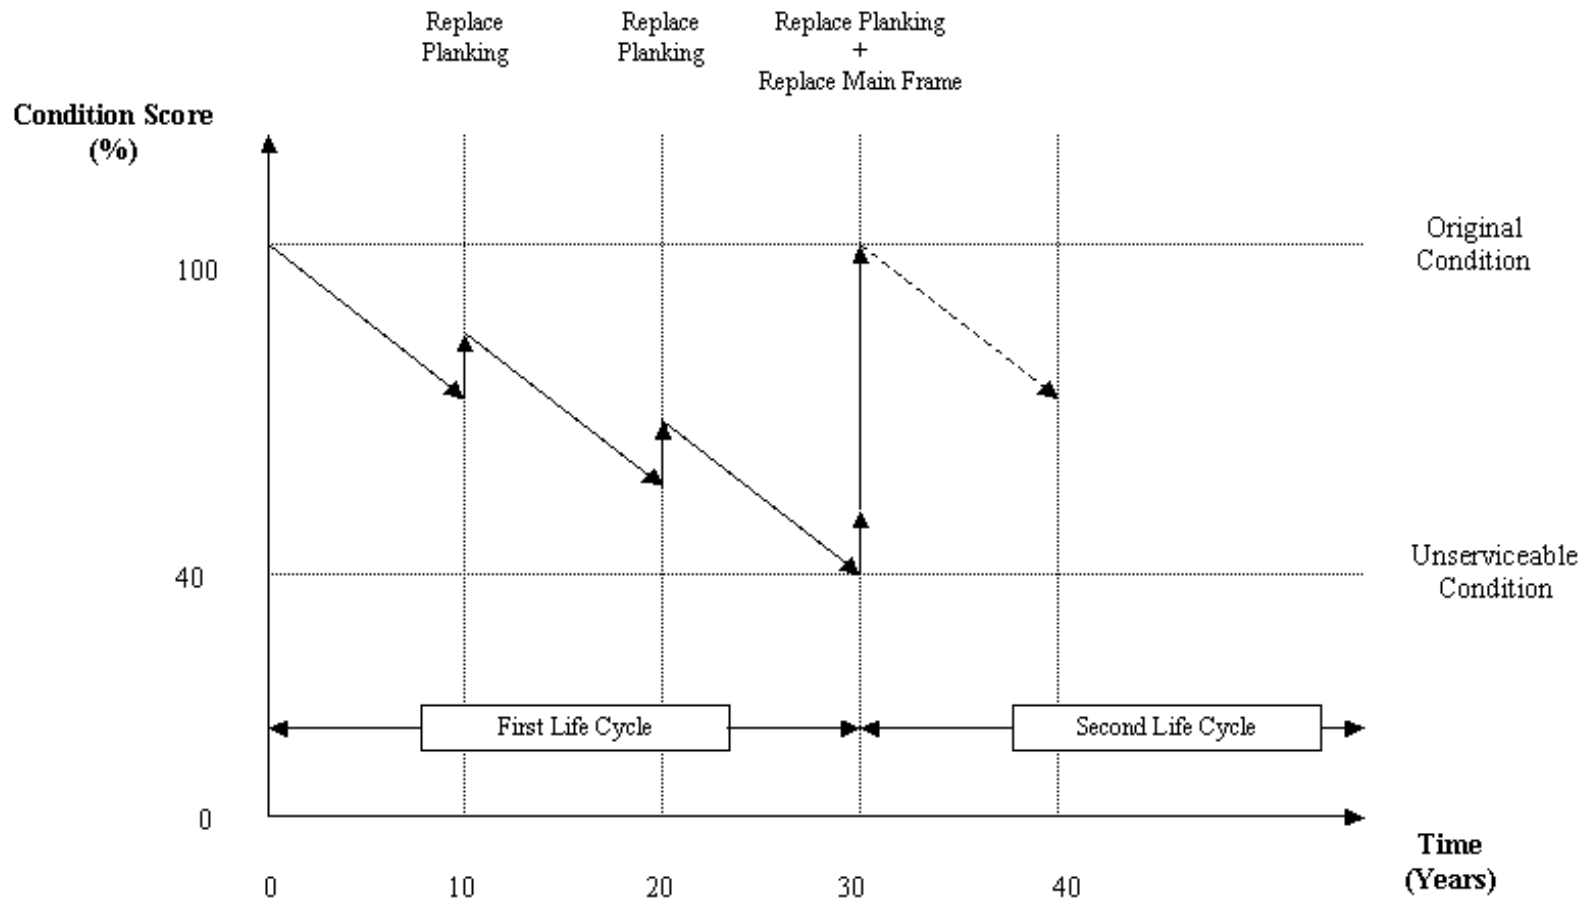
Fig. 13 – Lock Gate Illustrative Lifecycle Plan

N.B Replacing the planking represents minor maintenance, whereas replacing the main frame and planking represents major maintenance.

- 12.2.8 Following discussions, BCA proposed that on average the lock gates required their secondary planking to be replaced every 10 years (minor maintenance) and the main framework to be replaced every 30 years (major maintenance). This simplistic lifecycle plan could thus be represented diagrammatically (see Fig. 13). It was suggested that the main framework for a pair of lock gates costs approximately £16,000, where re-planking a pair of lock gates costs approximately £3,000.

- 12.2.9 This knowledge has been used to predict when each individual lock gate will fall below the desired level of service (as suggested by the lifecycle plan in Fig. 13), based on its year of manufacture (as shown in Appendix 14) and current condition (as shown in Table 12), and hence require major maintenance. This process has been undertaken as shown in Table 18 for a 30-year period. Note, lock gates recorded as original structures since restoration (i.e. pre 1992) are conservatively assumed to begin their first lifecycle in 1985, as it is known manufacture and installation was conducted before the Canal was re-opened.
