# **D6284 Towpath, Dockett Eddy Lane & D6285 Ferry Lane Safety Improvements**

## **Feasibility Report**

Project Title: D6284 Towpath, Dockett Eddy Lane &  
D6285 Ferry Lane – Safety  
Improvements

Document Title: Feasibility Report

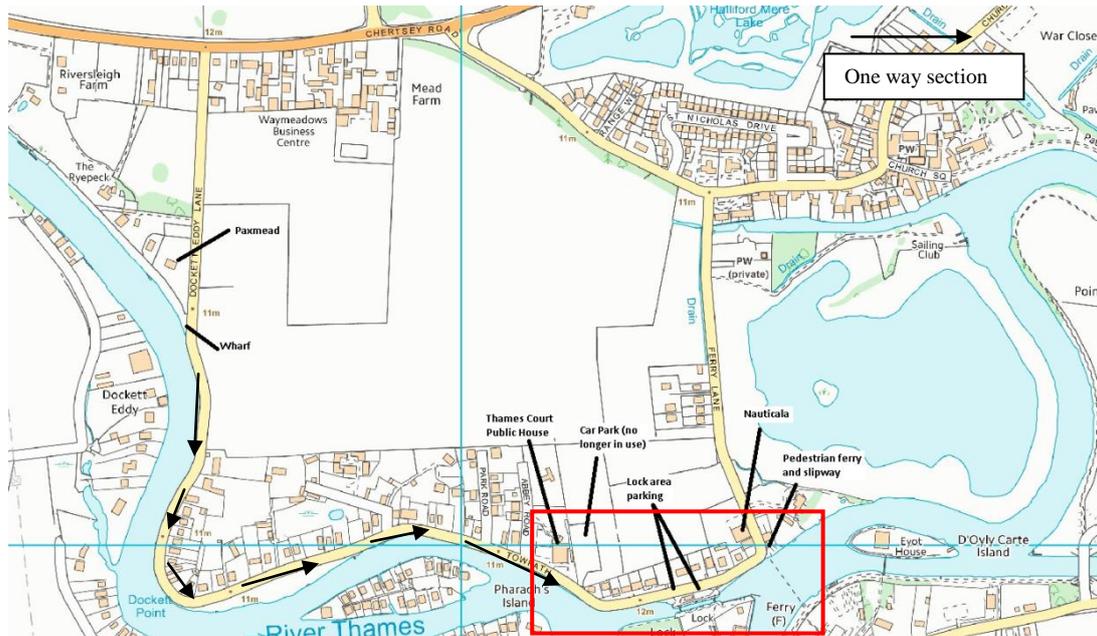
Figure 1: Map showing key locations

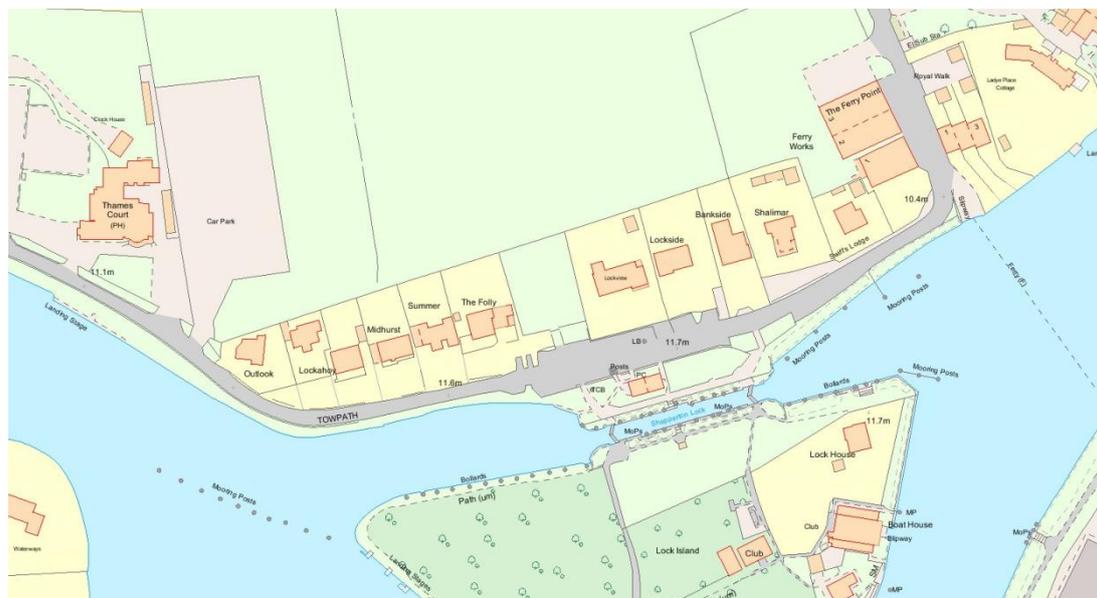
Figure 2: Map showing close up on Shepperton Lock area

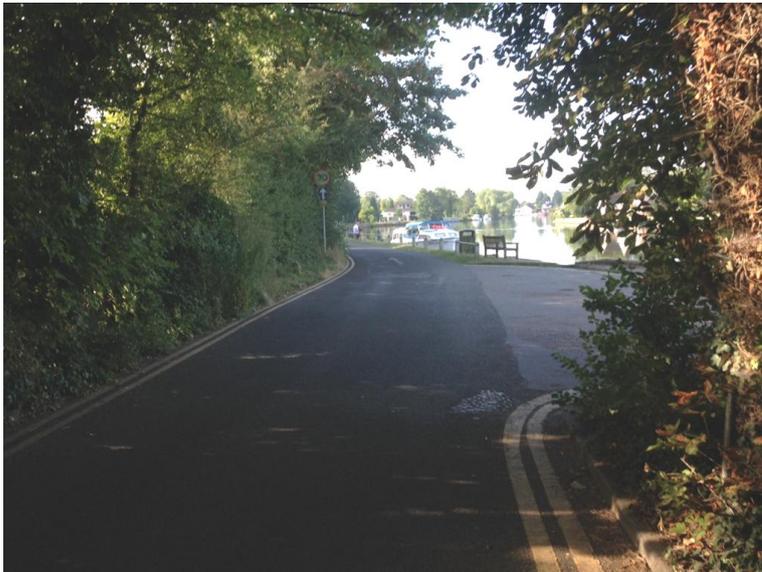
Figure 3: Southern end of Dockett Eddy Lane with the Wharf to right of photograph

Dockett Eddy Lane is relatively straight and is predominately fronted by fields, with a few residential properties as well as Paxmead, a Girlguiding activity venue. In the lane there is only a small section of parking restrictions at the southern end, in the form of double yellow lines. There is no pedestrian provision along the lane, with pedestrians having to walk on the carriageway. This lane does not have any street lights.

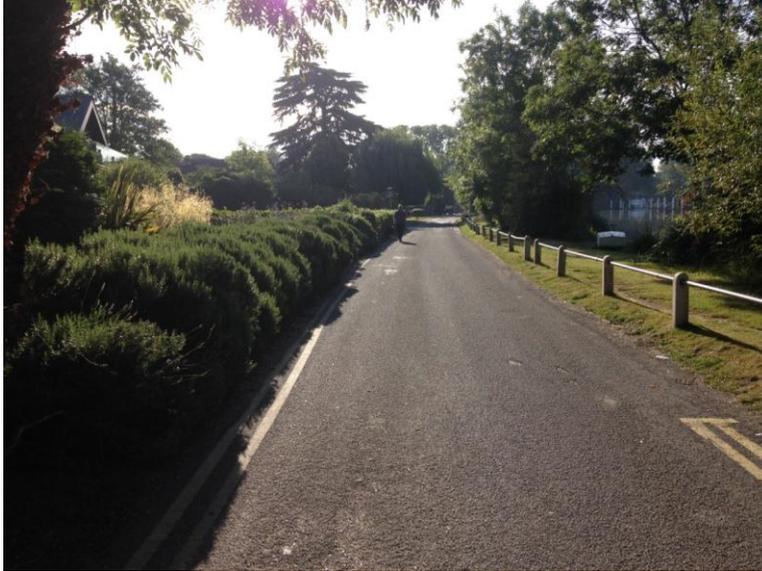
Figure 4: Towpath

Towpath meanders as it follows the River Thames to its south. Its northern frontage is predominately to residential properties, but also Thames Court public house. The northern side of the road has parking restriction along its entire length, in the form of double yellow lines, whereas the southern side has them in places along its length, allowing for informal vehicle parking where they are absent. At the eastern end of the road near the lock there is an informal car park on both sides of the road, on land owned by the borough council. There is only a short section of pedestrian footway to the east of the lane, however, for the majority of the road, pedestrians have to either walk on the carriageway or on the verge that is owned by the

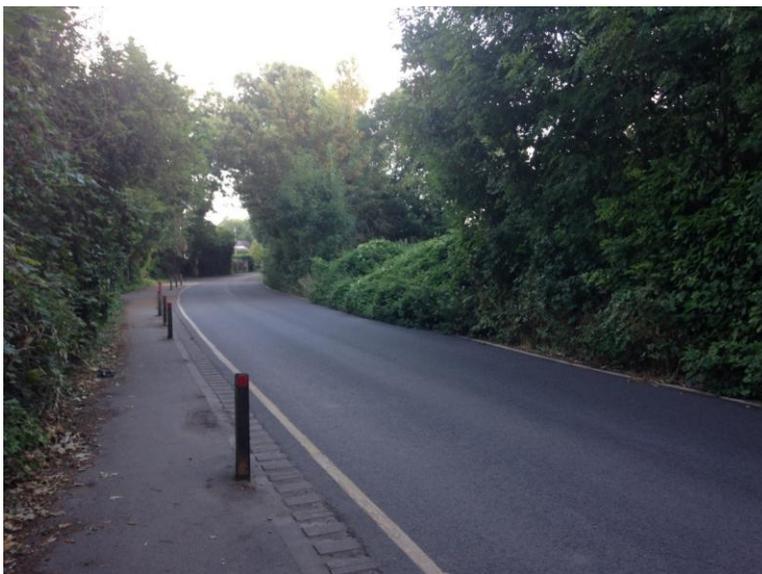
Figure 5: Ferry Lane

Ferry Lane is relatively straight and predominately fronted by fields on both sides, but with some residential and business properties, including Nauticalia. At the southern end of the lane there is a landing for boats to access the river, as well as a water ferry. There is parking restriction in the form of single yellow lines, for the vast majority of both sides of the lane. These restrictions prevent vehicles parking between 8am and 8pm on Mondays to Saturdays, between the months of May and October. A shared pedestrian and cycle facility runs along the western side of the carriageway. The majority of the lane is unlit.

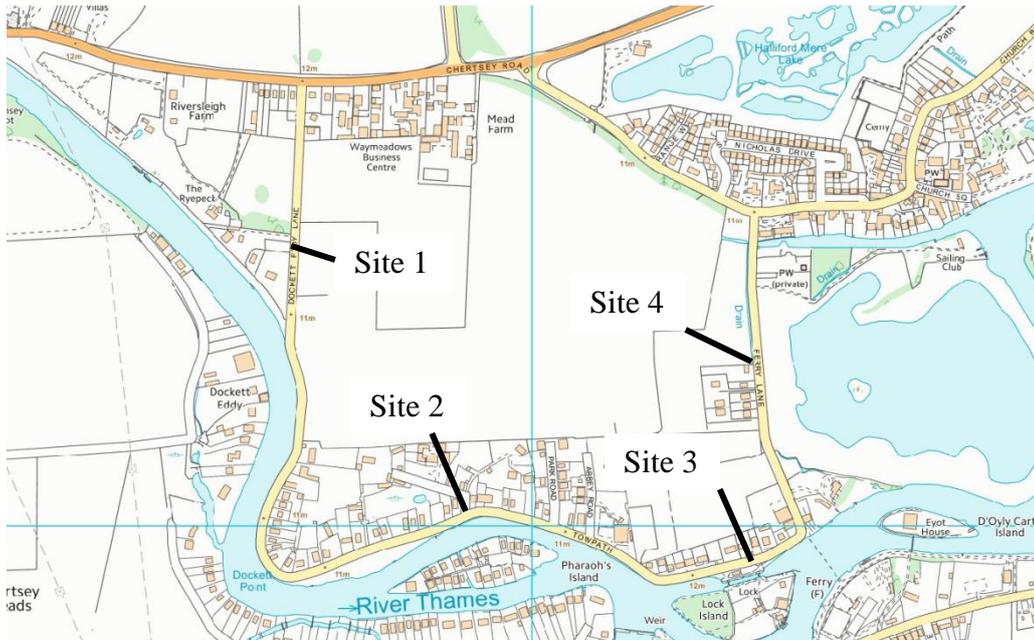
Automatic traffic count surveys using tubes were conducted at four locations along the three roads of Dockett Eddy Lane, Towpath and Ferry Lane for seven days in June 2016. The plan below shows the locations of the surveys.

Figure 6: Map showing vehicle survey locations

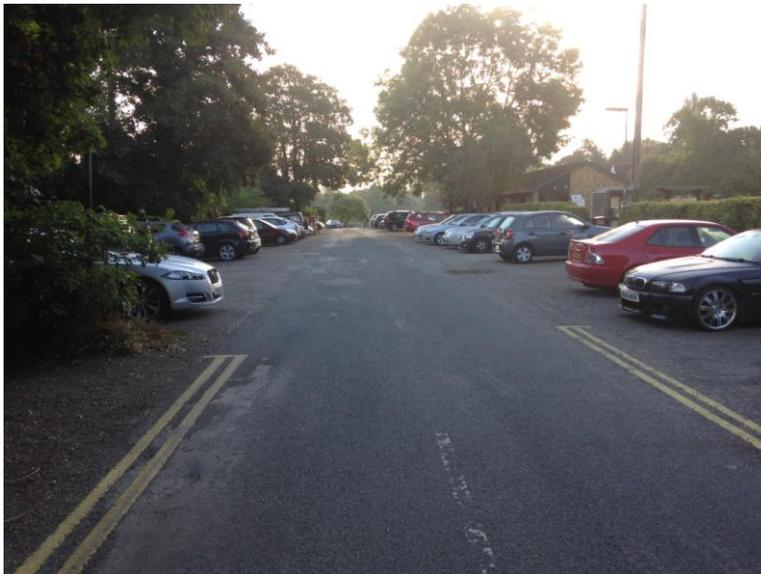
Figure 8: Parking area near Shepperton Lock

resulting in personal injury. This of course does not account for any near misses that may have occurred, as these would be unrecorded. The combined average mean speed in this area is 16.5mph, suggesting that the vast majority of motorists are driving slowly due to the nature of the environment. It is recognized that not all motorists drive sensibly and in accordance to their surroundings, as in this location one motorist during the survey week, between 5pm and 6pm on the Friday, was recorded travelling between 46-51mph, which is clearly dangerous considering the potential for pedestrians in the carriageway and vehicles conducting parking maneuvers. However, a balanced approach should be adopted and consideration given to whether funding and restrictions be implemented due to the actions of the extremely small minority. Due to the limited amount of land that is public highway, this puts limitations on options available for improvements, unless third party land owners are involved and in agreement.

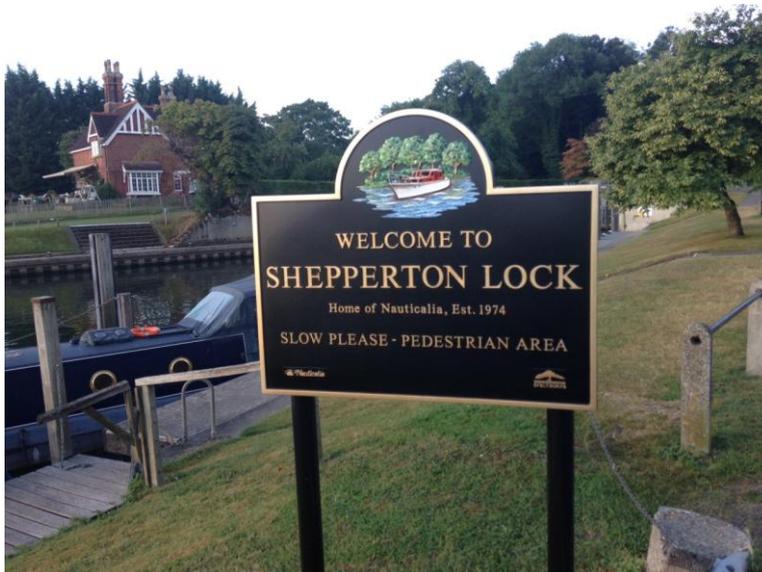
Figure 9: Photograph of gateway sign

Gateways are usually used at the entrance to an area to highlight to motorists that the environment they will be driving through may be different. It is noted that recently gateway signs have been introduced on non-public highway land that fulfill this option.

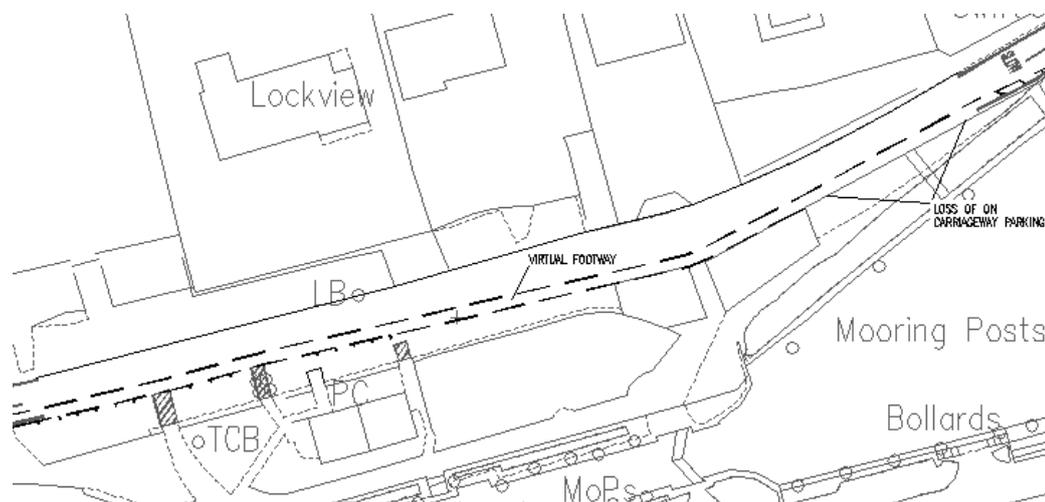
It has been requested that a virtual footway, using road markings, be placed along the southern side of the carriageway through the car parking area, to help raise driver awareness of pedestrian. This is a technique that has been adopted in other locations in Surrey and is viewed favorably. To ensure this works as effectively as possible, its termination locations would have to be carefully considered. Ideally this footway should allow pedestrians to walk from the car parking area eastwards and then directly cross over onto the formal footway that runs on the northern side of the road. In doing so this would result in the loss of space where currently up to four cars can park along the carriageway.

Figure 10: Sketch showing virtual footway

The majority of this option has safety benefits in highlighting space where pedestrians are likely to be walking, however due to a reduction in the number of parking spaces this option is not recommended.

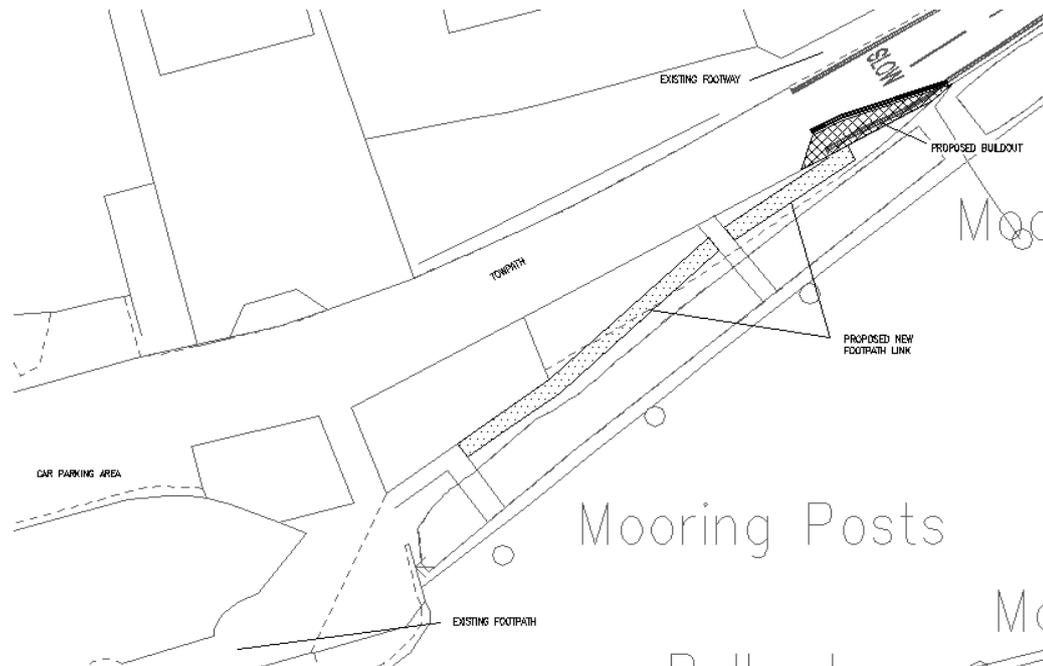
The safest situation for pedestrians is to keep them physically separated from traffic. This option looks at providing a footpath away from the carriageway, but would require permission from third party landowners as the verges are not public highway.

Figure 11: Sketch showing new footpath

To ensure not too much of the on carriageway parking is lost as well as maintaining clear visibility for the pedestrians, a buildout would be required in Towpath, at the northern end of the footpath link.

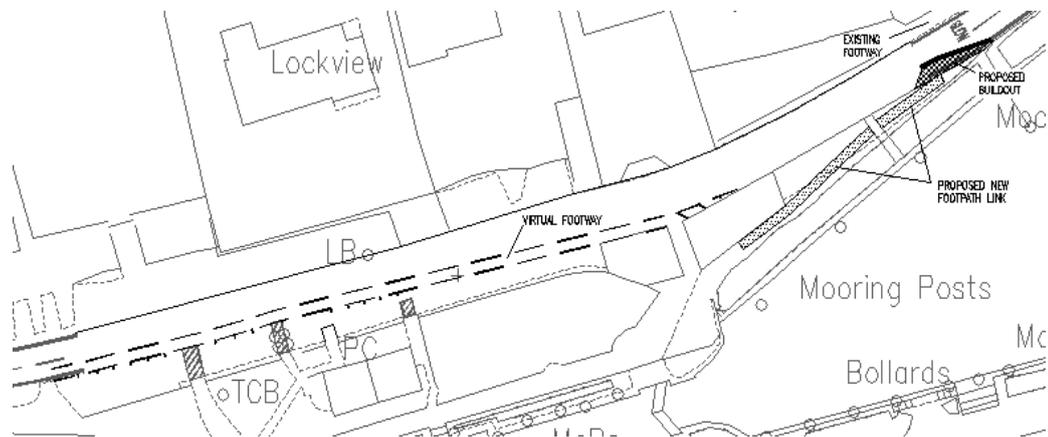
A combination of the two footway/footpath options would provide the most complete and potentially safest option. In this option the virtual footway would run until an access to the existing footpath, and then would link with the new footpath across third party owned land.

Figure 12: Sketch showing hybrid of the virtual footway and new footpath

pedestrian facility, and retaining the existing level of car parking space, and is therefore recommended. However, this option would require permission from third party landowners as the verges are not public highway.
