**Esher Green, Esher
Collision reduction scheme
Feasibility Report**

Project Title: Esher Green, Esher.
Collision reduction scheme

Document Title: Feasibility Report

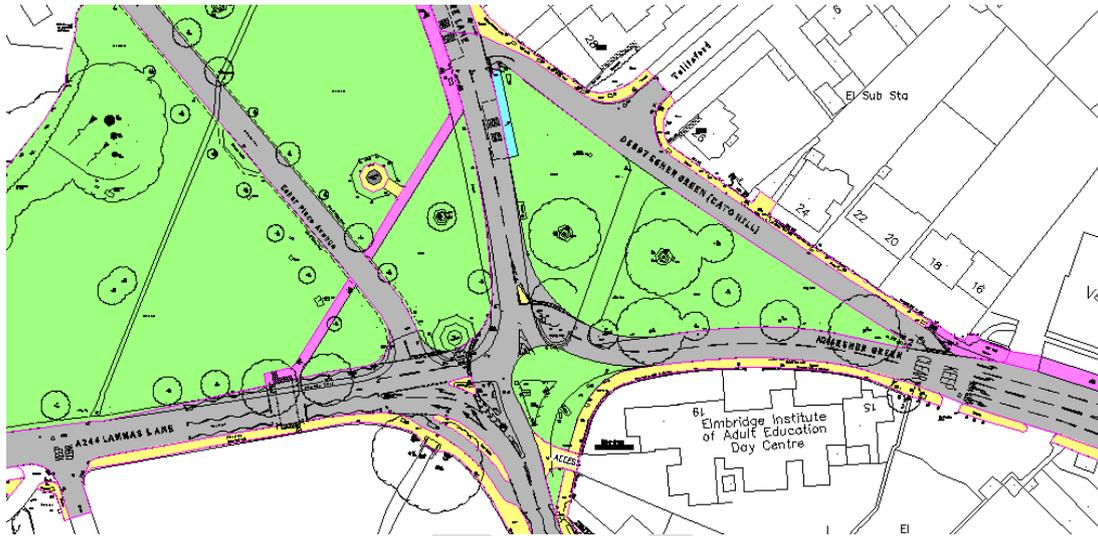
Figure 1: Recommended design for junction from March 2006 Local Committee Report

developed to remove the need for these restrictions (see Figure 1). It also said that monitoring of the location would be necessary following the construction of the scheme to ensure that road safety had not been compromised by this decision, and if it had, then to re-consider the implementation of the movement bans.

The scheme that was agreed in March 2006 (see Figure 1) has not progressed from the design stage due to the requirement to reposition the War Memorial, where discussions are on-going.
