**OFFICER REPORT TO LOCAL COMMITTEE
(Epsom and Ewell)**

**BLenheim ROAD EXPERIMENTAL CLOSURE
UPDATE REPORT**

13 SEPTEMBER 2010

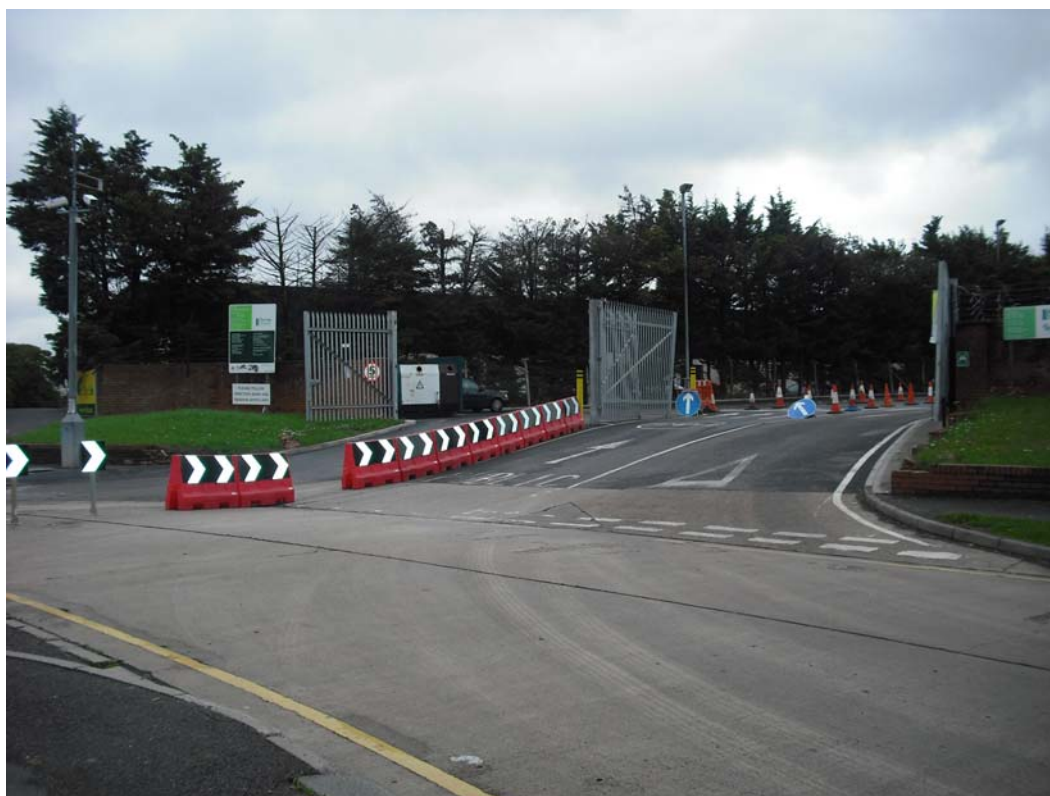
Waste site entrance

- 2.6 The plan assigned as Annex A is an illustration of the turning movements described.
- 2.7 Annex B is a drawing of the scheme installed.
- 2.8 Below are pictures of the site entrance and some of the signs drivers see when using approach routes.

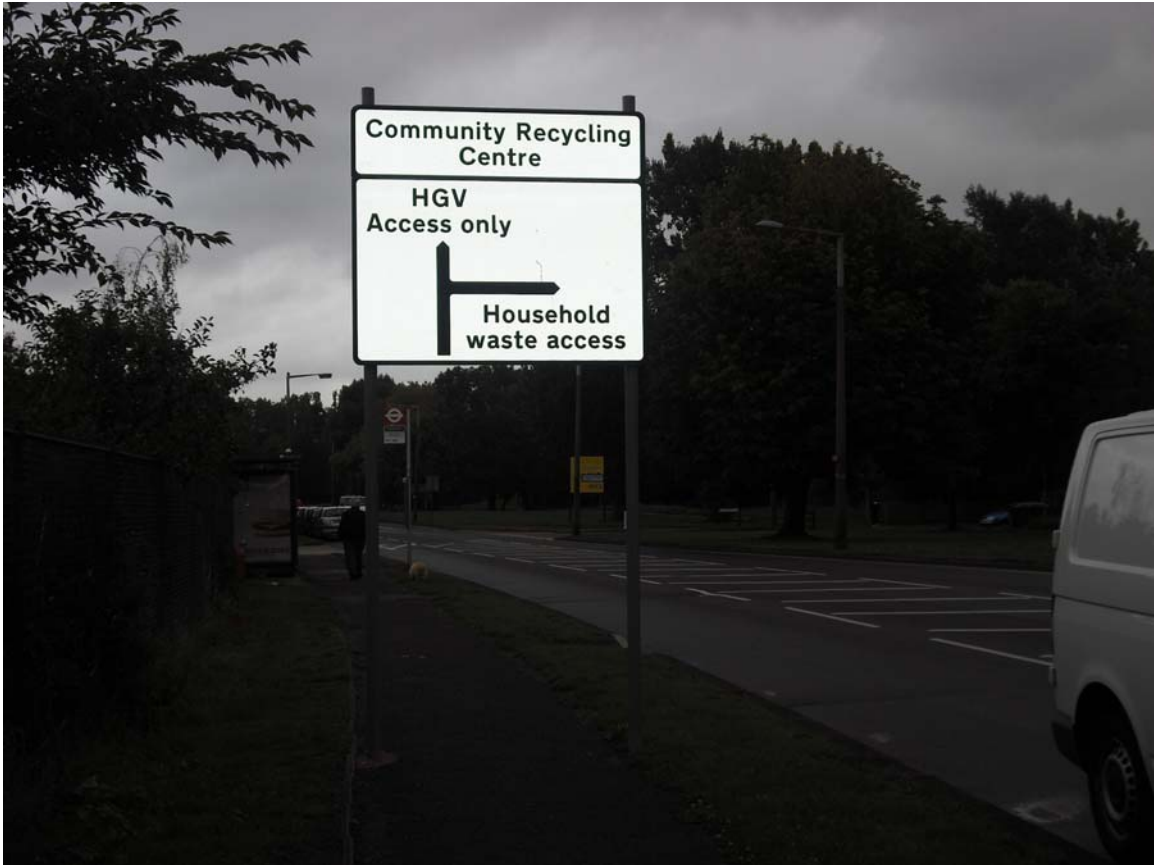
Longmead Road northbound between Hook Road and Felstead Road

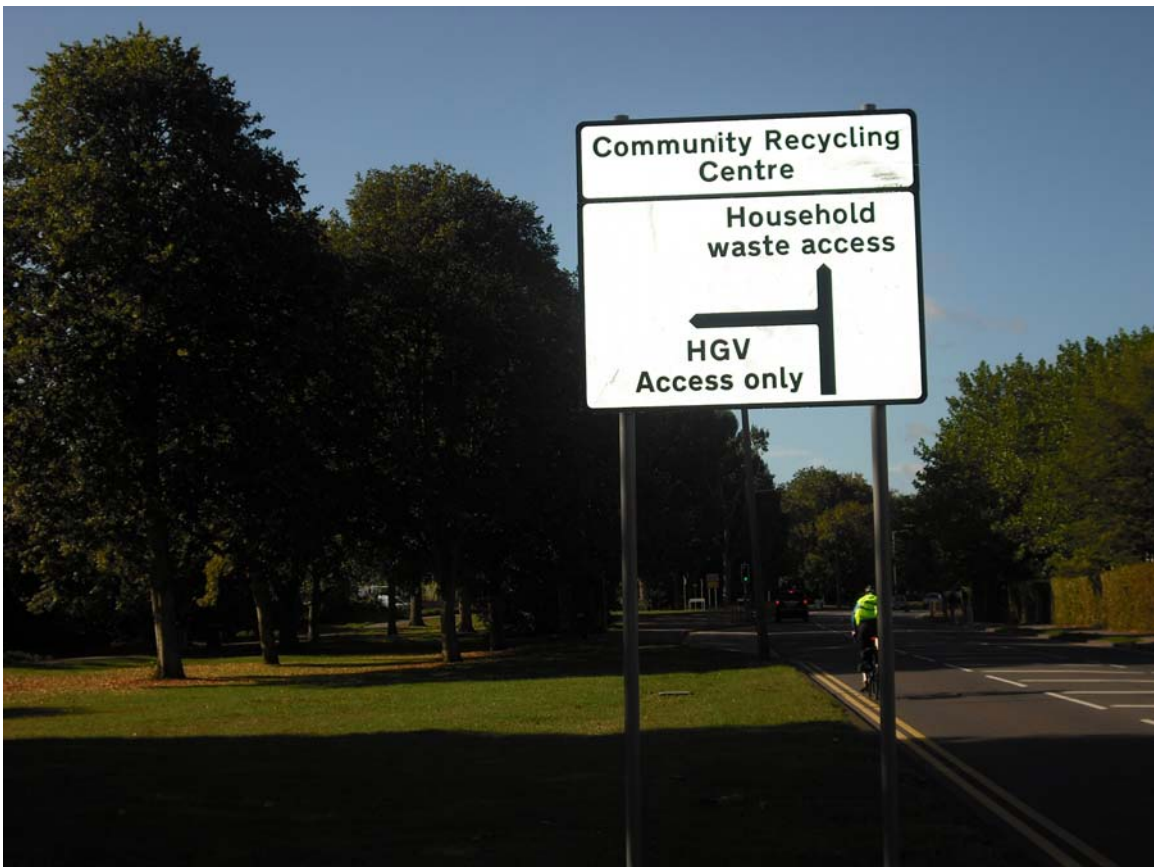
Longmead Road southbound approaching Blenheim Road

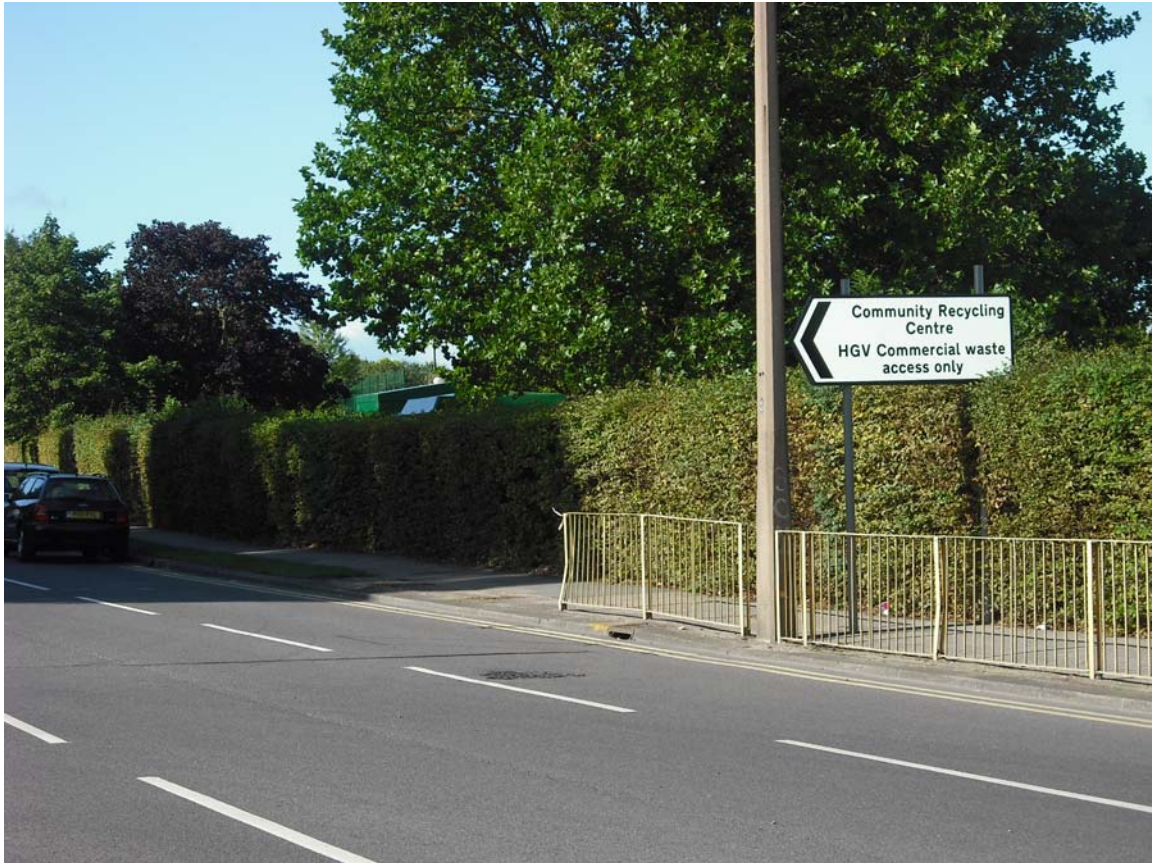
Longmead Road opposite Blenheim Road (double sided)
