**OFFICER REPORT TO LOCAL COMMITTEE
(ELMBRIDGE)**

**A307 TARTAR HILL PEDESTRIAN CROSSING PROPOSALS
FOLLOWING THE REMOVAL OF
TARTAR HILL FOOTBRIDGE**

27 SEPTEMBER 2012

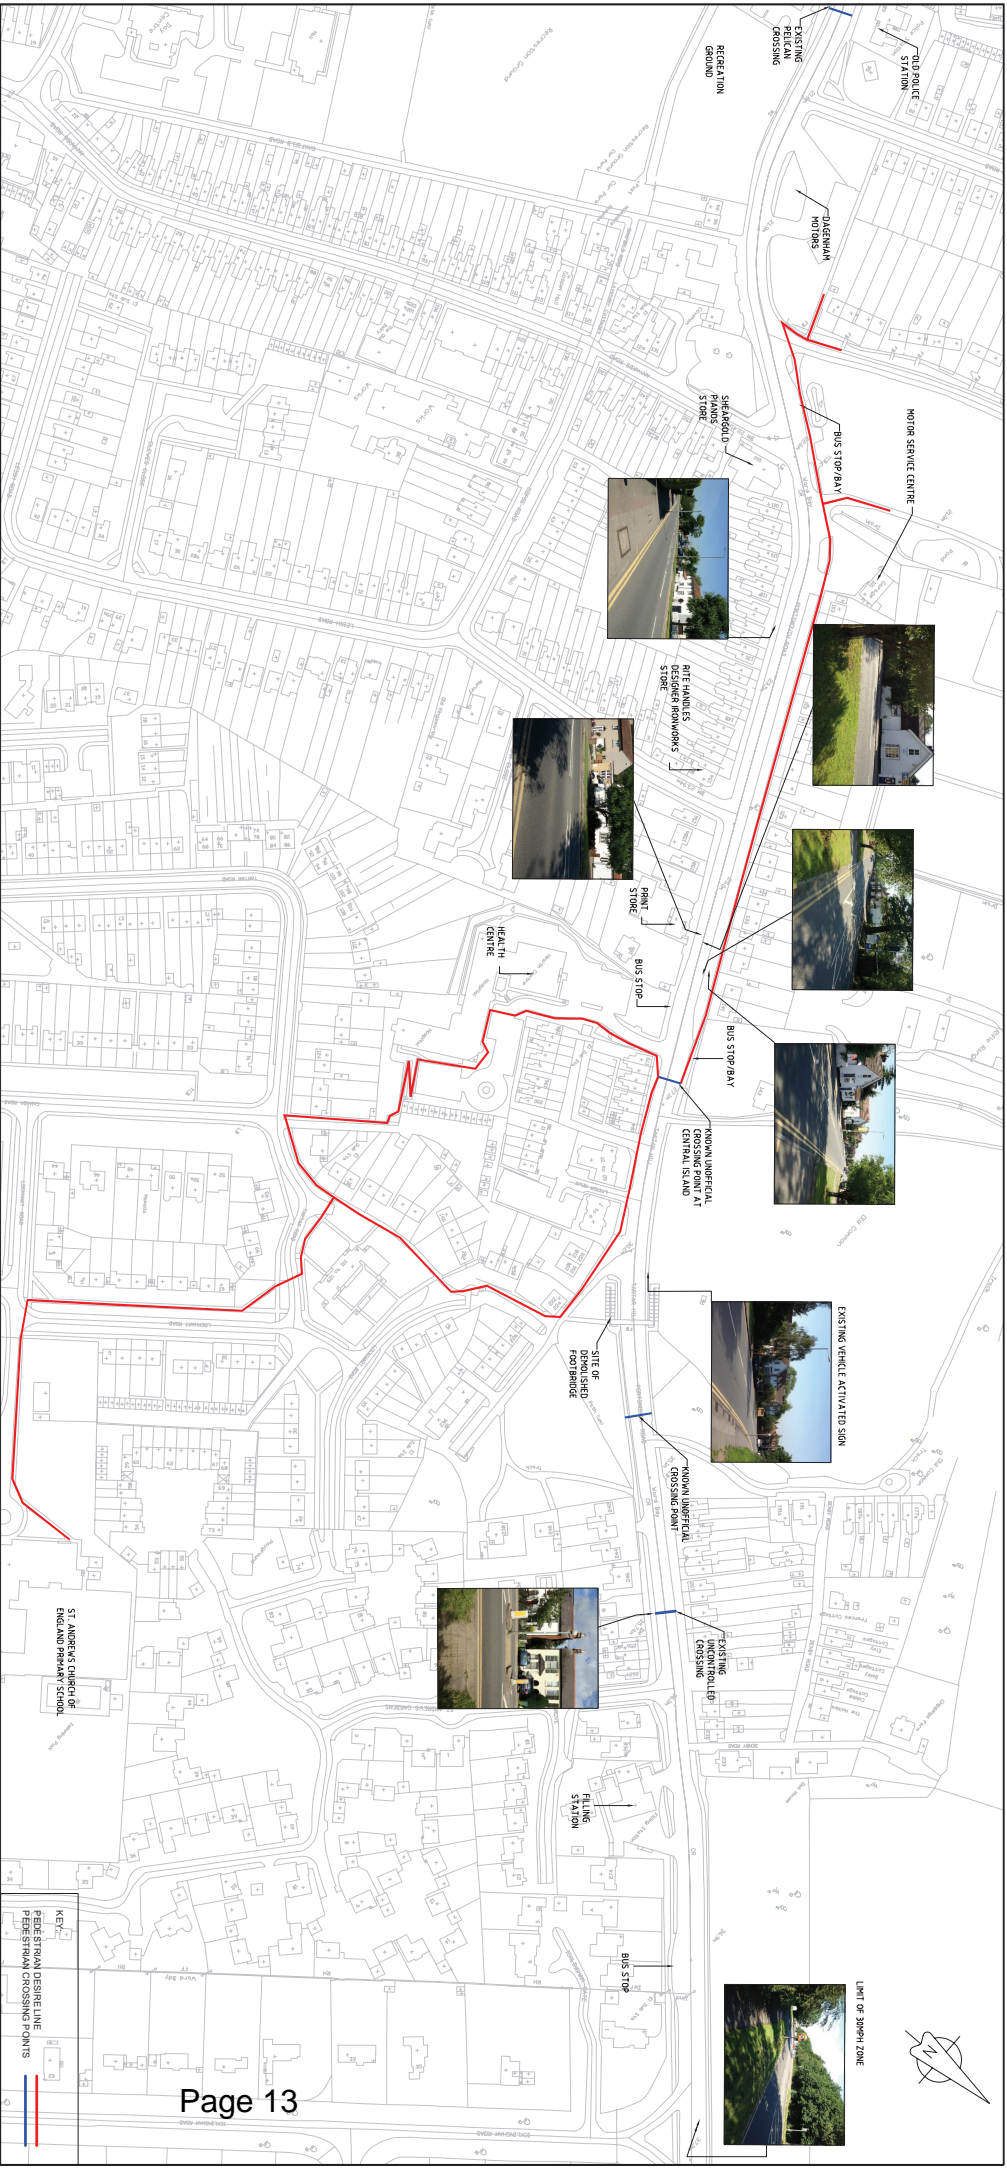
GENERAL ARRANGEMENT SCALE 1:1250

St. Andrews Church of England Primary School draws the most number of pedestrians at peak periods. A popular pedestrian route joins Portsmouth Road from the Old Common Road onto the north footway crossing the A307 at the central island at the Health centre, to gain access to the school. A small number of pedestrians also go to the Health Centre, although this is mainly accessed by vehicle (see drawing PC0227-001, Annex 2).

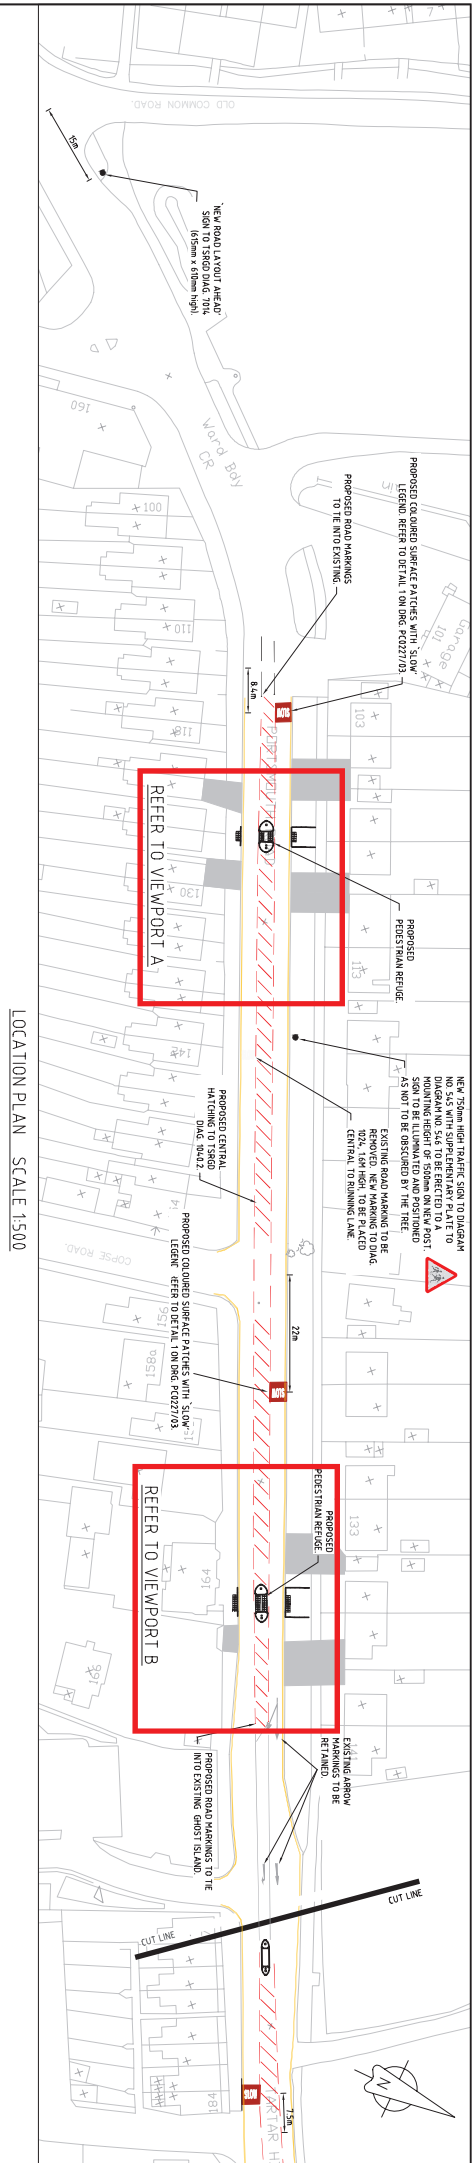
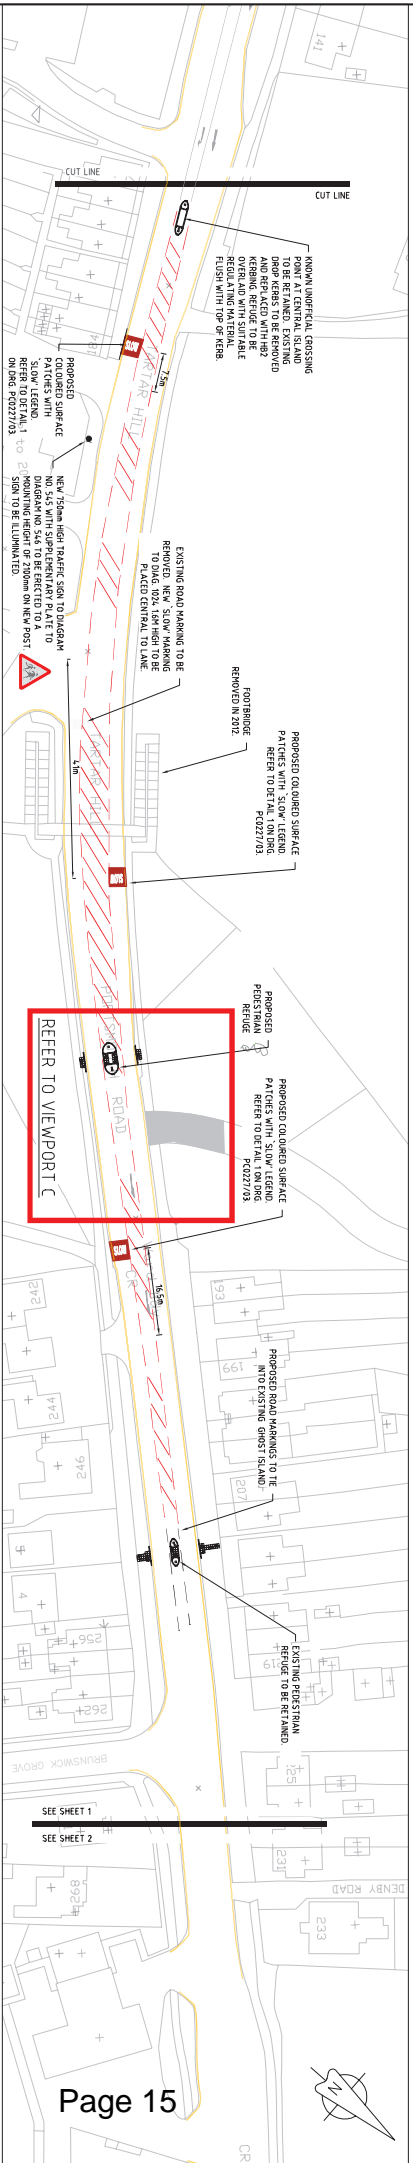
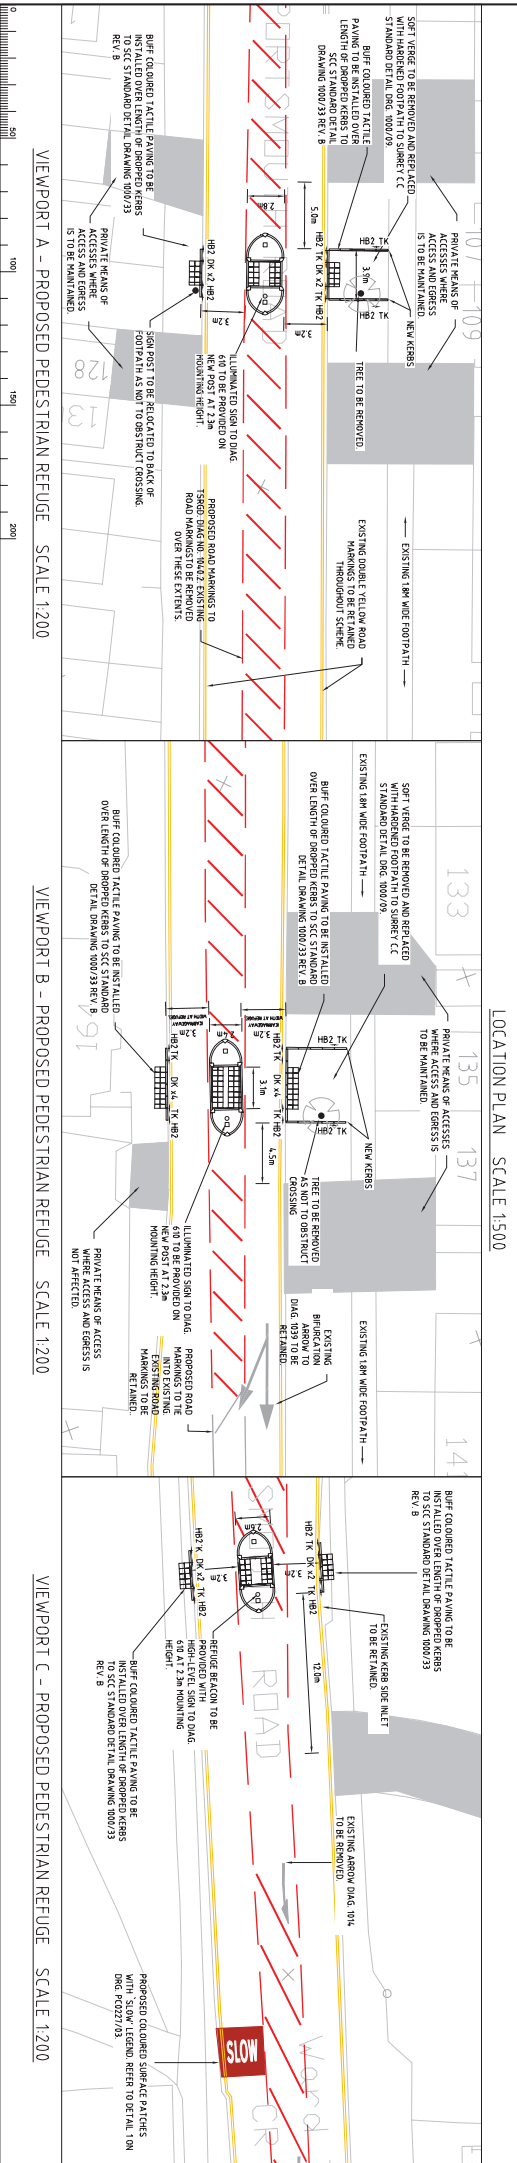
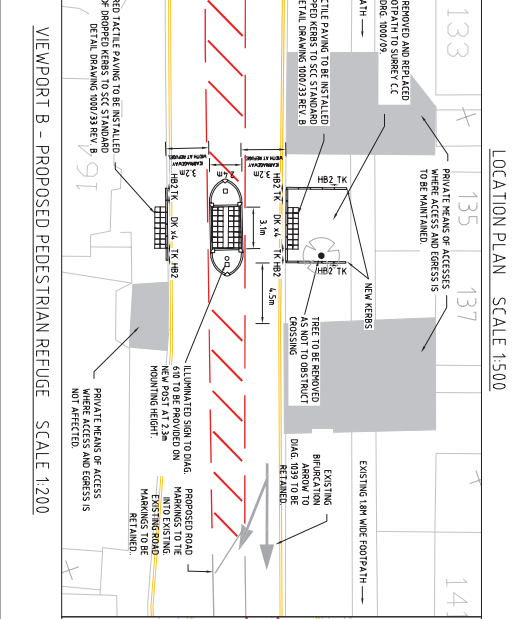
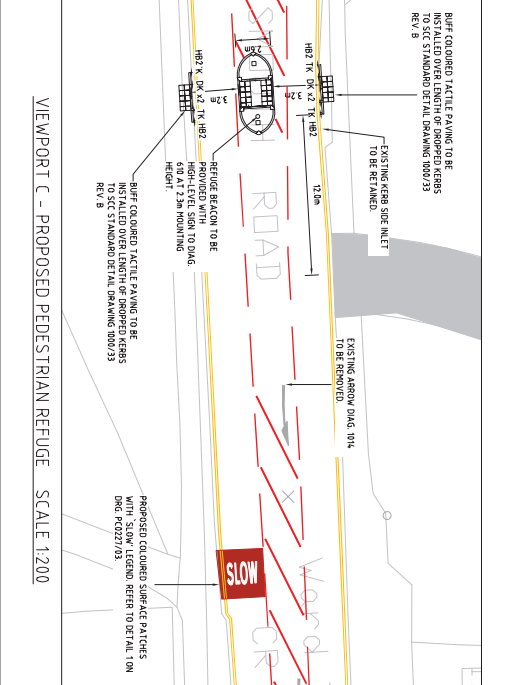
- 8.1 It is recommended that the improvements included in the scheme will provide a safer environment that would be beneficial to the community.
- 8.2 The recommended improvements include (see drawings PC0227_02 and 03 in Annex 2)

- A pedestrian refuge located south of the existing central island.
 - The provision of additional central islands at known unofficial crossing points, with its main function acting as a traffic calming measure whilst also aiding pedestrian safety without being an official crossing in a location which is not desirable.

- Central hatching to reduce carriageway widths.
 - A gateway at the north-easterly entrance to the scheme where the 30mph speed limit starts. This will include new signing, a coloured patch and rumble devices on the approach.

- Coloured surface patches with 'SLOW' legend throughout the scheme.
 - The provision of permanent Vehicle Activated Signs for speed management

A2.1	Location: Viewport C Summary: unclear carriageway width. Dwg. PC0227/02 indicates a carriageway width of 9.7 metres (2 x 4.1 metre running lanes and 1.5 metre refuge). However, site measurements indicate a carriageway width of 9.1 metres. Also the drawing indicates that existing dropped kerbs are present at this location which observations show that there are full height kerbs. It is unclear if the site conditions will allow scheme proposals to be constructed as proposed.	Confirm running lane and refuge widths at the location of the proposed pedestrian refuge.	Carriageway width of 9.1m confirmed. Drawing revised accordingly showing reduced running lane widths of 3.2m with a refuge width of 2.6m, following instruction from Area Team Manager.
A2.2	Location Viewport C / Nos 177 – 191A Portsmouth Road Summary: restricted access to / from side road Large vehicles, including refuse vehicles are unable to turn right out of the side road onto A307 Portsmouth Road without over-running the proposed pedestrian refuge. This is due to the close proximity of the proposed pedestrian refuge to the side road access. Conflict with the refuge and / or pedestrians standing within the refuge may result.	Confirm turning circles of all expected vehicles can be achieved without conflict with the proposed refuge. Relocate the proposed refuge further to the south-west to allow all turning circles of expected vehicles to be performed. Ensure proposed pedestrian refuge / uncontrolled crossing area is clear of the existing side inlet gully which is located 6.3 metres to the west of the side road access to Nos. 177 – 191A Portsmouth Road.	Noted. Refuge relocated.

A2.3	Location Viewport B Summary: restricted access to / from private drive of Nos. 135 & 137 Portsmouth Road Vehicles are unable to turn right out of the private drive of No. 137 Portsmouth Road to travel south-west on the A307 Portsmouth Road without over-running the proposed pedestrian refuge. Also a left turn into the private drive may also result in over-running of the nearside kerb. Also the right turn into / left turn out of No. 135 Portsmouth Road is likely to result in vehicles conflicting with the kerbs of the pedestrian refuge. This is due to the close proximity of the proposed pedestrian refuge to the private drives. Conflict with the refuge and / or pedestrians standing within the refuge may result.	Reduce the length of the proposed pedestrian refuge. Ensure turning circles of all expected vehicles can be achieved in and out of the private drives.	Noted.
A2.4	Location Viewport A Summary: risk of conflict with refuge due to approach speeds and vehicle alignment. Observations suggest that north-eastbound vehicle speeds are at / above the existing speed limit in the vicinity of Anyards Road. Also north-eastbound drivers take the 'racing line' when proceeding along Portsmouth Road and over-run the existing central hatching on the approach to Viewport A. Drivers are likely to continue to take the 'racing line' following the introduction of the proposed pedestrian refuge and hence are at risk of conflict with the kerbs of the proposed pedestrian refuge. This places pedestrians within the refuge at risk of conflict.	Provide a traffic island to the north-east of Anyards Road to ensure A307 Portsmouth Road drivers travelling north-east do not over-run the central hatching on the bend (ensuring turning circles of vehicles exiting Anyards Road are not affected), or; Relocate proposed pedestrian refuge further to the south-west to improve drivers forward visibility of the feature. NB. This would be subject to appropriate location for the refuge to be positioned between existing private drives and associated turning circles and clearance of mature trees within the northern verge.	Noted, however it is considered that the pedestrian refuge is positioned beyond the bend, away from the over-run area. There is no obvious location for a traffic island or for the relocation of the pedestrian refuge due to their position in relation to nearby junctions and private means of accesses. It is expected that the traffic calming proposals will reduce traffic speeds and change driver behaviour. Refuge to remain as shown and situation to be monitored.

A3.3	Location Viewport B Summary: potential for restricted pedestrian visibility. It is unclear why a 6.0 metre length of pedestrian refuge / uncontrolled crossing is proposed. If the refuge is full of pedestrians, those standing at the south-western end of the refuge will be unable to view south-westbound traffic due to pedestrians standing at the north-eastern end of the refuge, unless they enter the running carriageway (i.e. their view of approaching traffic will be blocked by other pedestrians). Pedestrians leaning into / stepping into the running carriageway are at increased risk of conflict with passing vehicles. This situation is reversed when a large number of pedestrians wish to cross in the other direction.	Reduce the length of the proposed central pedestrian refuge.	Noted. Final dimensions of pedestrian refuge to be agreed. Existing pedestrian refuges have a total length of 5m. There are no regulations defining the length of a refuge, only a minimum width of 2m. Site observations identified pedestrians standing in the shadow of the island due to the high number of pedestrians, pushchairs, bikes and scooters crossing at one time. The dimensions of the refuge need to be suitable to cater for the pedestrian demand. During these busy periods, it is often only two or three adults supervising several children and it is only the adults that require the visibility to determine whether it is safe to cross. It is not considered that this situation is any different to crossing from a footpath as oppose to a central refuge. Length of pedestrian refuge (tactile area) reduced to 3m approx. to provide a pedestrian standing area of 3m x 2.4m.

A3.4	Location Viewport A and B Summary: risk of pedestrian conflict. Pedestrians crossing from the proposed pedestrian refuges to the northern footway are at risk of conflict with the existing mature trees located within the existing verge. This is of particular concern to the visually impaired. Also pedestrians wishing to cross to the proposed pedestrian refuges from the northern footway, may be masked from approaching drivers by the foliage of the trees, which increases the potential for conflict when pedestrians attempt to cross the carriageway. This is of particular concern during dark conditions.	Confirm proposals for trees. Remove trees to maximise available footway width and visibility for and of pedestrians wishing to use proposed pedestrian refuges.	Reluctant to remove trees unless directly hindering footway access. Further investigation required to determine scope for realigning crossing to avoid trees.

A3.5	Location Viewport A Summary: Pedestrians at risk of conflict with post. Pedestrians crossing from the proposed pedestrian refuge to the southern footway (outside No. 134 Portsmouth Road) are at risk of conflict with the item of street furniture mounted in the footway (post with parking plate). This is of particular concern to the visually impaired.	Remove / relocate post clear of the uncontrolled crossing location.	Post to be relocated.
A3.6	Summary: drivers at risk of conflict with refuges. Due to the downhill gradient of the A307 Portsmouth Road, south-westbound drivers may not fully appreciate the location of the proposed pedestrian refuges. Conflict with the refuges may result, especially during dark conditions.	Provide high-level signs to Diag. 610 on each refuge beacon.	Agreed. Illuminated high level signs to Diag. 610 to be provided on new posts for pedestrian refuges in Viewport A and B. It is not considered that a refuge beacon is required at these locations to enhance driver awareness due to good visibility and flat gradient. Additionally concerns will be raised due to their proximity to residential properties. High level sign to be positioned on refuge beacon at Viewport C, as it is located on a hill and does not directly impose on nearby dwellings. Drawing to be revised accordingly.
