Brighton Road (Brook Road bus stop – northbound)

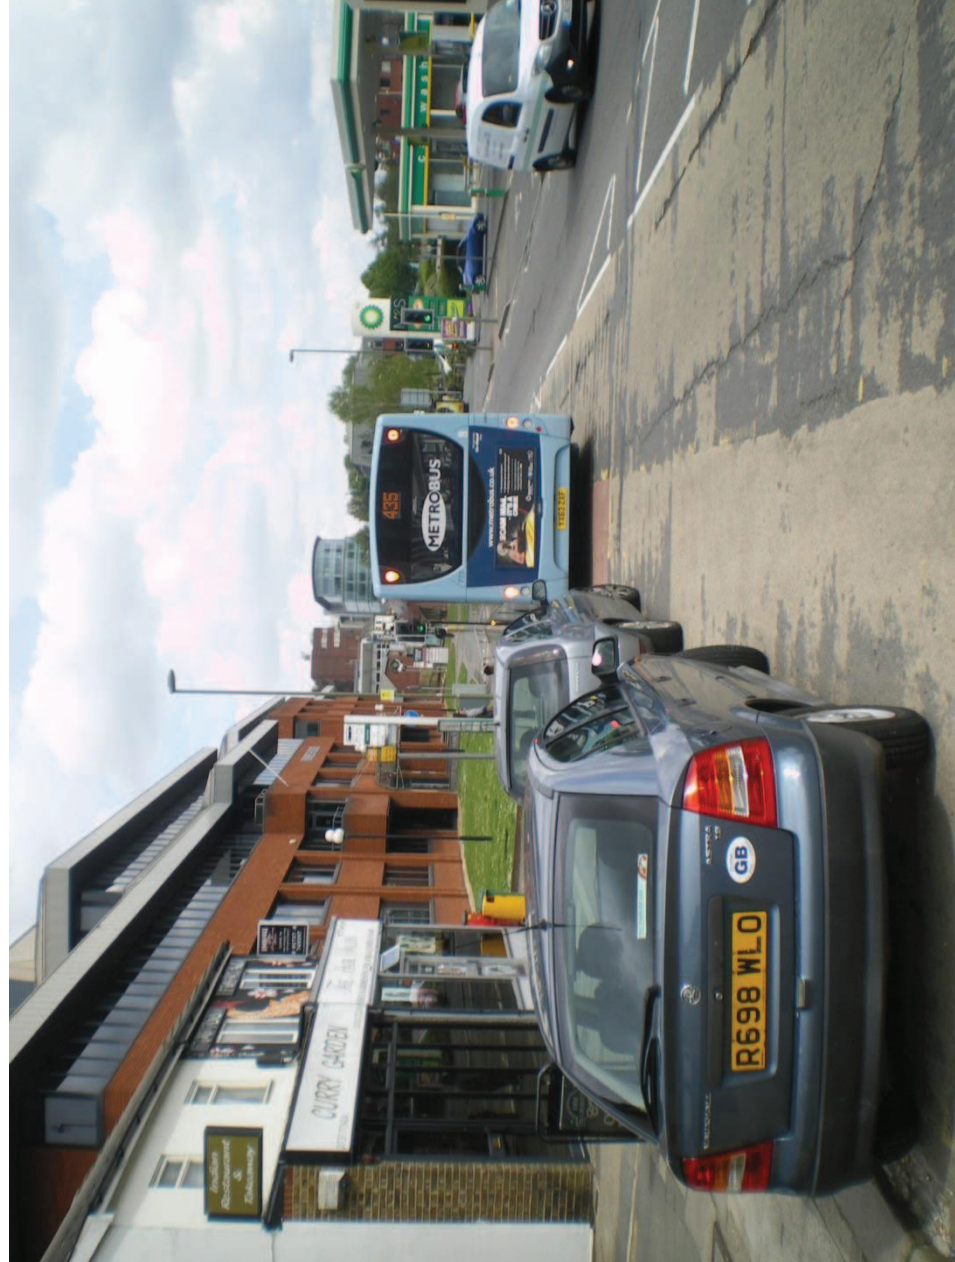
Current situation: Due to vehicles parking between marked parking bays and just before bus stop cage, buses are unable to pull into the kerb and therefore bus passengers are unable to have step-free access onto/off the bus due to the bus having to stop in the road next to the parked cars, or only being able to pull into the stop at an angle just beyond any parked cars. In some cases the buses are having to stop over the pedestrian crossing to allow passengers to alight/board because of guard railings on footway between bus case & signals.

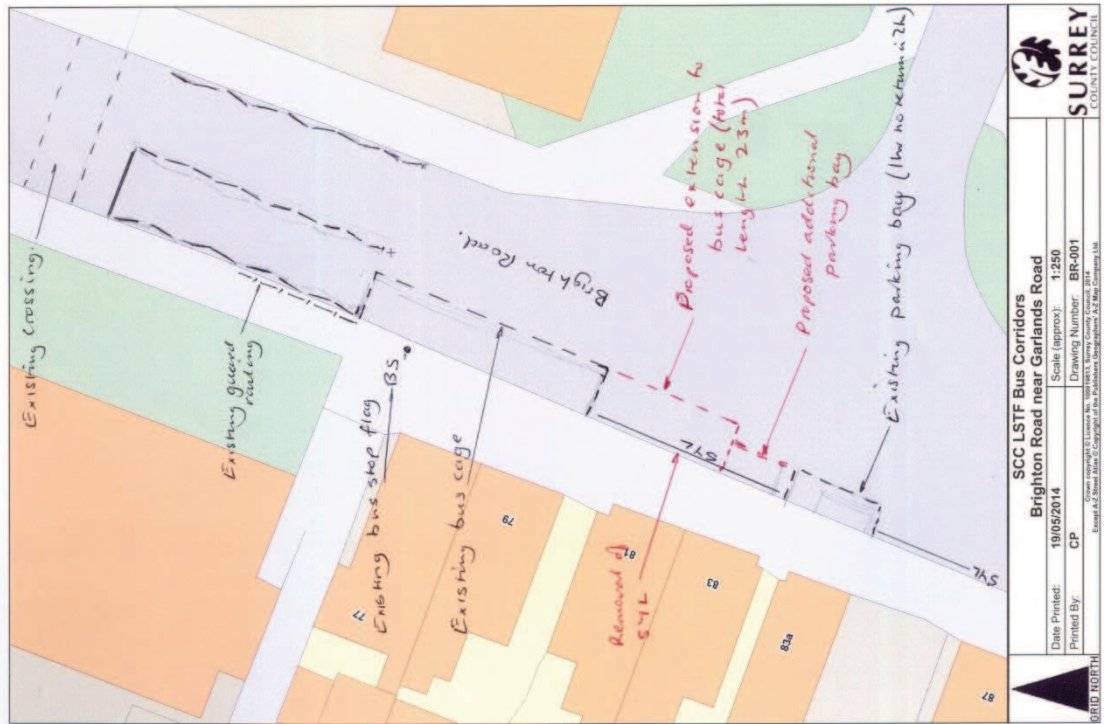
Design Solution: Extend bus cage further south taking in current area between marked parking bays and bus cage where vehicles are currently parking on single yellow line which is not clearly visible and so easily disputed. Also provide an additional parking bay between bus cage and existing parking bay. (This has been discussed with Surrey County Council Parking Team who have no objection)
