Annex G – Request for bus stop clearways at six bus stops on the K3 bus route in the Elmbridge area

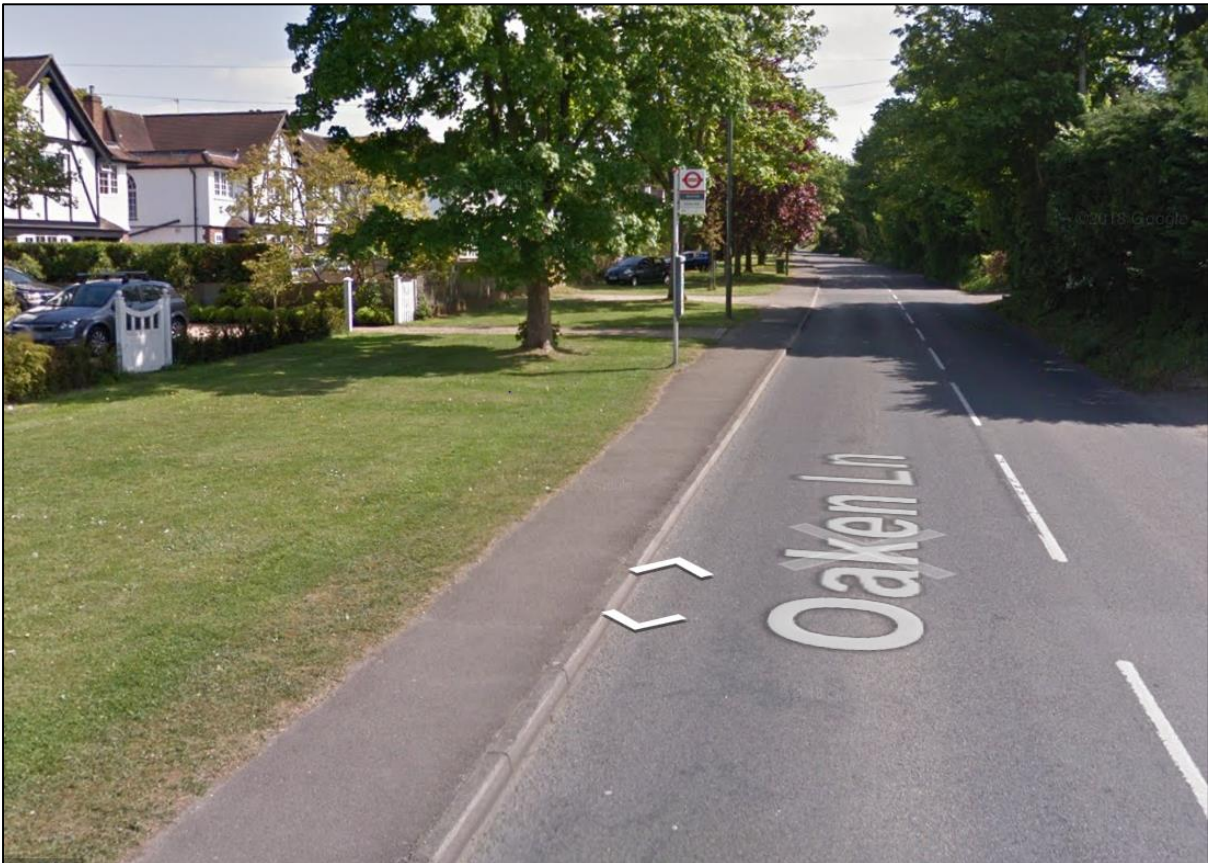
Location: Existing southbound bus stop in Oaken Lane, Claygate at Woodbourne Drive, Claygate

Problem: This bus stop currently has no bus cage. Recent TfL data shows the stop is moderately used. Whilst there are no reported issues of on-street parking, a bus stop clearway will ensure buses can access the bus stop at all times. Most frontagers have off-street parking for a minimum of two cars.

Proposal: To provide a new bus cage and clearway road markings to comply with TSRGD diagram 1025.1. To approve the bus stop clearway formally and to enable the restrictions to be enforced. The times of restriction should be 'no stopping at any time', which is appropriate to the operating times of the bus services (in accordance with DfT guidance for introducing bus stop clearways). Following committee approval, a letter would be sent to any directly affected frontage properties, advising of the new restriction prior to any bus cage being marked out.

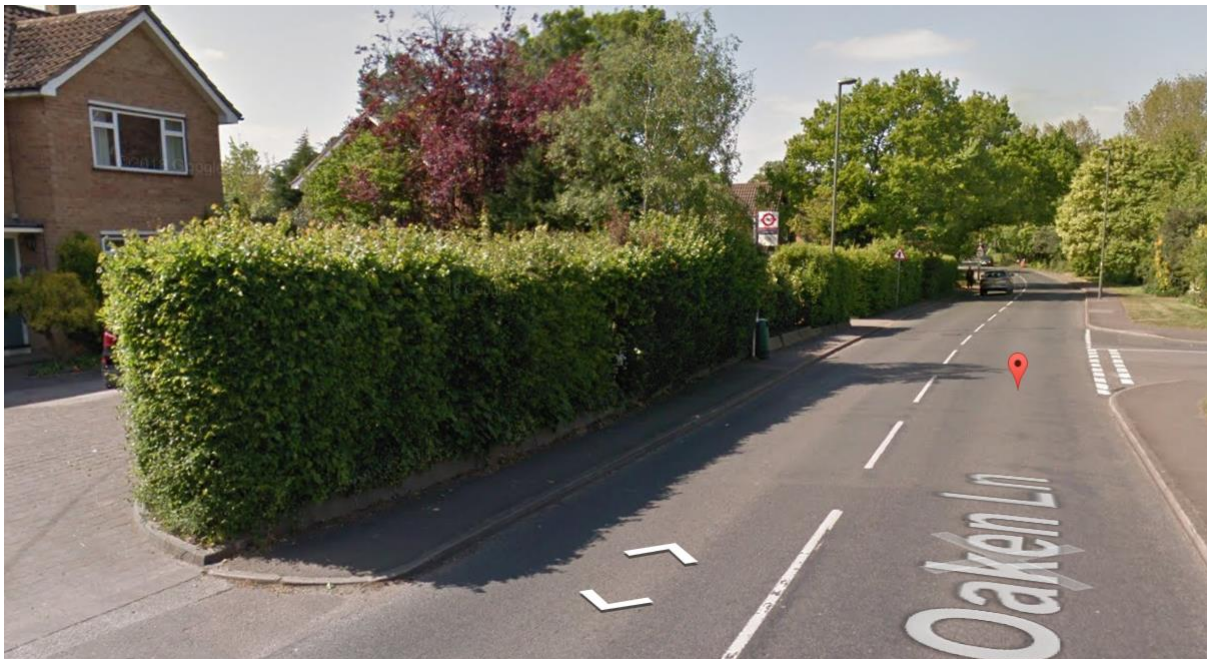
Location: Existing northbound bus stop in Oaken Lane, Claygate at Woodbourne Drive, Claygate

Problem: This bus stop currently has no bus cage. Recent TfL data shows the stop is moderately used. Whilst there are no reported issues of on-street parking, the bus stop clearway will ensure buses can access the bus stop at all times. Most frontagers have off-street parking for a minimum of two cars.

Proposal: To provide a new bus cage and clearway road markings to comply with TSRGD diagram 1025.1. To approve the bus stop clearway formally and to enable the restrictions to be enforced. The times of restriction should be 'no stopping at any time', which is appropriate to the operating times of the bus services (in accordance with DfT guidance for introducing bus stop clearways). Following committee approval, a letter would be sent to any directly affected frontage properties, advising of the new restriction prior to any bus cage being marked out.

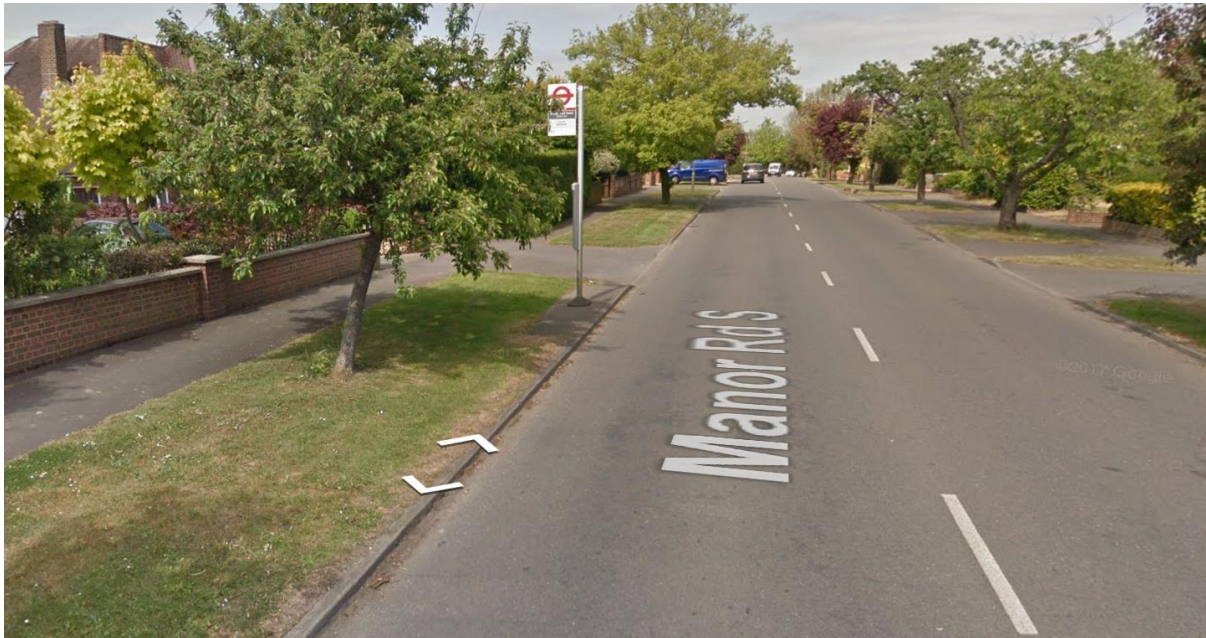
Location: Existing northbound bus stop in Manor Road South, at Manor Road South/Oaken Lane.

Problem: This bus stop currently has no bus cage and very little hard standing for waiting passengers. Recent TfL data shows the stop is moderately used. Some parking issues have been reported by operator TfL, particularly at weekends, due to activities and events at the adjacent sports grounds in Oaken Lane. Most frontagers have off-street parking for a minimum of two cars.

Proposal: To provide a new bus cage and clearway road markings to comply with TSRGD diagram 1025.1. To approve the bus stop clearway formally and to enable the restrictions to be enforced. The times of restriction should be 'no stopping at any time', which is appropriate to the operating times of the bus services (in accordance with DfT guidance for introducing bus stop clearways). Following committee approval, a letter would be sent to any directly affected frontage properties, advising of the new restriction prior to any bus cage being marked out. (Improvements are also planned to increase and improve the passenger waiting area.)

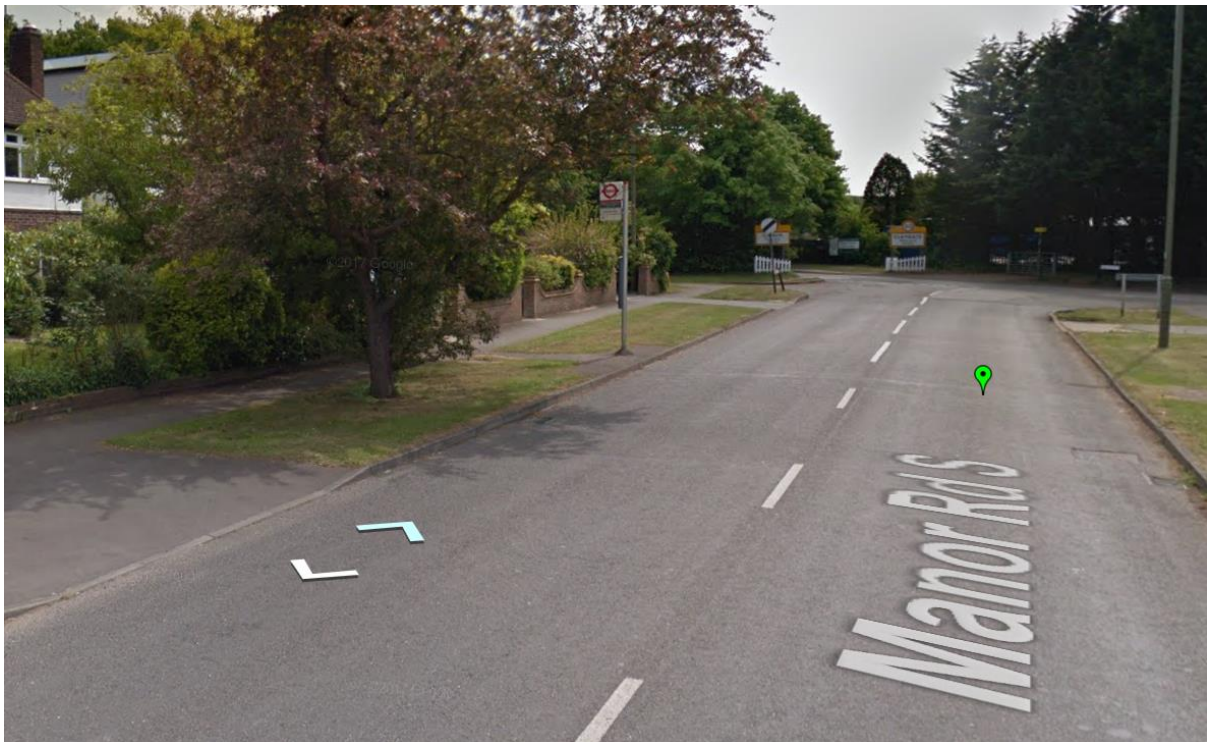
Location: Existing southbound bus stop in Manor Road South, at Manor Road South/Oaken Lane.

Problem: This bus stop currently has no bus cage and very little hard standing for waiting passengers. Recent TfL data shows the stop is moderately used. Some parking issues have been reported by operator TfL, particularly at weekends, due to activities and events at the adjacent sports grounds in Oaken Lane. Most frontagers have off-street parking for a minimum of two cars.

Proposal: To provide a new bus cage and clearway road markings to comply with TSRGD diagram 1025.1. To approve the bus stop clearway formally and to enable the restrictions to be enforced. The times of restriction should be 'no stopping at any time', which is appropriate to the operating times of the bus services (in accordance with DfT guidance for introducing bus stop clearways). Following committee approval, a letter would be sent to any directly affected frontage properties, advising of the new restriction prior to any bus cage being marked out. (Improvements are also planned to increase and improve the passenger waiting area.)

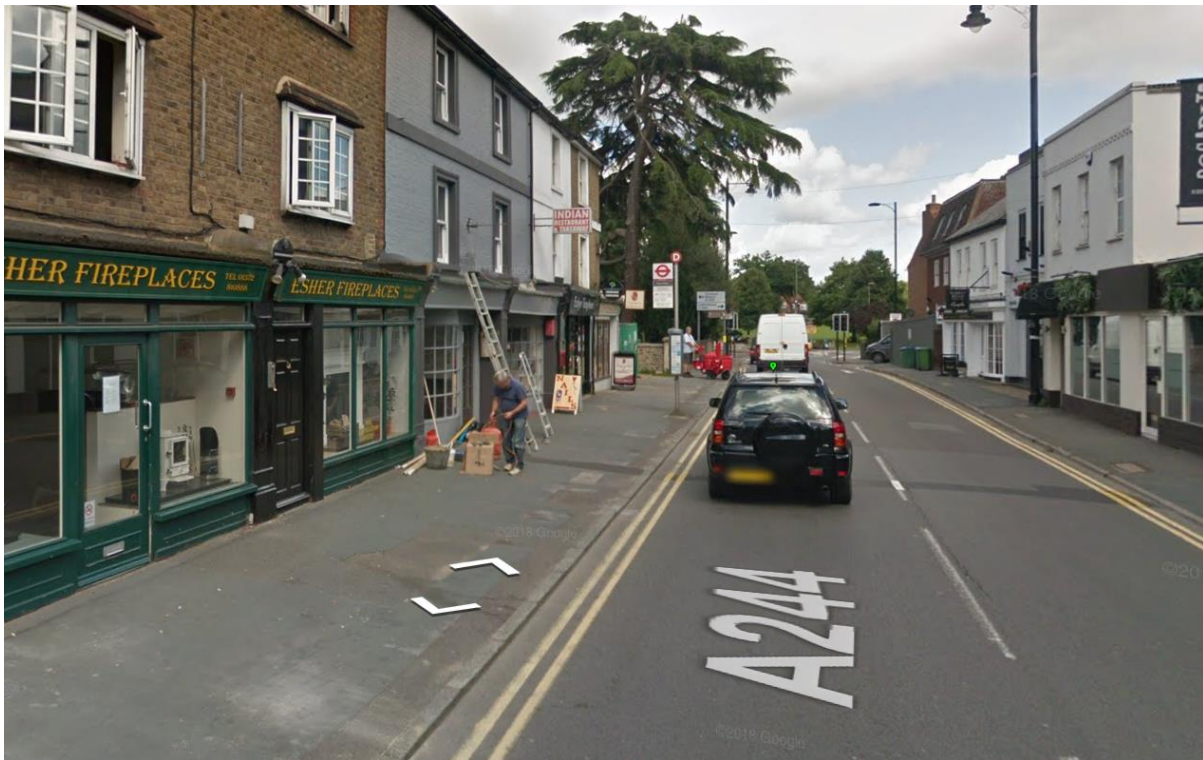
Location: Existing northbound bus stop in Church Street, Esher (for alighting only).

Problem: This bus stop currently has no bus cage. However, it benefits from double yellow line parking restrictions, but these have no associated loading restrictions. Whilst it is important that businesses can be serviced by delivery vehicles the kerb space next to the bus stop should be protected from inconsiderate parking by delivery vehicles. The proposed bus stop clearway will leave sufficient kerb space south of the bus stop from where deliveries can be made.

Proposal: To provide a new bus cage and clearway road markings to comply with TSRGD diagram 1025.1. To approve the bus stop clearway formally and to enable the restrictions to be enforced. With no loading restriction applicable to this street and a busy commercial frontage, a bus stop clearway will ensure buses have access to the bus stop at all times. The times of restriction should be 'no stopping at any time', which is appropriate to the operating times of the bus services (in accordance with DfT guidance for introducing bus stop clearways). Following committee approval, a letter would be sent to any directly affected frontage properties, advising of the new restriction prior to any bus cage being marked out. (Improvements are also planned to increase and improve the passenger waiting area.)

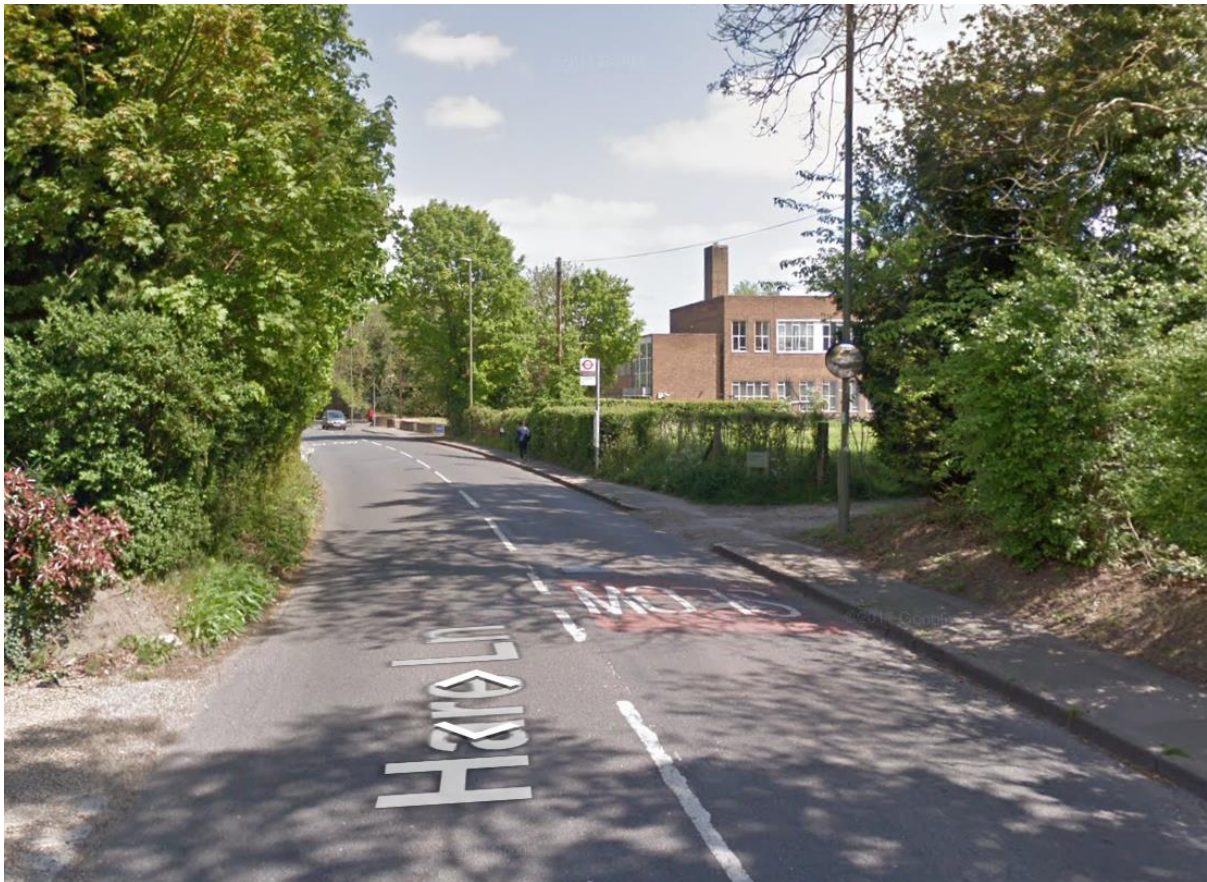
Location: Existing northbound bus stop in Hare Lane, at Loseberry Road, Claygate.

Problem: This bus stop currently has no bus cage. Whilst Hare Lane in this locality has few parking issues, a bus stop clearway will deter any unnecessary and unwanted parking on or close to the bus stop.

Proposal: To provide a new bus cage and clearway road markings to comply with TSRGD diagram 1025.1. To approve the bus stop clearway formally and to enable the restrictions to be enforced. The times of restriction should be 'no stopping at any time', which is appropriate to the operating times of the bus services (in accordance with DfT guidance for introducing bus stop clearways). Following committee approval, a letter would be sent to any directly affected frontage properties, advising of the new restriction prior to any bus cage being marked out.
