Annex C - Request for bus stop clearways at 13 bus stops within north Epsom quality bus corridor

Common elements to each bus stop clearway request: The approved bus cage and clearway markings will each be restricted to 'no stopping at any time'. This is appropriate to the operating times of Route 418, which runs from early morning until around midnight, seven days a week. Following committee approval, a letter would be sent to any directly affected frontage properties, advising of the new restriction.

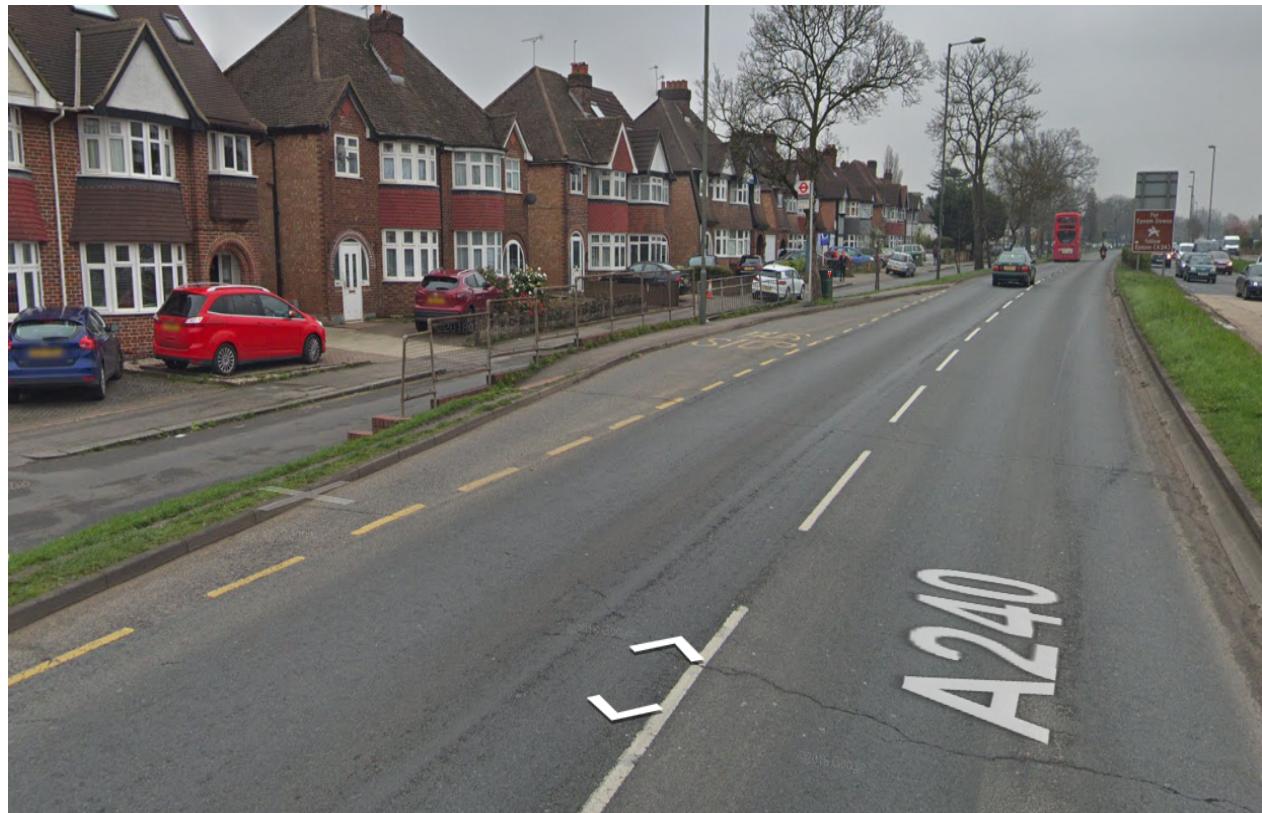
Location: Existing south-eastbound bus stop in Kingston Road (A240), called Worcester Park Road, but near Grafton Road, and a service road parallel to the A240.

Existing: The bus stop has a bus cage but no clearway markings, and occasionally vehicles are noted waiting in the lay-by.

Proposal: To approve the bus stop clearway, and to add clearway markings such that the bus cage conforms to TSRGD Diagram No.1025.3, the correct diagram for lay-by bus stops.

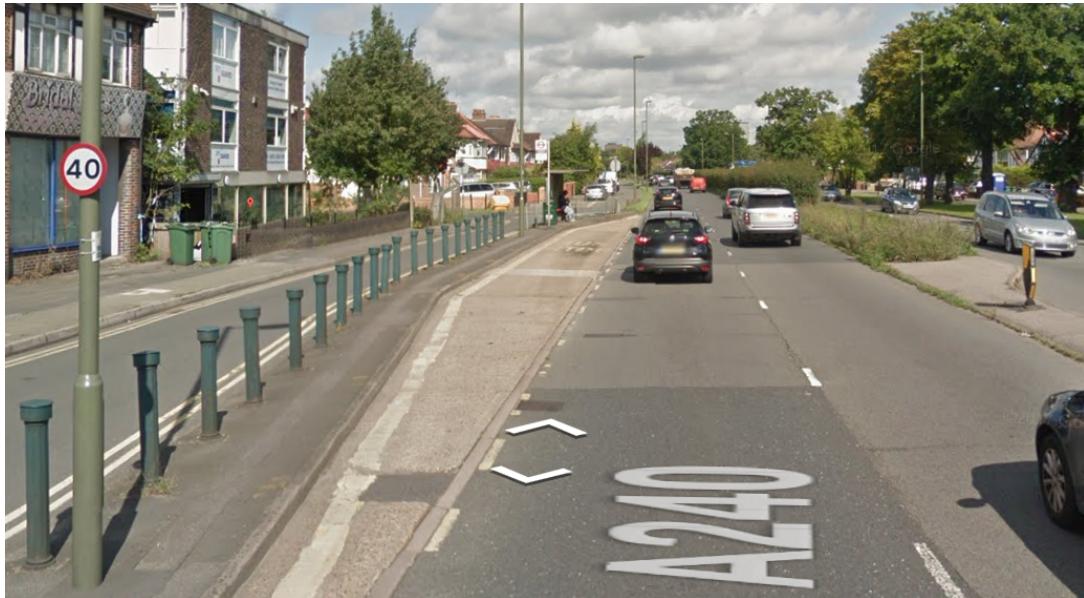
Location: Existing north-westbound bus stop in Kingston Road (A240), at Ruxley Lane, adjacent to a service road and local shops

Existing: The bus stop has a bus cage and clearway marking that conforms to TSRGD to Diagram No.1025.3 for a bus stop in lay-by. The adjacent shops attract occasional parking or delivering activity.

Proposal: To approve the bus stop clearway.

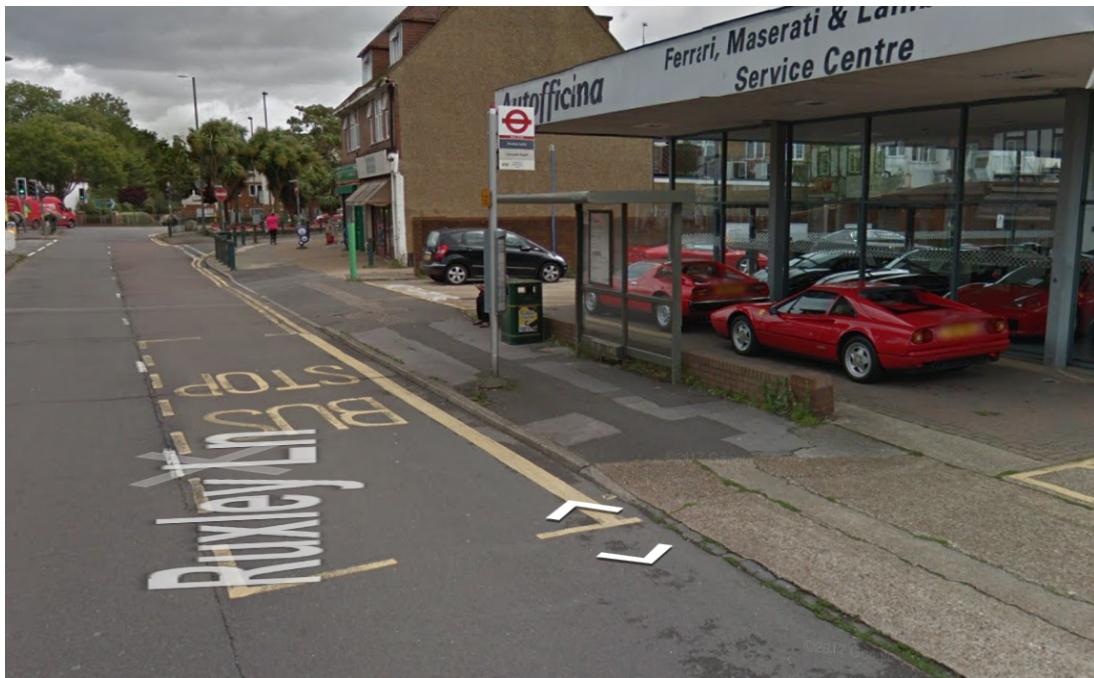
Location: Existing south-westbound bus stop in Ruxley Lane, outside 5 Ruxley Lane, immediately south of Kingston Road.

Existing: The bus stop has a bus cage and clearway marking which conforms to TSRGD Diagram No.1025.1. Loading to nearby shops and business occasionally blocks access to the bus stop.

Proposal: To approve the bus stop clearway.

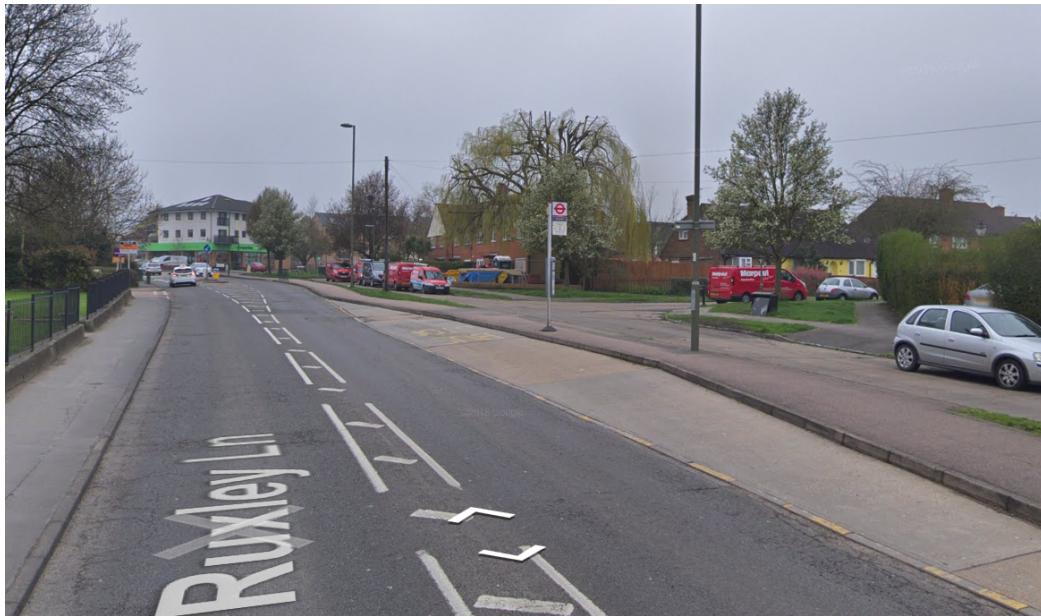
Location: Existing north-eastbound bus stop in Ruxley Lane, near Cox Lane, and a service road parallel to Ruxley Lane.

Existing: The bus stop has a bus cage but no clearway markings. The bus stop is near the entrance to Epsom and Ewell High School, and is occasionally used by parents for drop off and collection.

Proposal: To approve the bus stop clearway, and to add clearway markings such that the bus cage conforms to TSRGD Diagram No.1025.3, the correct diagram for a lay-by bus stop.

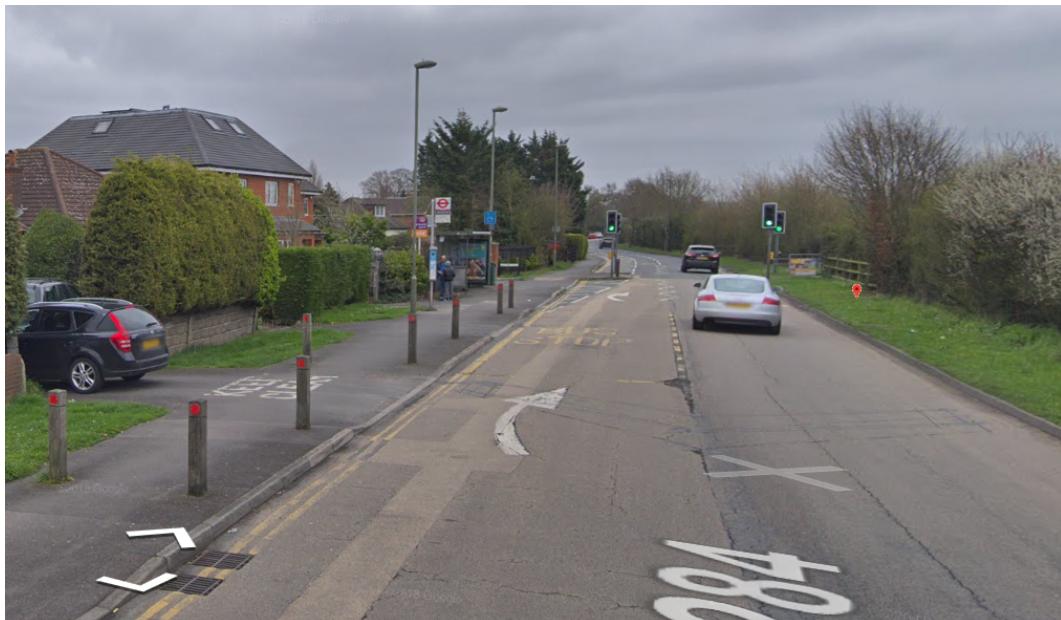
Location: Existing south-eastbound bus stop in Chessington Road, outside 470 Chessington Road, near Nightingale Drive.

Existing: The bus stop has a bus cage and clearway marking which conforms to TSRGD Diagram No.1025.1. The bus stop also has a bus shelter. Local shops occasionally attract parking.

Proposal: To approve the bus stop clearway.

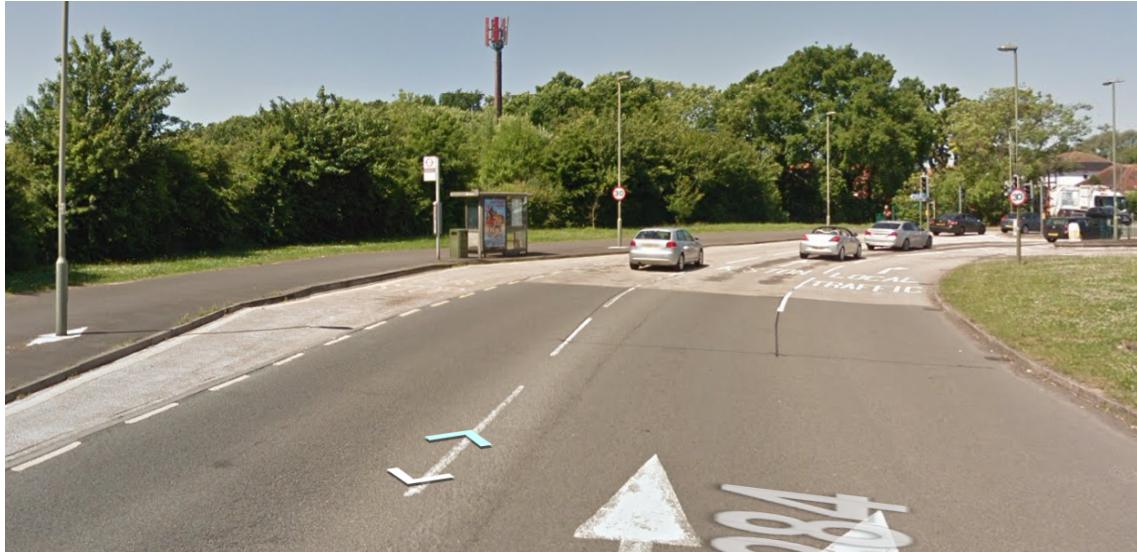
Location: Existing north-westbound bus stop in the dual carriageway section of Chessington Road, adjacent to Horton Park, and opposite Nightingale Drive

Existing: The bus stop has a bus cage and clearway markings conforming to TSRGD Diagram No.1025.3 for bus lay-by. Local shops occasional attract parking.

Proposal: To approve the bus stop clearway. There are no directly affected properties as the road is next to Horton Park.

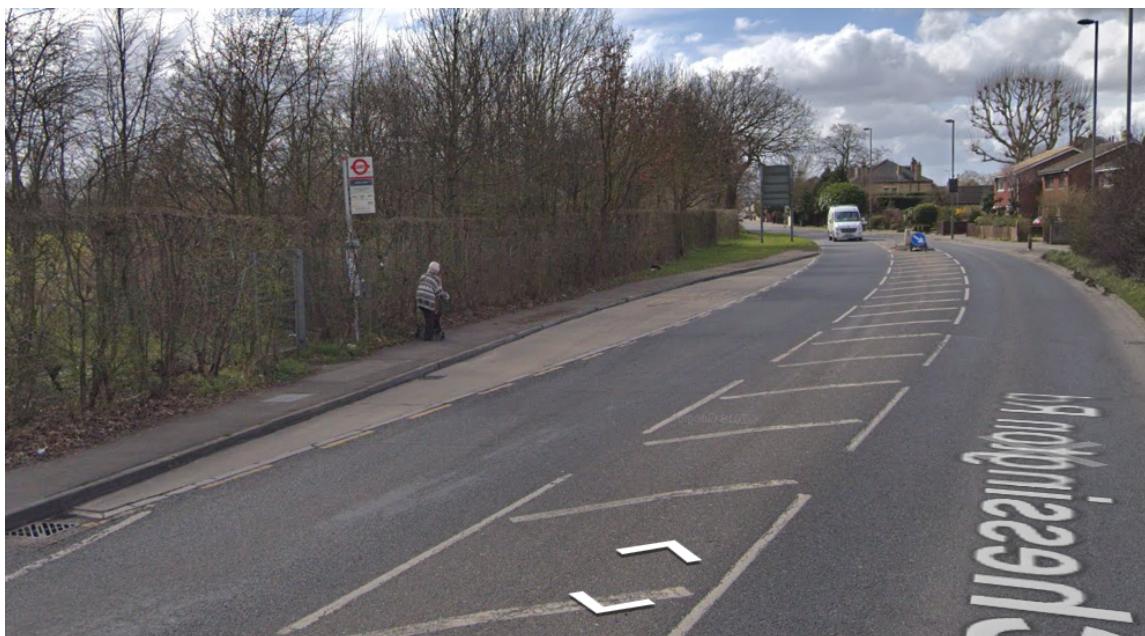
Location: Existing north-westbound bus stop in Chessington Road, adjacent to Horton Arena. The stop is called Hook Arena

Existing: The bus stop is within a lay-by has a bus cage only, but no clearway marking. The lay-by is sometimes used for parking on Sundays when there is a car boot sale on Hook Arena.

Proposal: To approve the bus stop clearway, and to add clearway markings such that the bus cage conforms to TSRGD Diagram No.1025.3, the correct diagram for a lay-by bus stop.

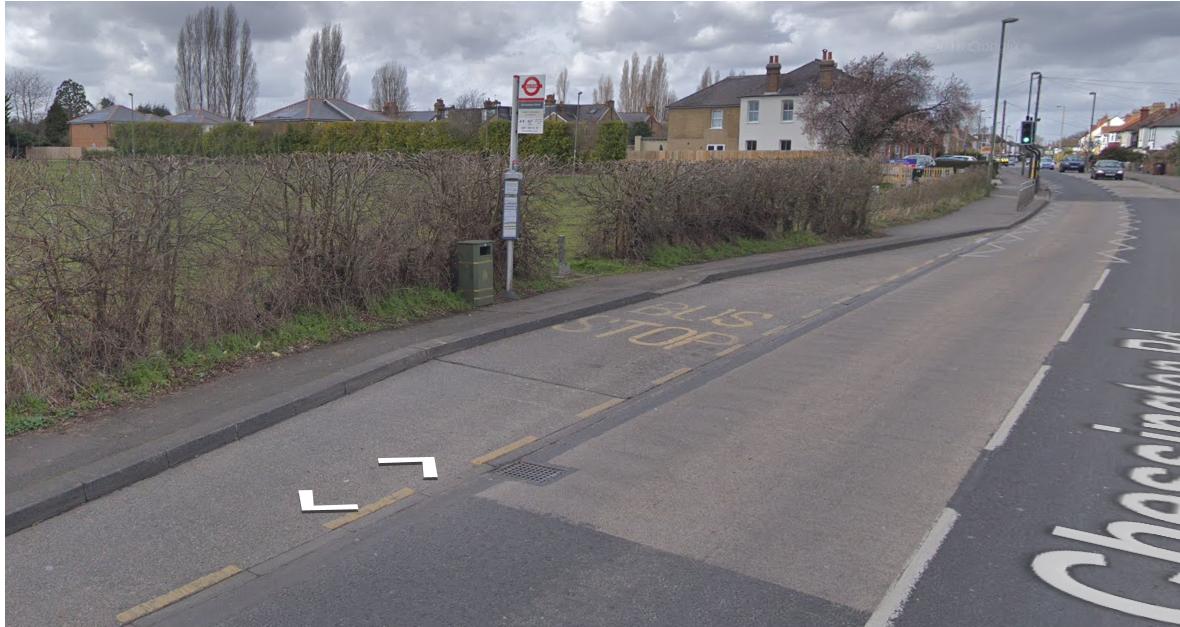
Location: Existing north-westbound bus stop in Chessington Road, adjacent to Riverholme Drive

Existing: The bus stop is within a lay-by has a bus cage only, but no clearway marking.

Proposal: To approve the bus stop clearway, and to add clearway markings such that the bus cage conforms to TSRGD Diagram No.1025.3, the correct diagram for a lay-by bus stop.

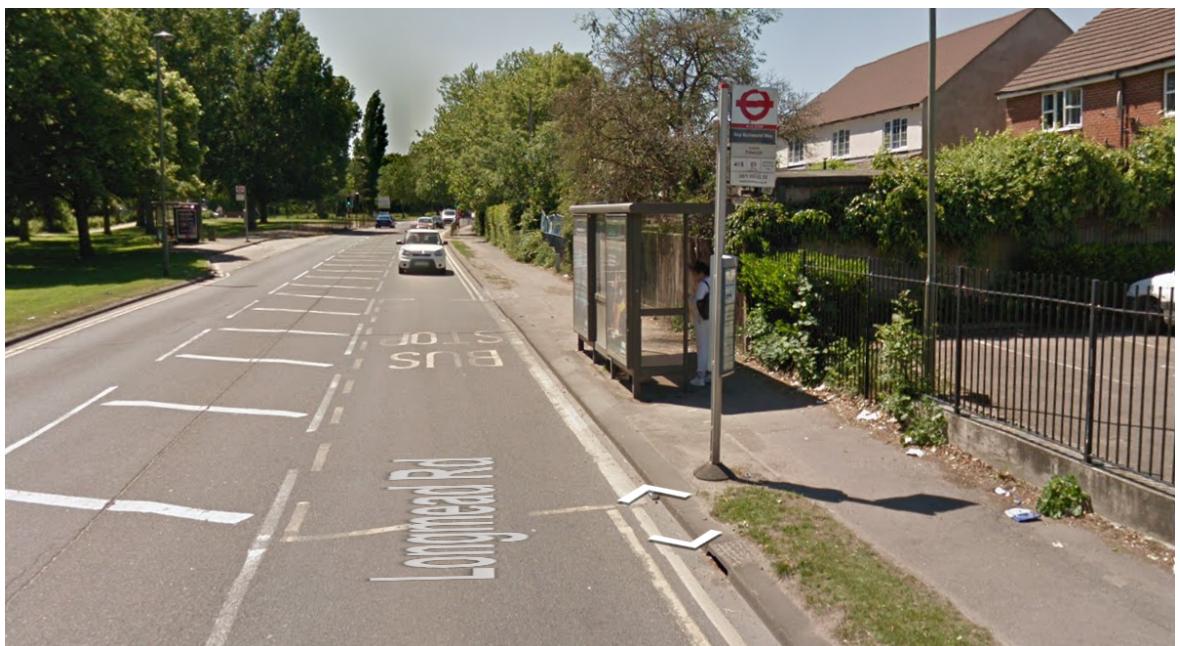
Location: Existing north-eastbound bus stop in Longmead Road, adjacent to Roy Richmond Way and Blenheim High School.

Existing: The bus stop has a bus cage and clearway marking which conform to TSRGD Diagram No.1025.1. The adjacent High School attracts some drop off and pick up parking on or near this stop.

Proposal: To approve the bus stop clearway.

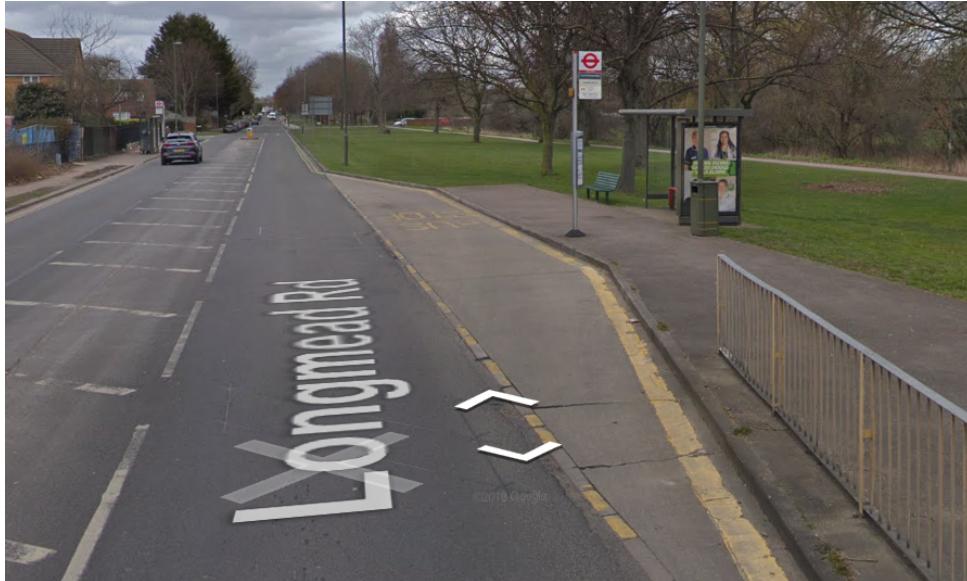
Location: Existing south-westbound bus stop in Longmead Road, adjacent to Roy Richmond Way and Blenheim High School.

Existing: The bus stop is within a lay-by and has a bus cage and clearway marking which conform to TSRGD Diagram No.1025.3 for bus lay-bys. This lay-by is frequently used to drop-off or pick-up workers from the adjacent industrial estate.

Proposal: To approve the bus stop clearway.

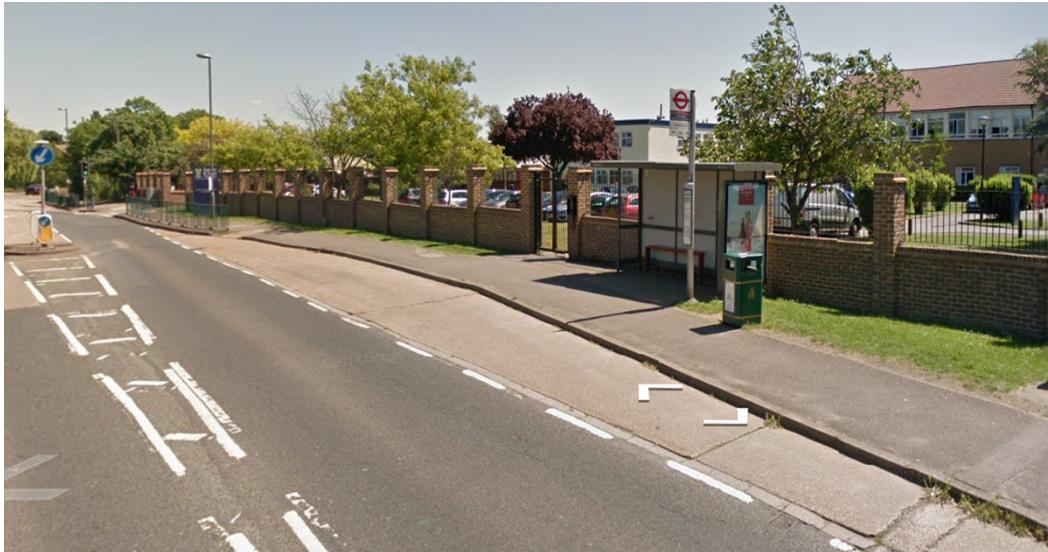
Location: Existing south-westbound bus stop in Ruxley Lane, adjacent to Cox Lane and Epsom and Ewell High School.

Existing: The bus stop has no bus cage or clearway markings. The close proximity of the school entrance means the lay-by is at risk from pick-up and drop-off parking.

Proposal: To provide a new bus cage and clearway road markings to comply with TSRGD diagram No.1025.3, for bus stop lay-bys. To approve the bus stop cage and bus stop clearway.

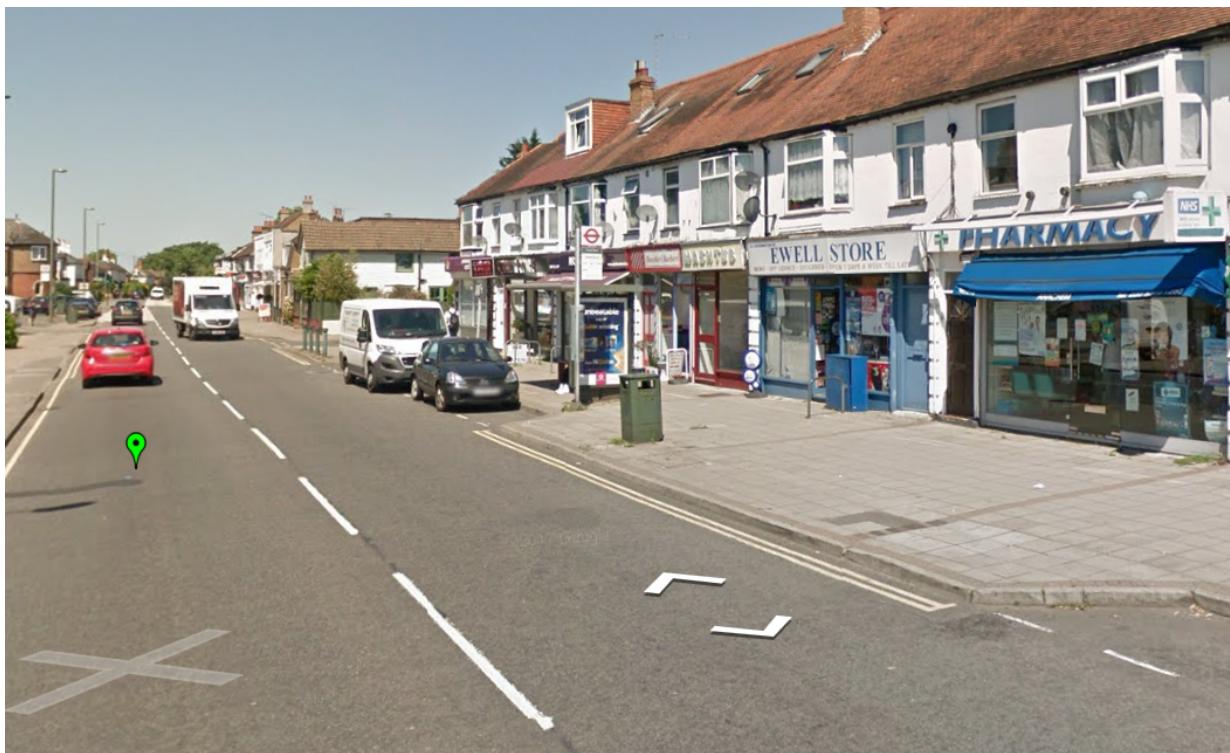
Location: Existing south-eastbound bus stop in Chessington Road, adjacent to Plough Road

Existing: The bus stop lay-by has been converted into a defined parking bay and buses currently stop on the double yellow line downstream of the lay-by. Although these restrictions give some protection from casual parking, there are no loading restrictions at this location. The close proximity of local shops means the bus stop is at risk from casual parking, particularly in the evening, and from loading at any time.

Proposal: It is proposed to create a new bus cage and clearway road markings to comply with TSRGD Diagram No.1025.1 along the built-out section of kerb (in the foreground of the photo) to replace the current double yellow line. Subject to consultation with TfL, the bus stop pole, which is their asset, would be relocated a few metres to the south-east to provide a target stopping position for the bus. The pole would be positioned approximately opposite the pharmacy (No 210 Chessington Road). The available funding unfortunately does not extend to relocating the bus shelter, a Clear Channel type with advertising, which are relatively costly to move. This would remain at its current location until such time as the shelter contract is renewed. Relocation would occur as part of this contract and is considered the most cost effective solution.

To approve the bus stop cage and bus stop clearway as described above.

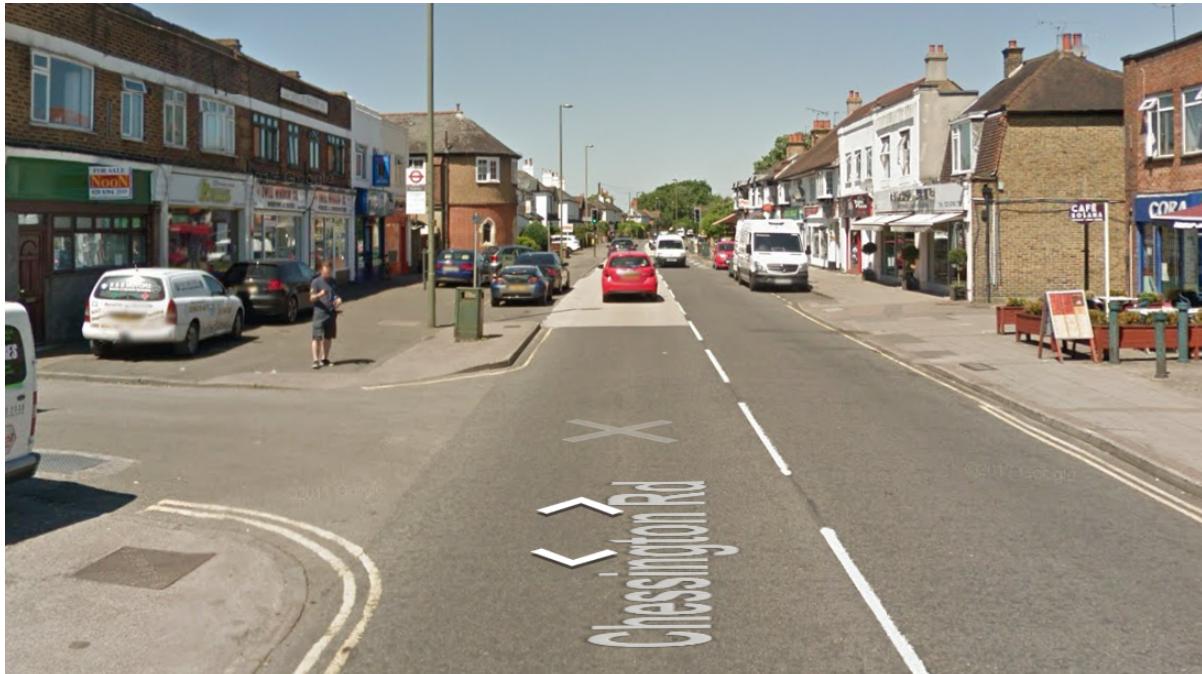
Location: Existing north-westbound bus stop in Chessington Road, adjacent to Plough Road

Existing: The bus stop has no bus cage or clearway markings, although some protection from parking results from a single yellow line. However, the close proximity of local shops means the bus stop is at risk from casual illegal parking. There are no loading restrictions at this location.

Proposal: To provide a new bus cage and clearway road markings to comply with TSRGD diagram No.1025.1. To approve the bus cage and bus stop clearway. The cage would be the minimum length feasible at 13m and would slightly over-sail the parking bay in front of the bus stop. However, the parking bay white road markings would remain and this overlap would not change the status of the parking lay-by.
